Impact of the CZU Fire on Stream Habitat in the Coastal Portions of Gazos and Waddell Creeks

Jerry J. Smith
San Jose State University (retired)
frogs_and_fish@yahoo.com

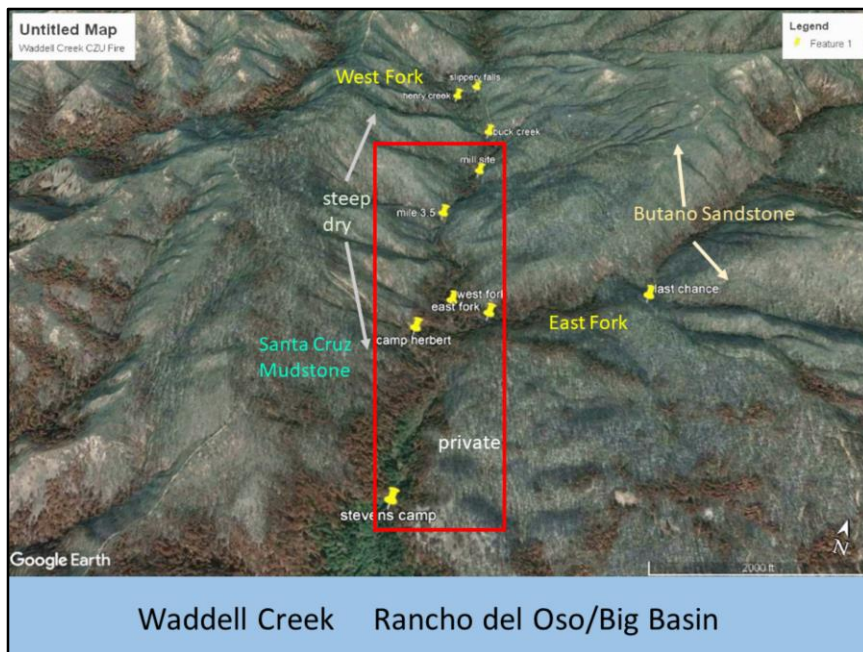
This Google Earth photo of Waddell Creek immediately after the 2020 fire shows the severe upland fire damage in the coastal portion of the watershed, within the Rancho del Oso (RDO) portion of Big Basin State Park (the gray landscape, with dead or severely damaged standing or downed trees). In the most downstream portion (bottom) of the watershed the green forest along the stream extends to upstream of Stevens Camp, about 2.6 miles upstream of the ocean and about 0.8 miles upstream of the Twin Redwoods trailside camp in RDO. The orange forest in the photo shows moderate canopy burn, extending upstream to the lower east and west forks of Waddell. Farther upstream on the West Fork (along the Skyline to Sea Trail) and on the East Fork, most of the riparian forest was severely burned.

The red rectangle brackets a reach of six sample sites assessed in 2021, with three others also assessed in 2022 downstream of the direct fire effects. The west upland slope of Waddell and West Fork Waddell is steep and drier. Most of the watershed is composed of Santa Cruz Mudstone, which weathers easily to silt and fine gravel. Upstream on the East Fork, resistant Butano Sandstone produces cobbles and small boulders.

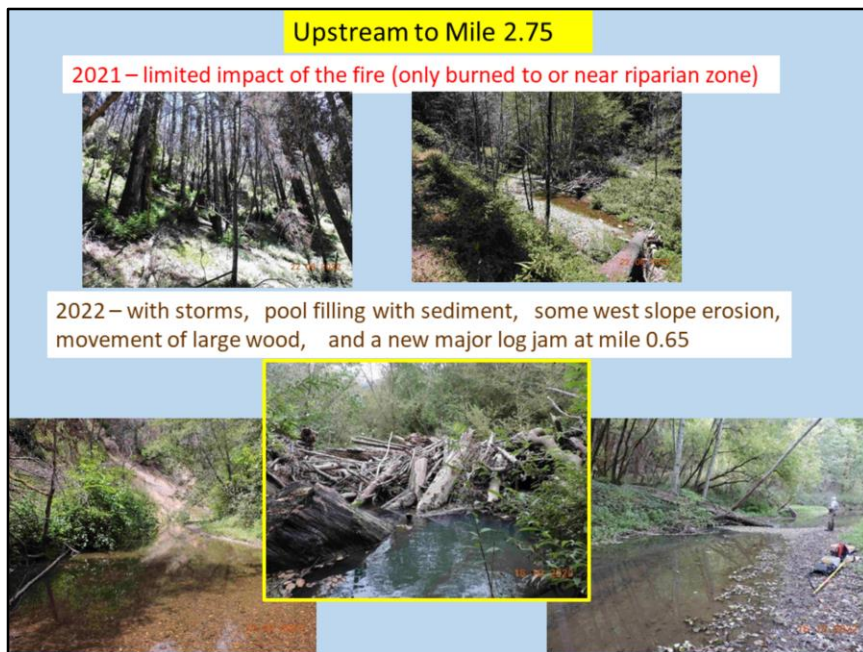
Upstream to mile 2.75 on Waddell Creek the CZU Fire burned upslope but did not damage the riparian vegetation. At the upstream end of the reach, some trees were burned and toppled into the adjacent stream and some streamside alders were apparently cooked and killed (photo upper right). However, the channel was little affected in 2021.

The larger storms in October and December 2021 produced some localized slope erosion and debris flows (photo, lower left at Twin Redwoods Camp, mile 1.8). The high water also moved much old and new channel wood, including producing a major new high, tight, and wide log jam in a narrow, entrenched channel (like a cork in a bottle) at mile 0.65 (Photo, lower middle). That log jam is probably a substantial barrier to fish passage, and probably was in most of December 2021.

Pools in the reach suffered substantially with the December 2021 floods, with wood moved and sediment deposited, filling pools, which are important for over-winter survival of juvenile coho and steelhead. The photo on the lower right is typical, where old fallen alders were rinsed away, and the long, deep pool was mostly filled with sediment, except around a single large log.

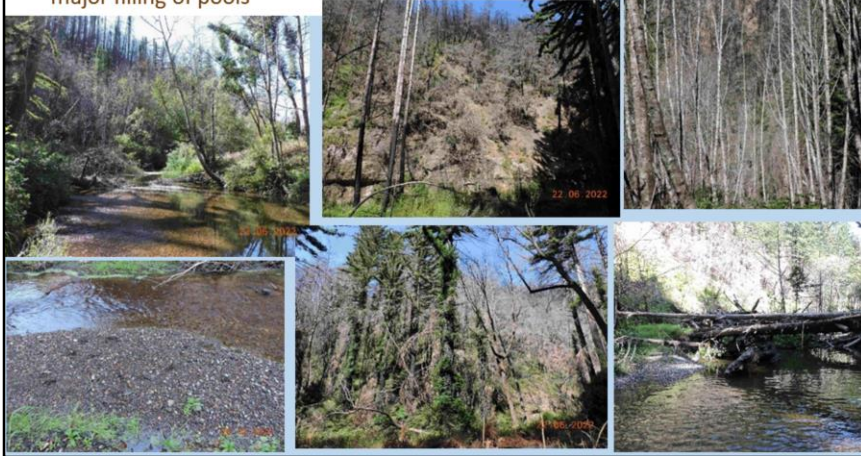
Miles 2.8 – to the confluence of the East and West Forks

2021 and 2022—fire burned to and across stream, alders killed, majority of canopy lost from surviving trees, water temperature increased, alder log jam, steep west slope erosion of fines and mudstone gravel, major filling of pools

From mile 2.8 to the confluence of the forks the fire burned to and across the stream, killing most streamside alders and eliminating much of the channel shade (photos, upper left and upper and lower middle). Steep west slope erosion in the first winter (photos, upper middle and right), including a ridge top to stream debris flow at the forks (photo, upper right), dumped abundant small angular mudstone gravels (photo, lower left) into channel filling formerly deep pools (photo, upper left). Conditions were similar in 2022, because pools had already been filled and high flows added more sediment, rather than flushing it.

One debris flow in 2021 (at mile 2.85) also dumped several large trees into the channel, which caught some of the killed and transported alders, creating a large partly open log jam (photo, lower right). That log jam was tripled in length in December 2021 by storms that added many more dead alders to the jam.

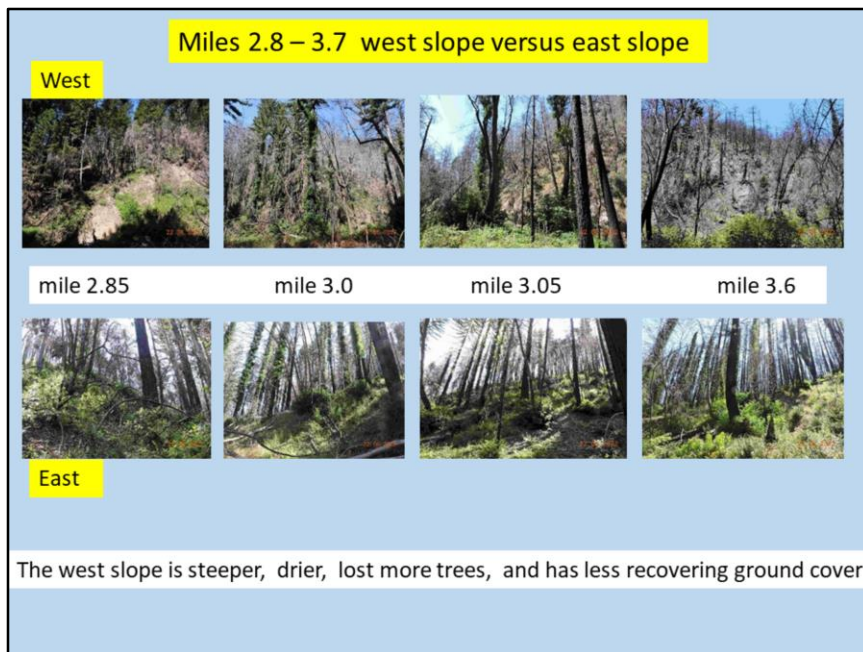
The differences between the west slopes and east slopes above Waddell and West Fork Waddell were dramatic from miles 2.8-3.7. The west slope is much steeper and drier, and had more forest tree loss (including common Douglas firs). Ground cover recovery to protect the slope from erosion has been limited, despite more rain in the second winter. The east slope is less steep, and ground cover has substantially recovered. Most lower east slope redwoods had basal and trunk sprouting, and tanoaks had basal sprouts. The east slopes suffered relatively little erosion in the two years after the fire.

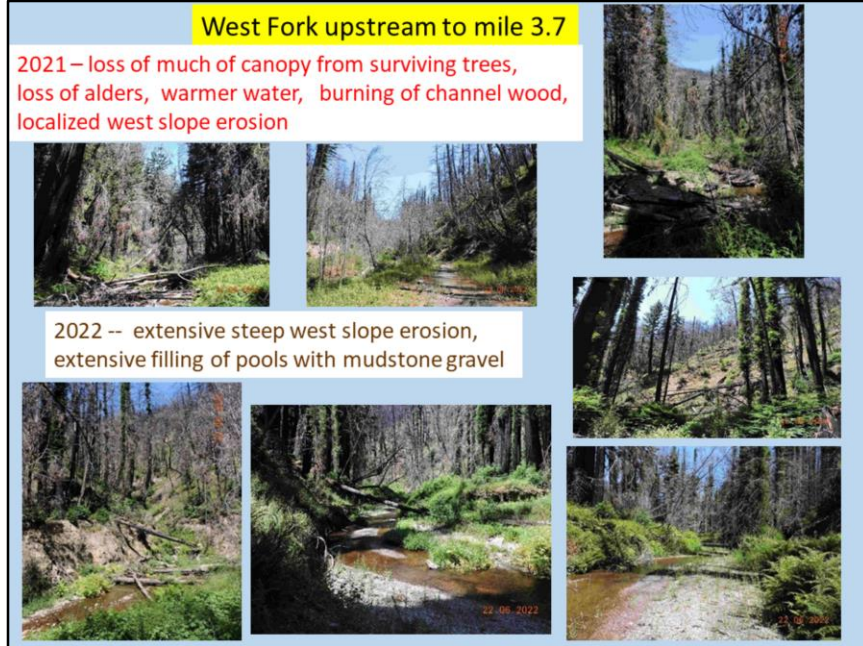
On the West Fork the fire burned across the stream killing the alders and removing most of the canopy of surviving trees (upper photos), including the riparian redwoods, which responded with branch and trunk epicormic sprouts. Streamside and lower slope bigleaf maples basally sprouted from their dead trunk by late summer 2021 (photo, upper middle) and will provide stream shading within about 10-15 years. The canopy loss resulted in increasing summer stream temperatures by 2-4 degrees C, but the effect was probably moderated by higher stream flow.

Channel wood that aided pool formation was also burned, including a major log jam from 1998 that was frequently a significant partial barrier to fish passage (photo, upper right). In 2021 there was only very localized sedimentation of the pools, because of the mild winter. However, with the October and December 2021 storms, west slope erosion was extensive throughout the West Fork (photo, lower left). Most pools were filled with gravel and fines. (The typical effect is shown in the two lower middle and right photos, where large deep pools were more than 90% filled).

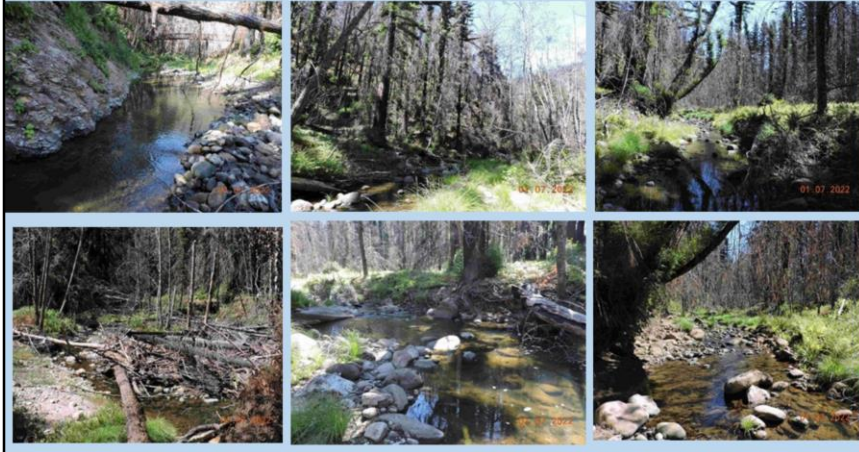
Lower East Fork

2021 – loss of alders and much of streamside canopy of other trees, slightly warmer water (shade from steep north slope)

2022 – little channel change in cobble/boulder armored channel from upstream Butano Sandstone. Silt in pools but no filling.

The fire burned the alders and upslope trees on the East Fork, eliminating alders and Douglas firs, but because of the northeast orientation of the stream and the steep north-facing slope, much of the shading remains.

The East Fork of Waddell Creek usually has larger flood peaks than the West Fork, but the stream bed is steeper and is armored with cobbles and small boulders from the Butano Sandstone from farther upstream. Slope erosion was apparently limited or captured within the riparian corridor. There was a coating of fine sediment in the pools, but no significant pool filling, The East Fork channel presently is in the best condition within the watershed.

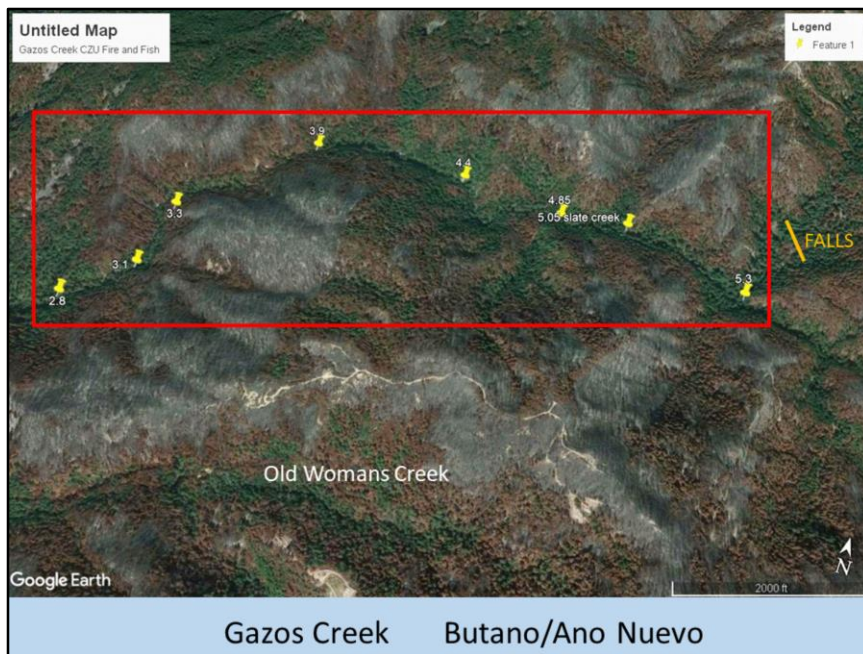
Compared to Waddell Creek, the CZU Fire burned less severely to or near the channel of Gazos Creek, above mile 2.8 within Butano and Ano Nuevo State Parks. Upslope the burn was heavier than that near the stream, and was also heavy in Old Woman's Creek watershed, a tributary that enters Gazos Creek farther downstream near mile 2.0. Steelhead (and coho salmon through 2005) have access to below the falls at the Mountain Camp at about mile 5.45.

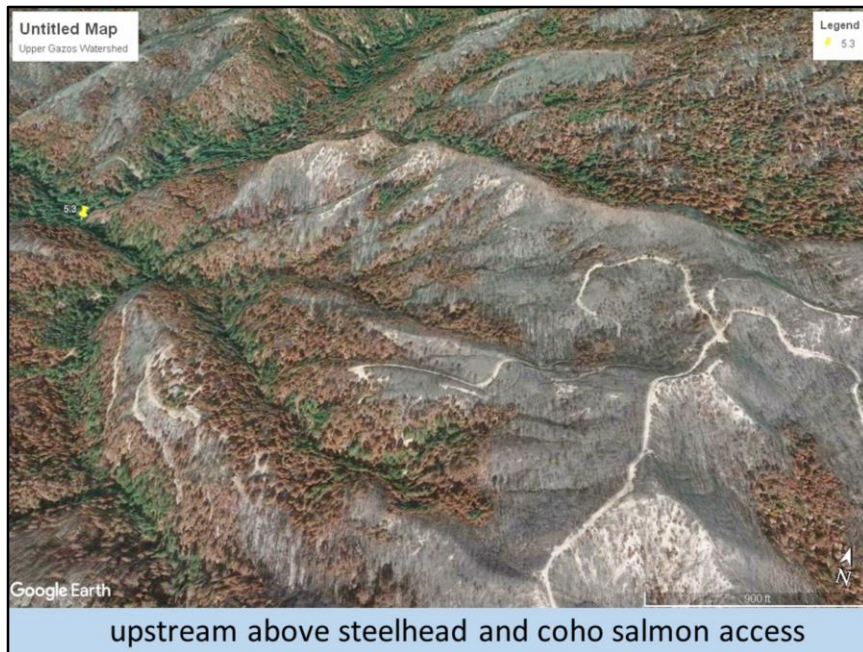
Upstream of the falls there was an intensive burn, that would be a source of sediment input downstream.

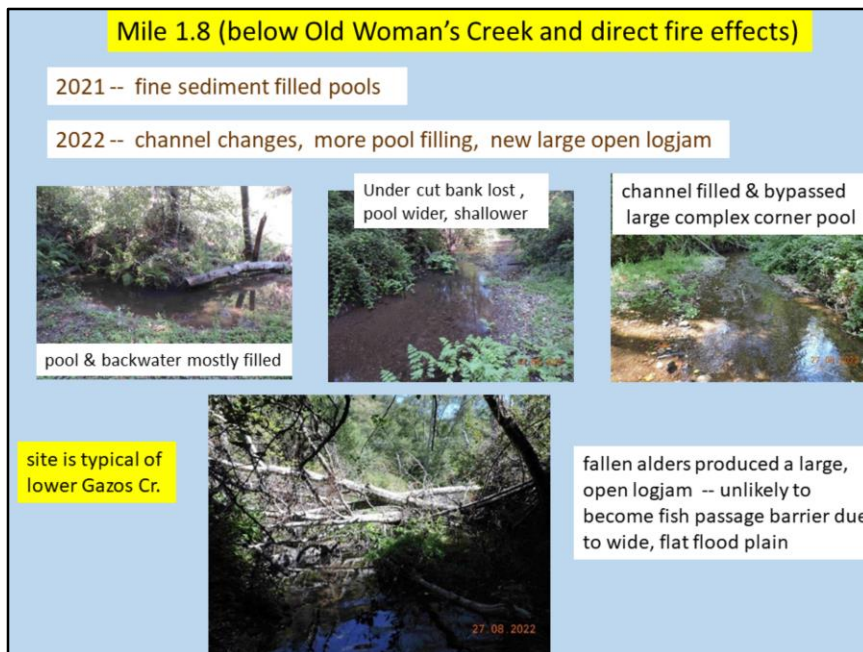
Downstream of mile 2.0, the indirect effects of the burn upstream on Gazos Creek and Old Woman's Creek were limited to fine sediment input in the first winter after the fire. However, the storms in October and December 2021 produced substantially more erosion in both watersheds and delivered it downstream throughout lower Gazos Creek. At mile 1.8 the storms and sediment filled pools (photos, upper left and middle) and rearranged the channel (photo, upper right).

The storm flows also undercut and toppled alders, including producing a large open log jam just upstream of the 1.8 mile sample site (lower photo). Alder trunks tend to break up within several years. In addition, the channel downstream of mile 2.0 tends to have a sandy, rather flat, and broad flood plain (low entrenchment). The stream tends to cut under or around fallen and accumulated wood, rarely become a durable, significant fish passage problem.

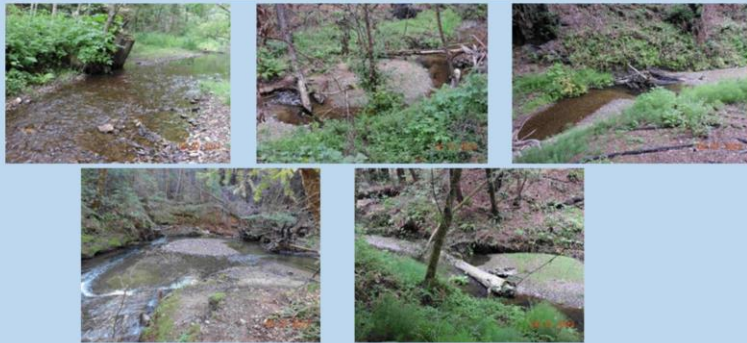
Miles 2.8 - 5.3 part 1

2021 – burn had minimal effect on riparian canopy, but some fallen and cut wood added to channel. Erosion added silt to channel

2022 – storms added abundant fines and gravel to channel, filling pools

From mile 2.8 through 5.3, streamside and channel conditions responded generally the same. The fire burned to or near the stream bed, but loss of streamside trees or shading changed relatively little overall (upper photos). Temperature recorders in 2021 found little change in summer water temperatures, partly due to increased stream flow, despite the drought.

General channel conditions changed little following the mild first winter, although fine sediment was increased on the stream bed. However, the storms in October and December 2021 dumped substantial fine sediment and fine gravel into the stream and moved the slurry throughout the reach. Many pools were eliminated (photo, middle left), and most pools were substantially filled (lower photos). The loss of pools may have resulted in the spotty pattern of fish abundance, as adult steelhead apparently avoided spawning reaches without large pools. Although overall juvenile steelhead abundance in 2022 was atypically high, the scarcity of pools may affect overwinter juvenile survival.

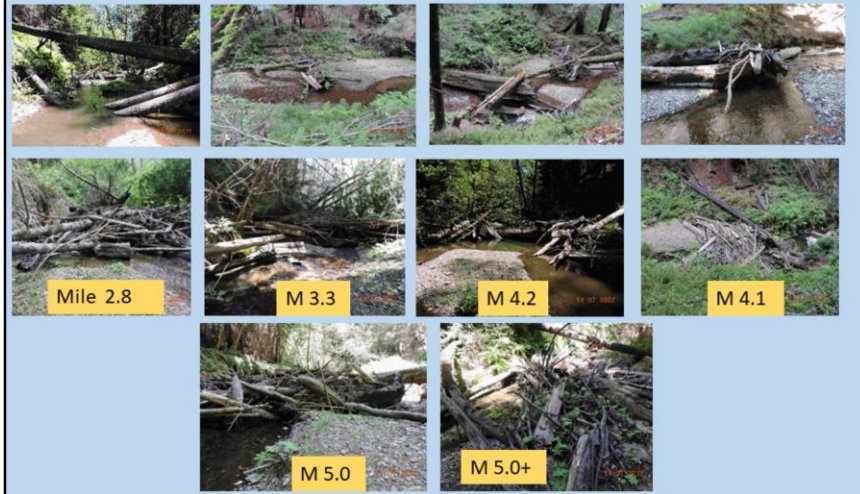
Miles 2.8 – 5.3 part 2

2022 -- more dead or damaged trees added to channel from steep streamside slopes, aggregated by high flows and narrow/entrenched channel into 6+ log jams that are serious present or potential fish passage barriers.

Substantial new wood from fallen and cut trees was added in both years after the fire (upper photos). The storms in October and December 2021 moved the wood around in the channel and often aggregated it as log jams anchored on fallen trees in narrow, entrenched portions of the channel. Much of the Gazos Creek channel upstream of mile 2.5 is entrenched (photo, upper left) , partly because the streamside road has eliminated much of the former flood plain.

In 2022, at least 6 major log jams were present, that act as potential or actual fish passage problems (photos, lower two rows). They should be modified and monitored. The jam at mile 2.8 pre-dates the fire, and was partially burned by the fire. It enlarged and tightened by 2022. The jam at mile 4.2 was formed by a debris flow with redwood trees in 1999, and had been a fish passage problem of variable difficulty until December 2021, when more than two-thirds of the wood was dislodged by the storms. Unfortunately the dislodged wood was captured by fallen trees in the narrow channel at mile 4.1, merely moving the severe jam..
