## Waddell Creek Post-fire Resurvey July and October 2022

(revised from August 2022; text revisions are in *italics bold*)

Jerry J. Smith

31 October 2022 (errors corrected on page 5 and photos 110,114,122,125 on 11 November 2022)

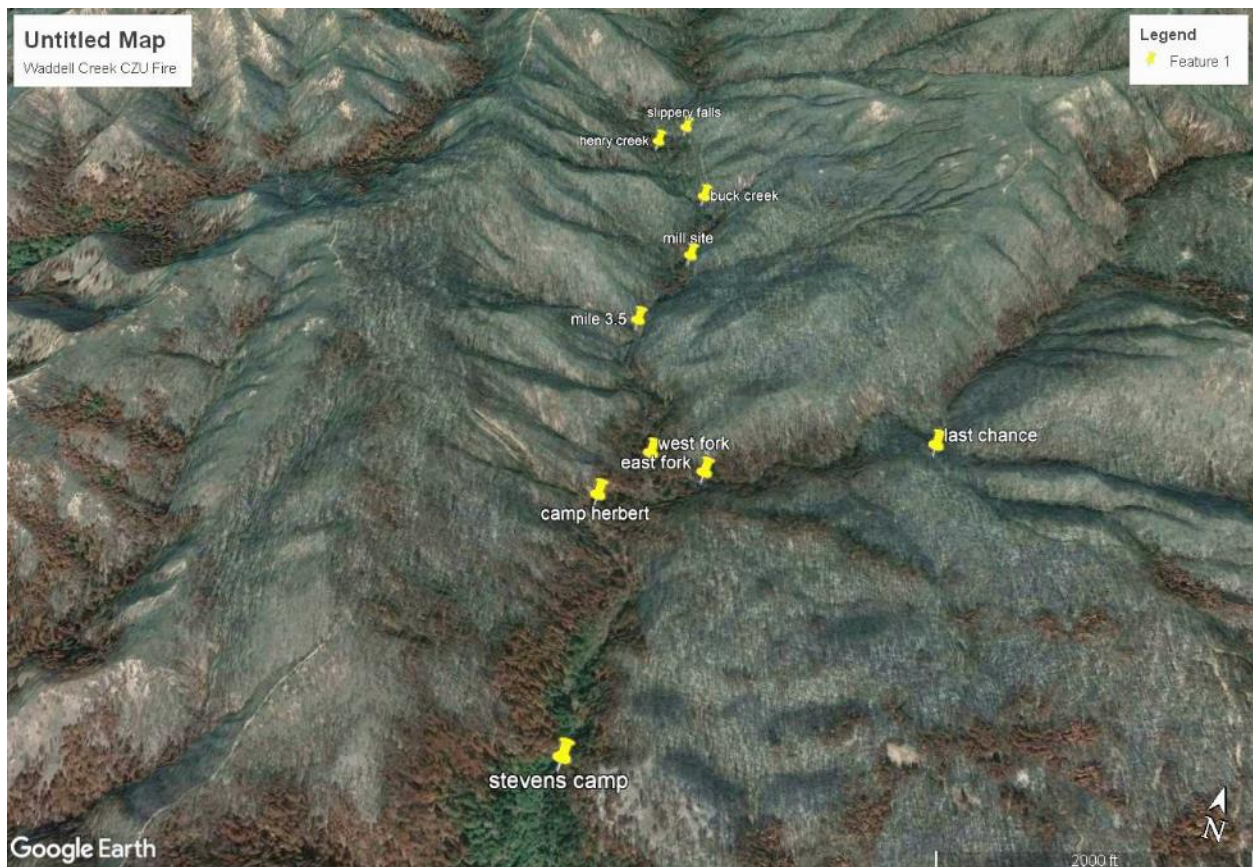
Figure 1. Google Earth aerial photo of Waddell Creek watershed from downstream of Stevens Camp (mile 2.55) to the upper watershed of the East and West forks (taken fall 2020 after the CZU Fire). The green streamside is intact riparian and lower upslope forest. Orange is medium burned forest extending upstream to mile 3.6+ (Mill Site). Remainder of the watershed in gray is severely burned upland with mostly standing or downed burned trees only. Yellow icons are historical fish sampling sites used since 1992.

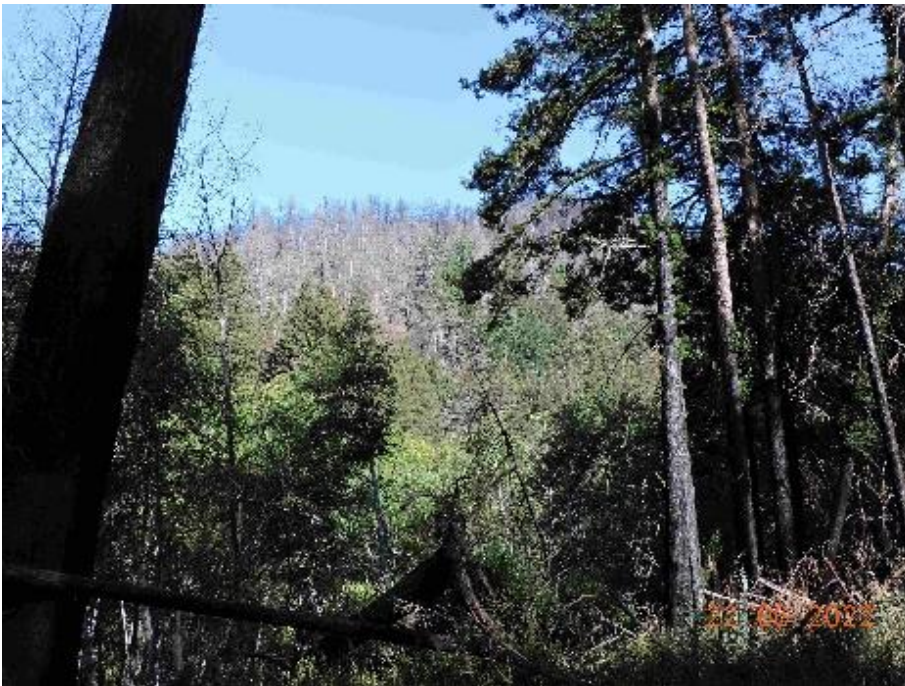
Photo 22. Mile 2.6. Looking across channel to severely burned upper west slope.

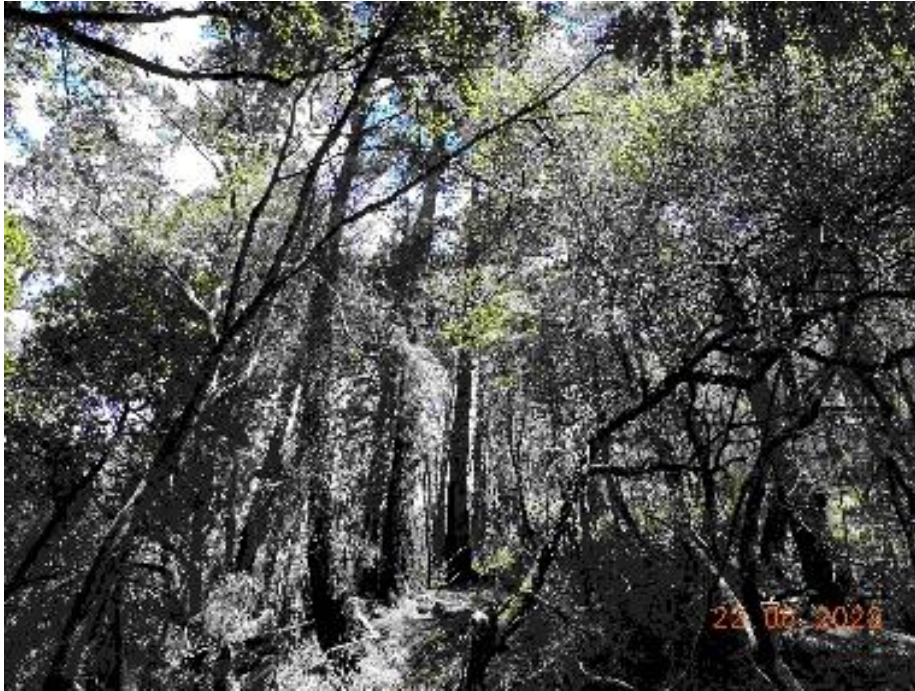
Photo 23. Mile 2.4. Burned forest east and upslope from road.

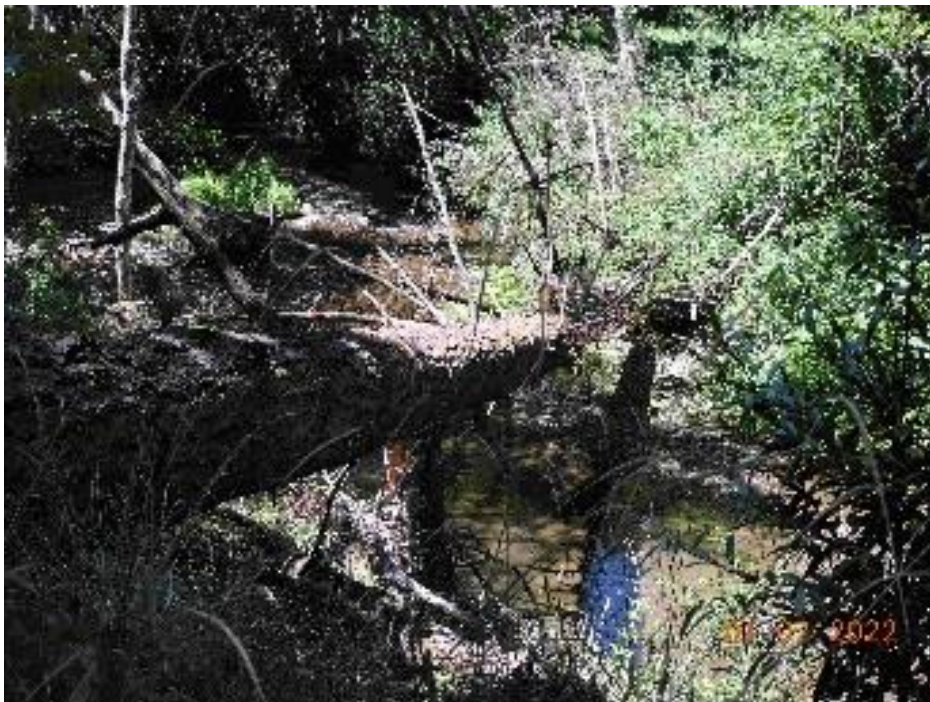
Photo 24. Mile 2.65+. Douglas fir burned and toppled into channel and dead small alders cooked by fire on the right bank stream terrace.

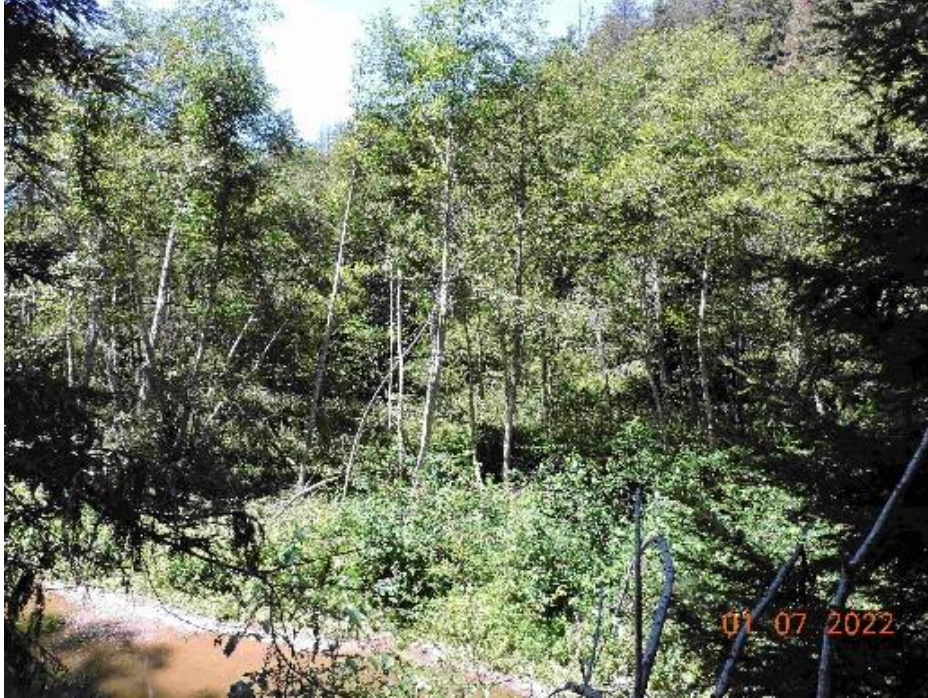
Photo 25. Mile 2.65+. Mostly intact right bank riparian forest, with young alder growth at streamside.

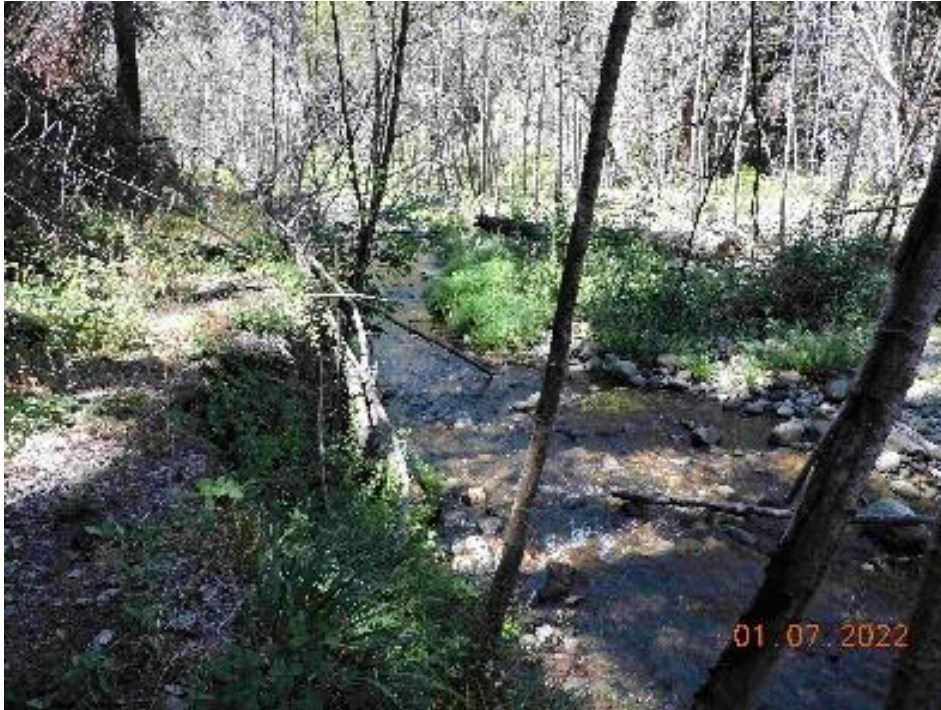
Photo 27. Mile 2.7+. Dead alders cooked by streamside fire in 2020. Clean sandstone cobble/gravel riffle and run.

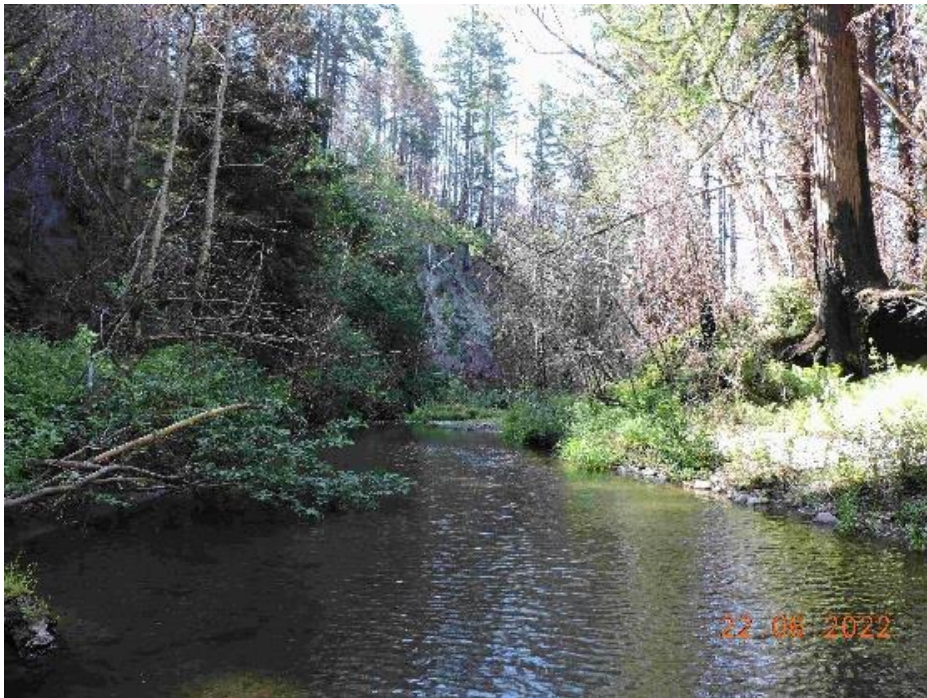
Photo 30. Mile 2.75+, looking downstream. Loss of most alders, with partially burned east slope in background.

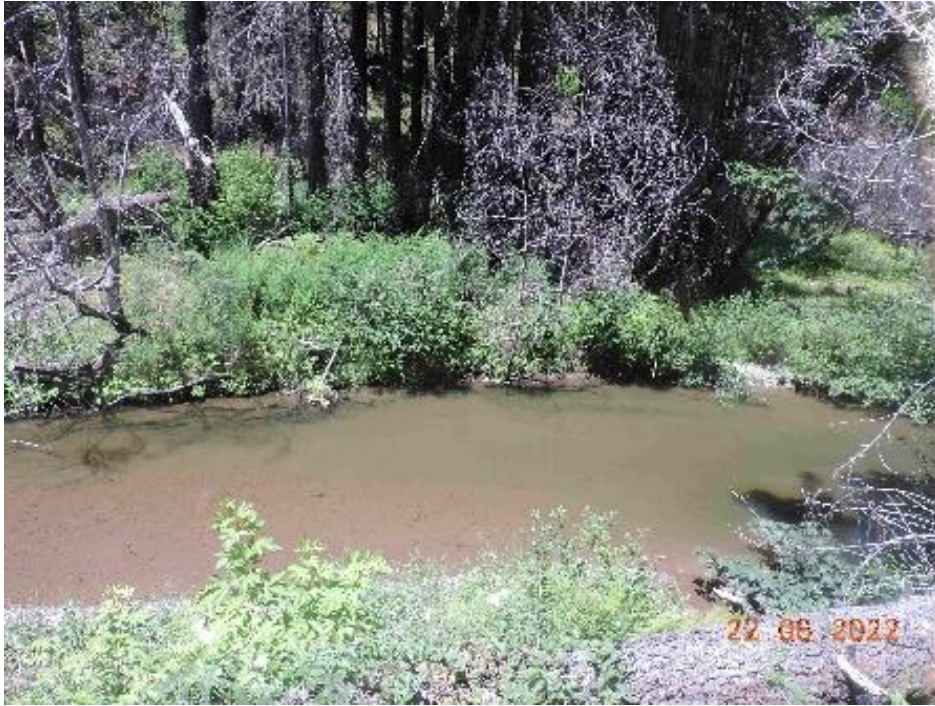
Photo 31. Mile 2.8. One of several substantially filled formerly large and deep pools between here and the forks.

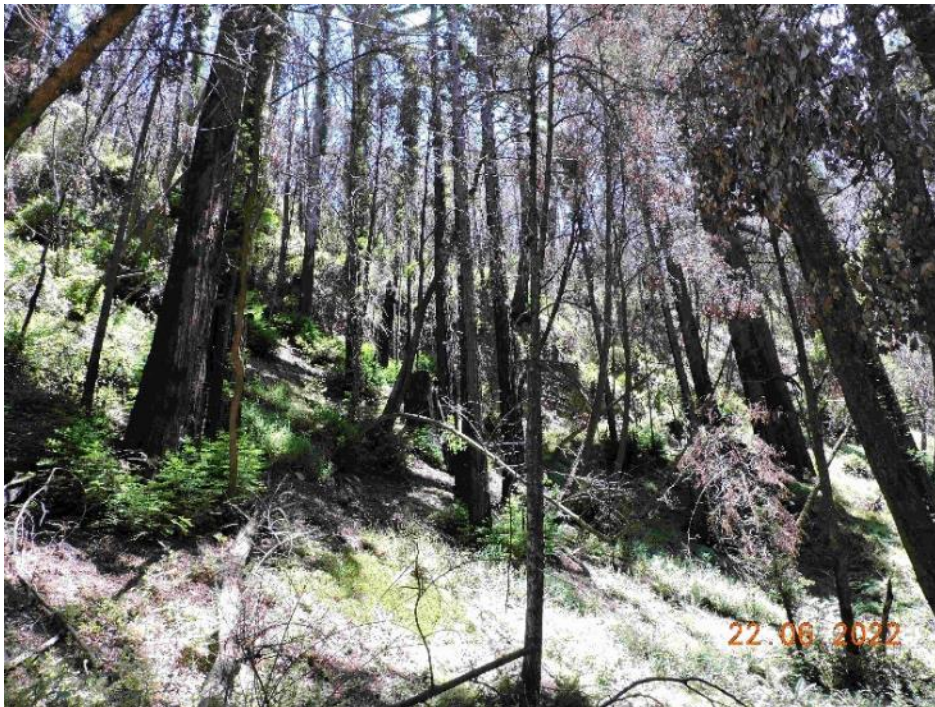
Photo 32. Mile 2.85. East slope with basal sprouting tan oaks and redwoods and with established ground cover (ground cover was lacking in 2021).

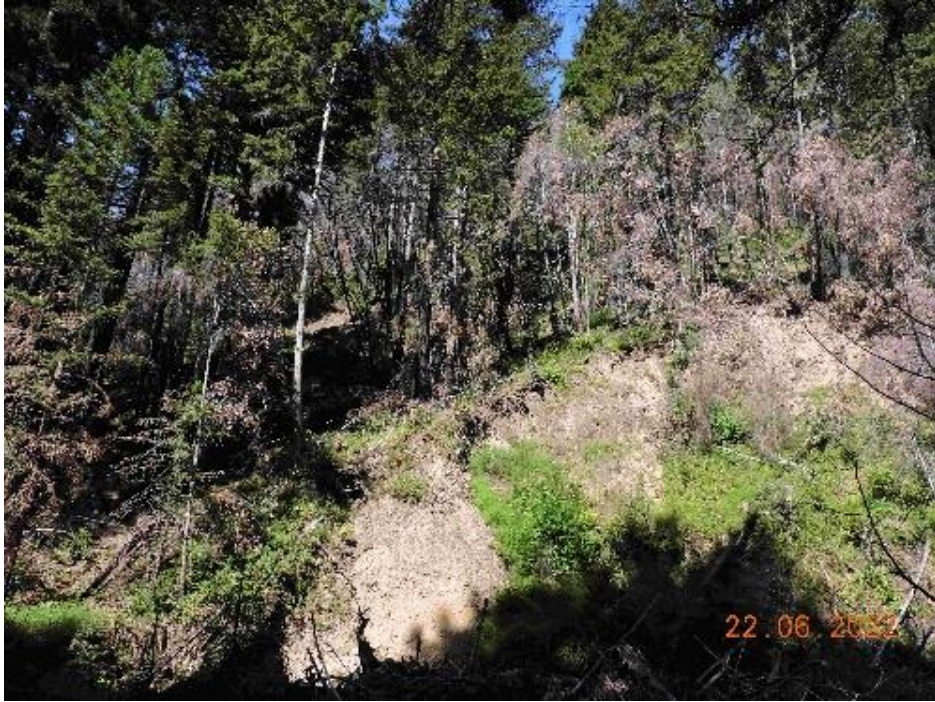
Photo 35. Mile 2.85+. **West** slope failure and debris flow from 2021 at 2021 logjam.

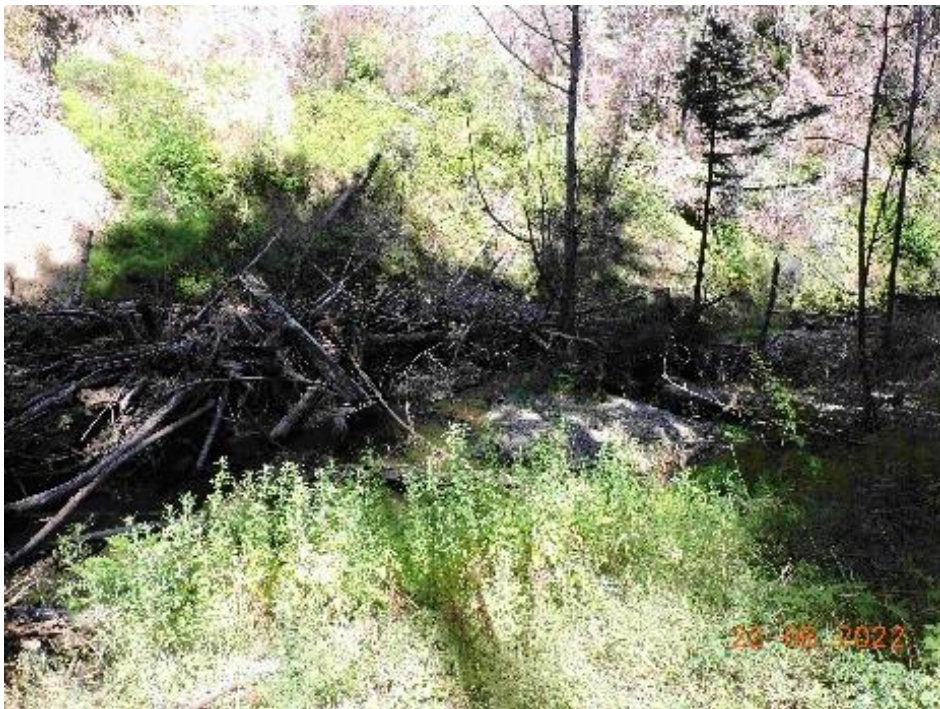
Photo 36. Mile 2.85+. Upstream enlarged portion of the logjam, consisting of dead, flood-transported alders.

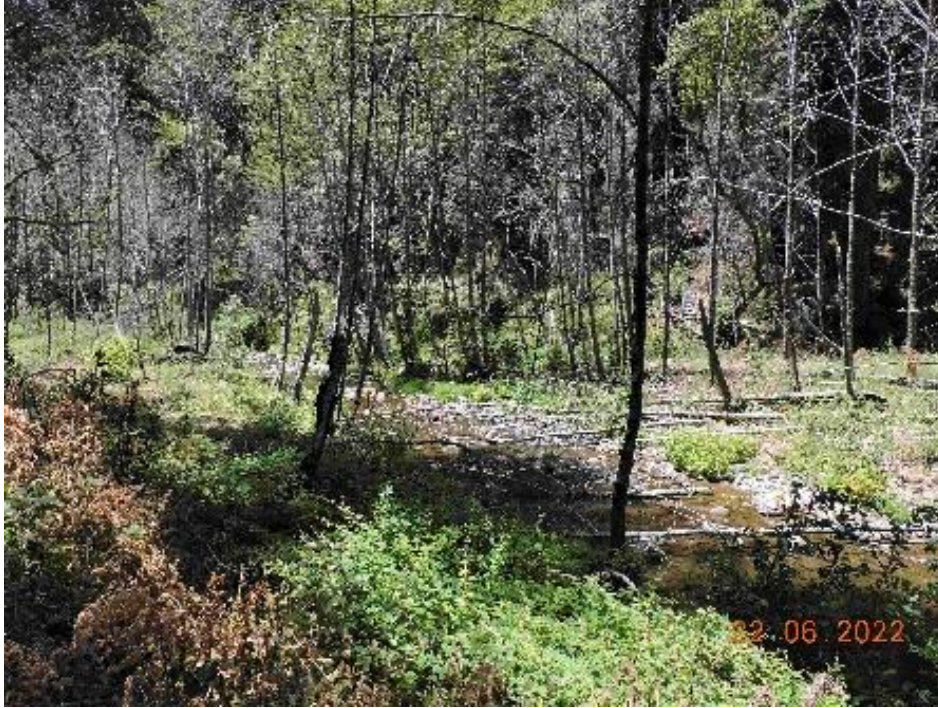
Photo 39. Mile 2.9. Dead and down alders upstream of flood plain forest and at upstream bottom of the bypass trail.

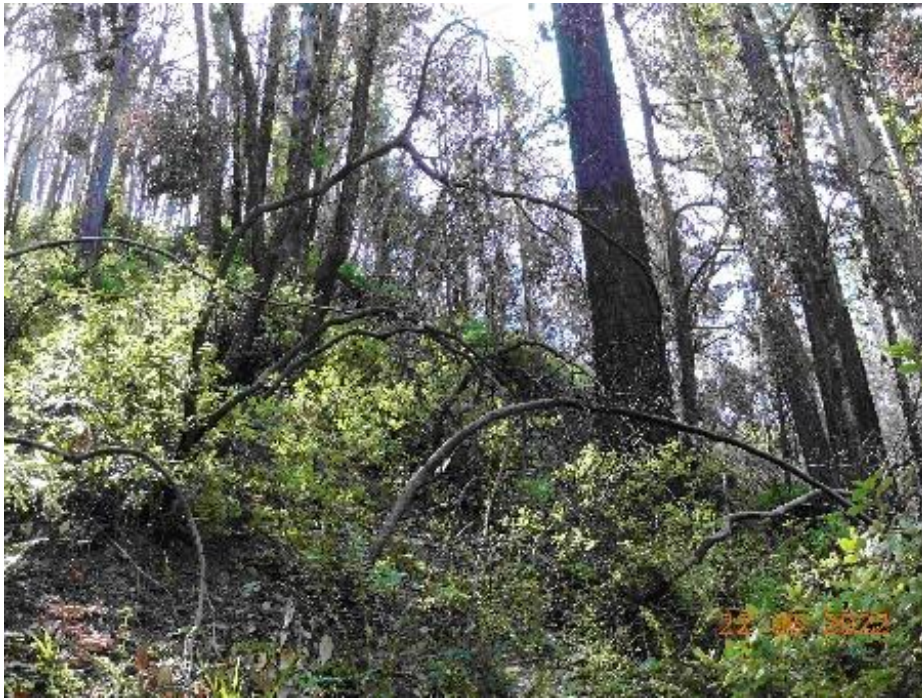
Photo 40. Mile 2.9. East Slope with tanbark oak oaks with standing burned trunks and basal sprouts.

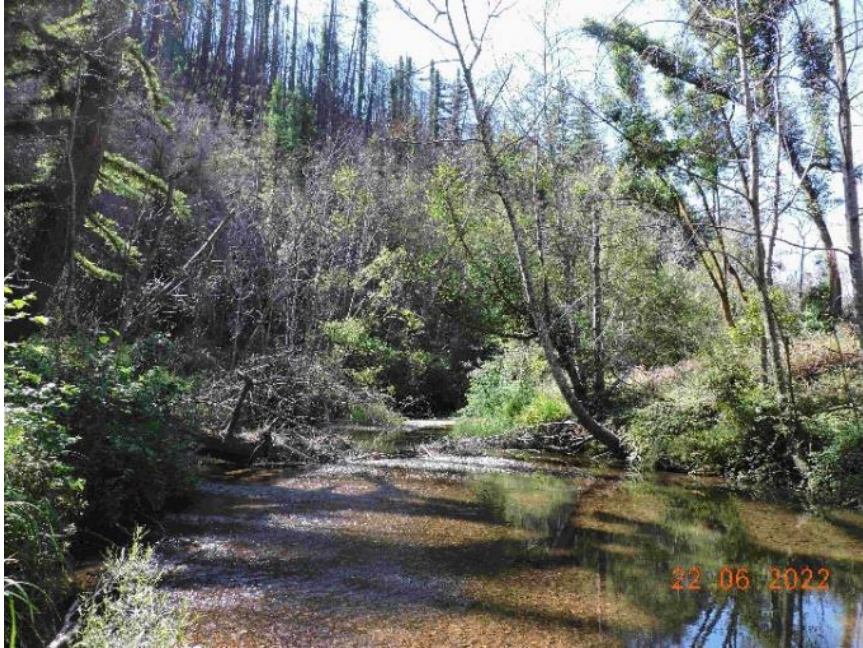
Photo 41. Mile 2.9+, looking downstream. Formerly large pool now severely filled with small mudstone gravel. Dead alders. New leaves on branches of surviving redwoods, California bays, and big-leaf maples. Upper east slope forest in the left background.

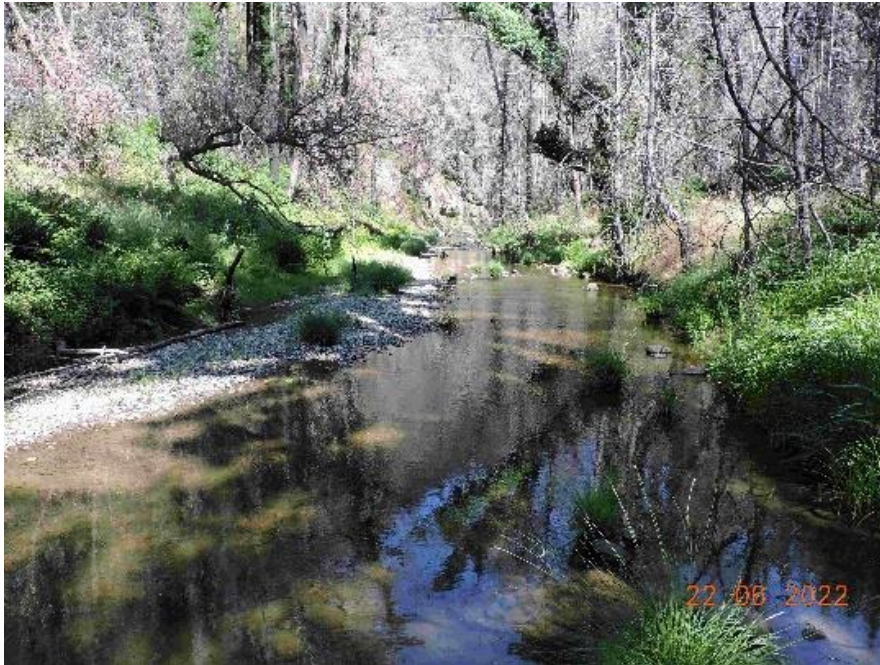
Photo 43. Mile 2.9+, looking upstream. Aggraded channel and filled pools, with burn to both banks in 2020. The steep west slope in the background is typical of the source of channel sediment from here upstream to the forks.

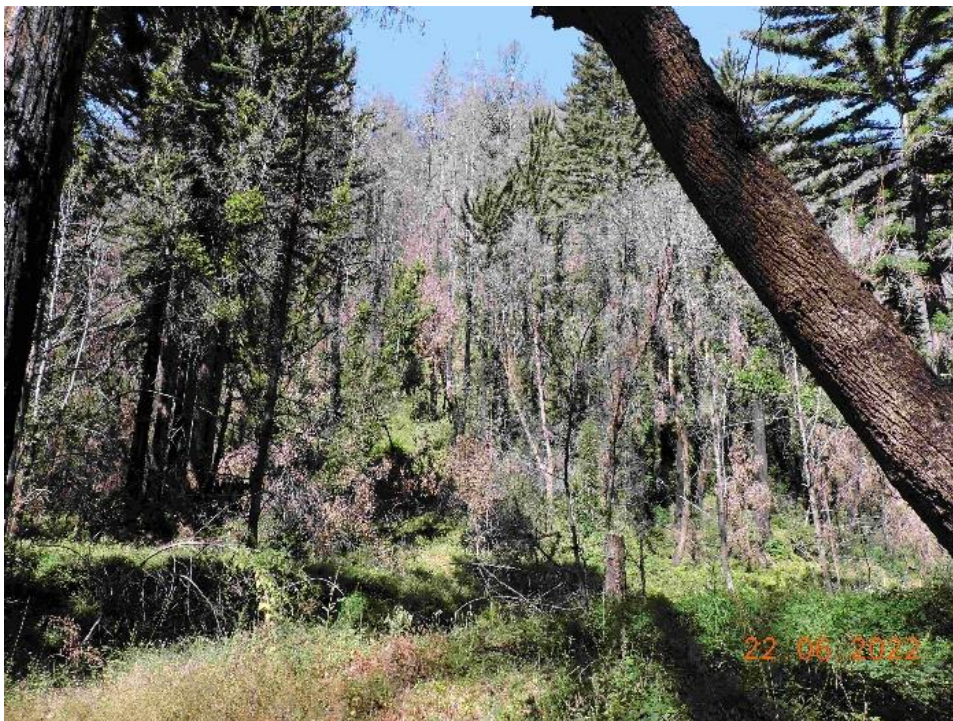
Photo 44. Mile 2.95-. Looking across the east terrace and stream to West terrace and upper slope.

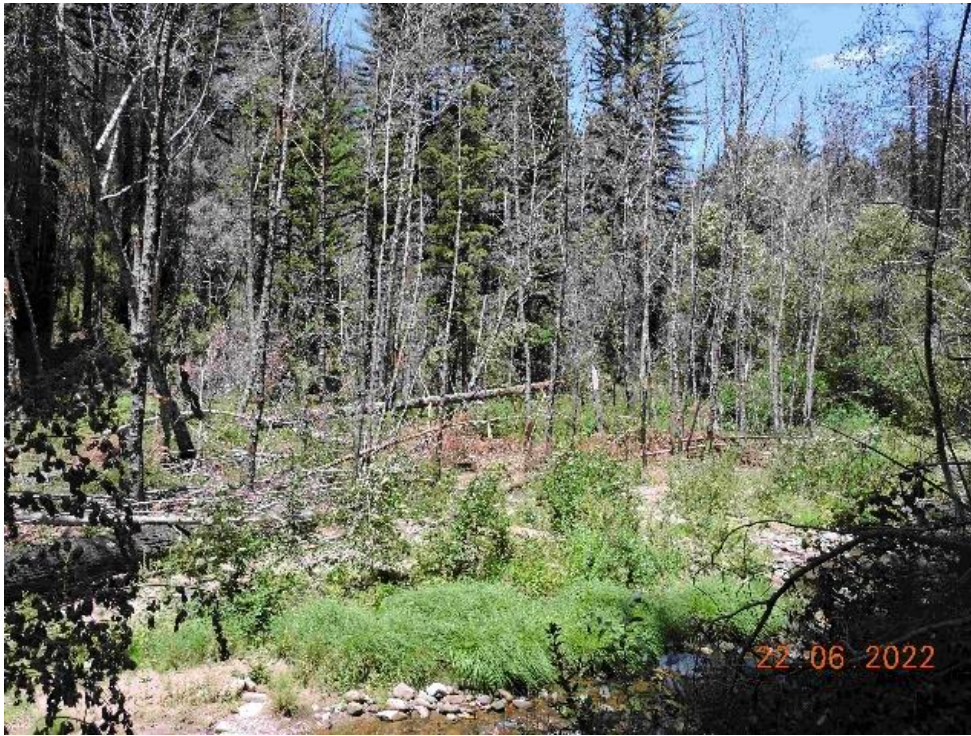
Photo 45. Mile 2.95. Dead west bank alders and scarce new alders at edge of unshaded stream.

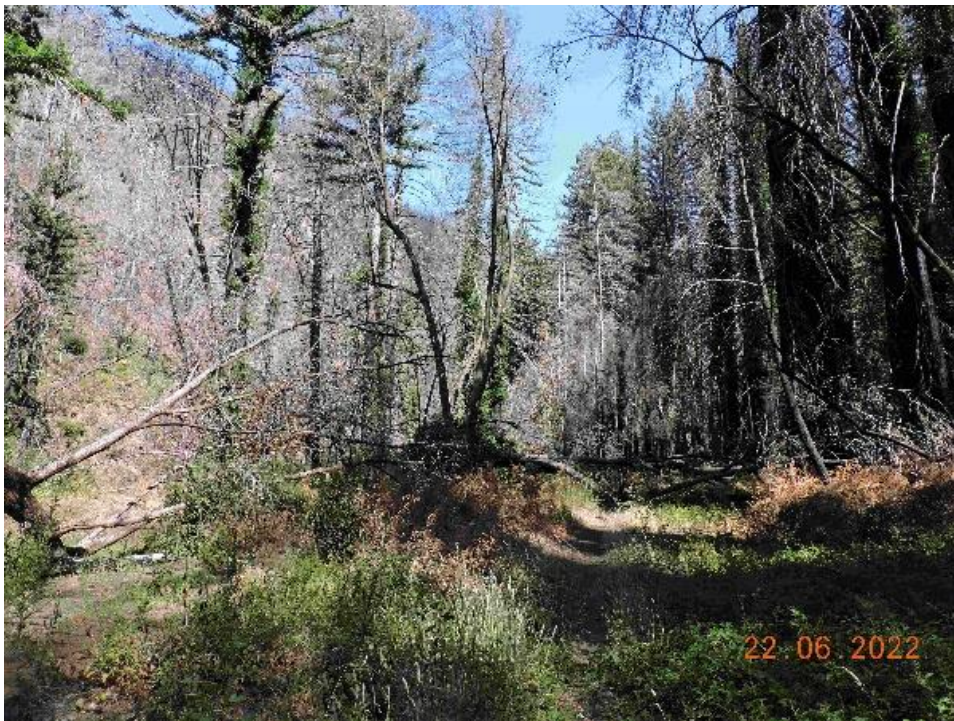
Photo 46. Mile 3.0. Severe burn on both banks and west slope.

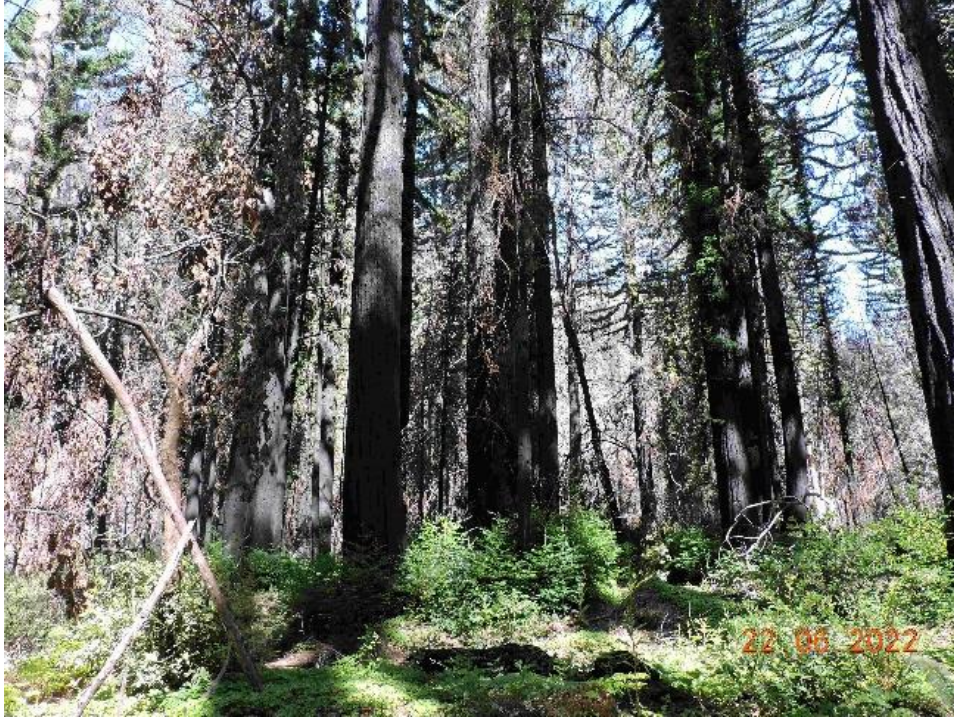
Photo 49. Mile 3.05+, Camp Herbert. Burned forest with dead tanbark oak trunks, but with basal sprouts and redwoods with trunk and branch epicormic sprouts.

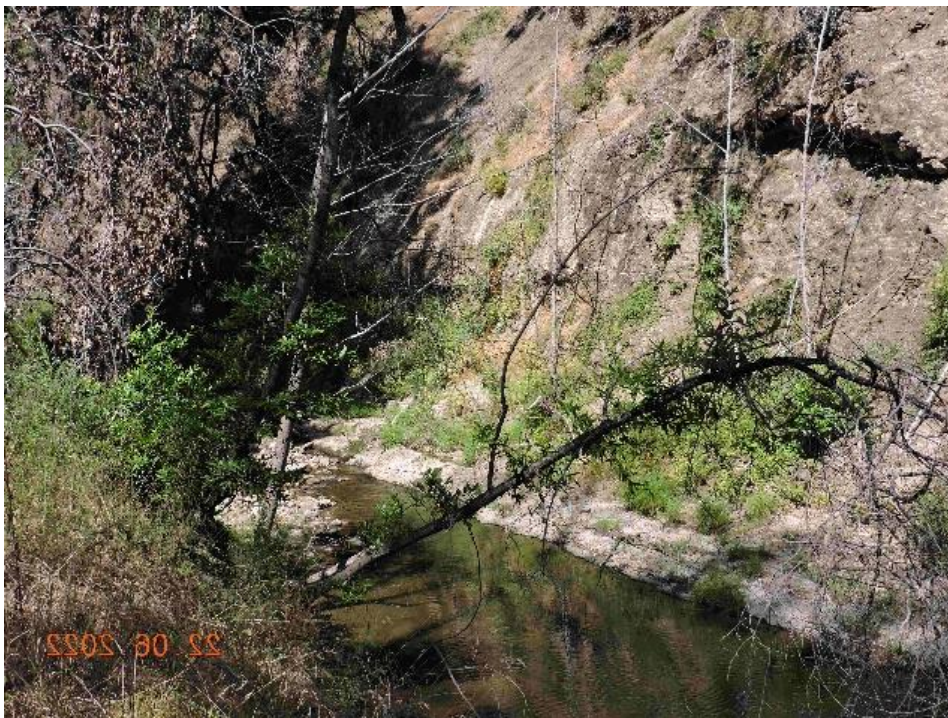
Photo 52. Mile 3.05+, Camp Herbert. Steep eroded slope and substantially filled pool from lower west slope erosion.

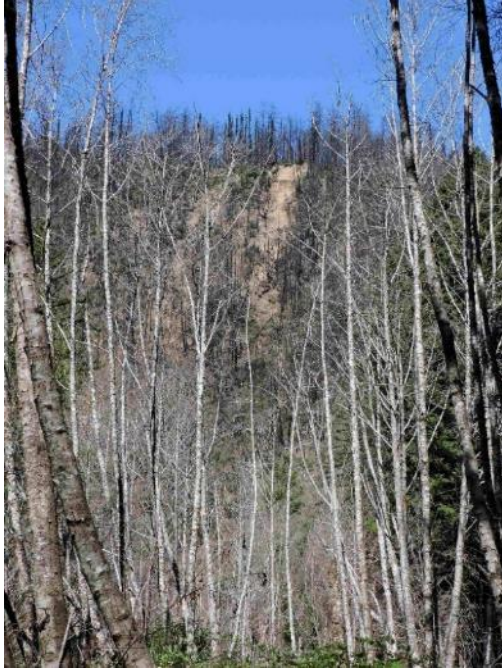
Photo 55. Mile 3.05+. West slope viewed through alders on lower East Fork, with severe burn and debris flow from ridge top to Waddell Creek, responsible for much of the channel filling downstream.

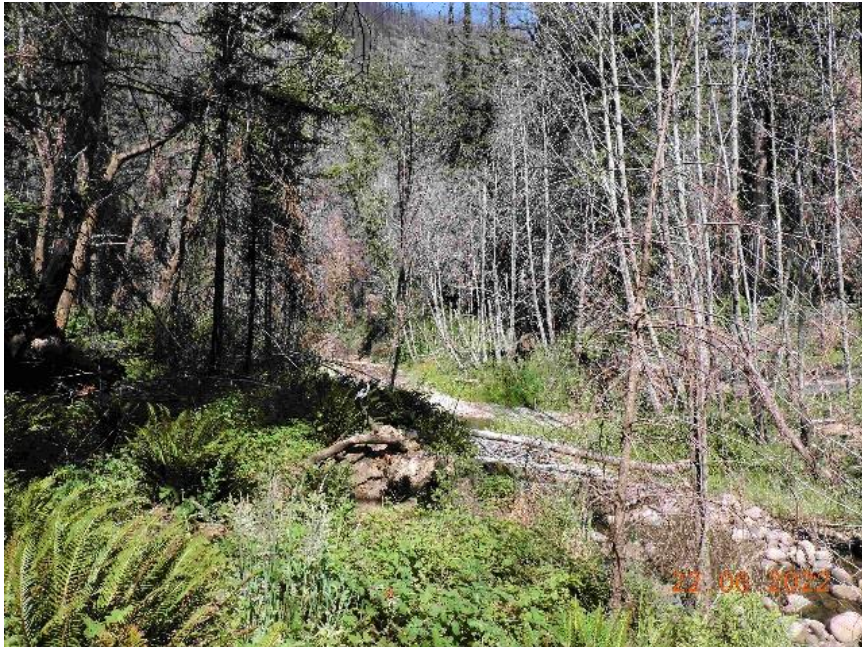
Photo 56. Confluence of East and West forks, mile 3.1. All alders killed on the flats between the two forks.

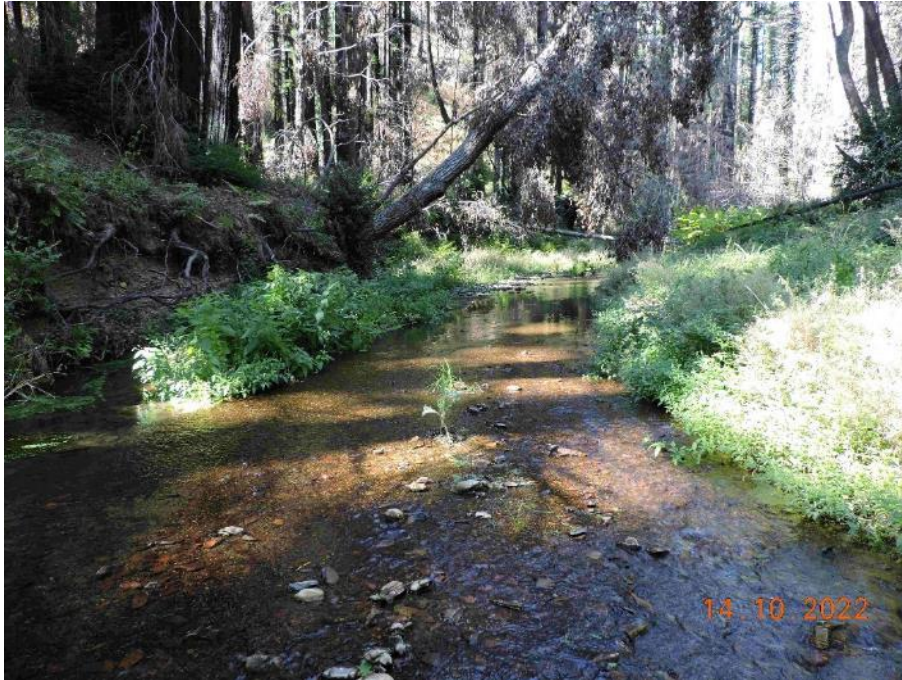
Photo 63. West Fork mile 3.15+, looking upstream. Formerly deep pool (3-4 ft) with large wood and right bank backwater near the head. Frequently too deep to sample effectively. Now more than 90% filled, leaving shallow glide and pool habitat.

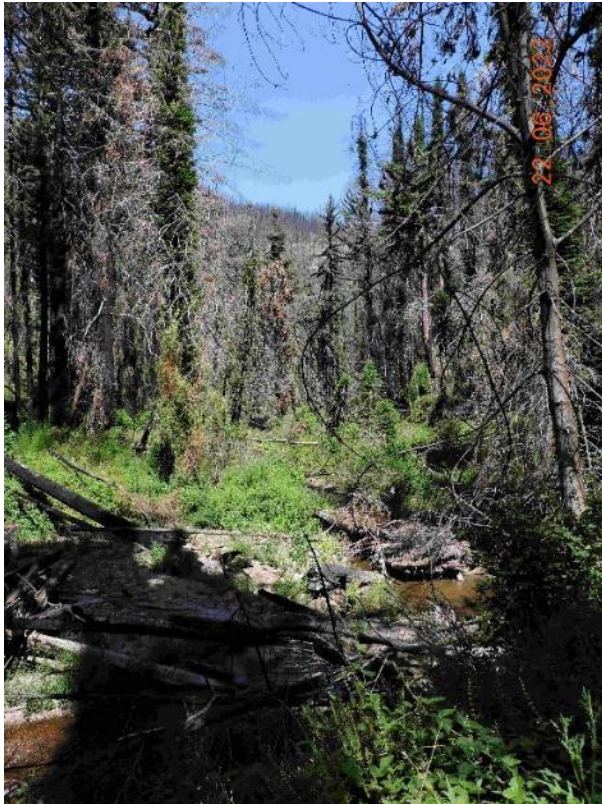
Photo 70. West Fork, mile 3.4. Streamside habitat at a 1998 large logjam (a frequent partial fish passage barrier) that was substantially burned in the fire. Now passable in aggraded channel.

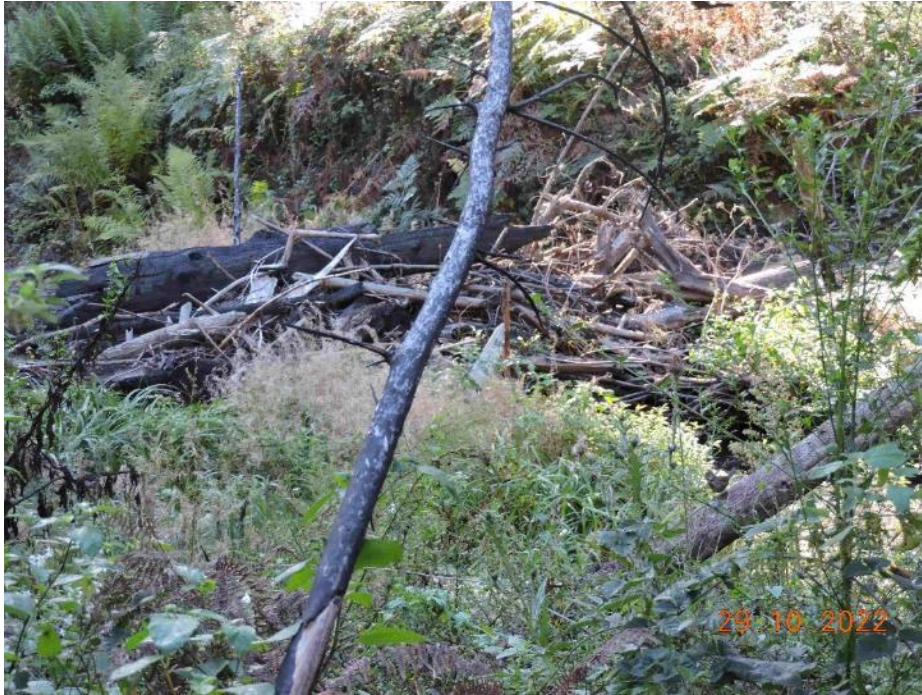
Photo 73. West Fork, mile 3.45. Large fallen tree and accumulated smaller wood is potentially a loose and erodible jam. The channel upstream is aggraded.

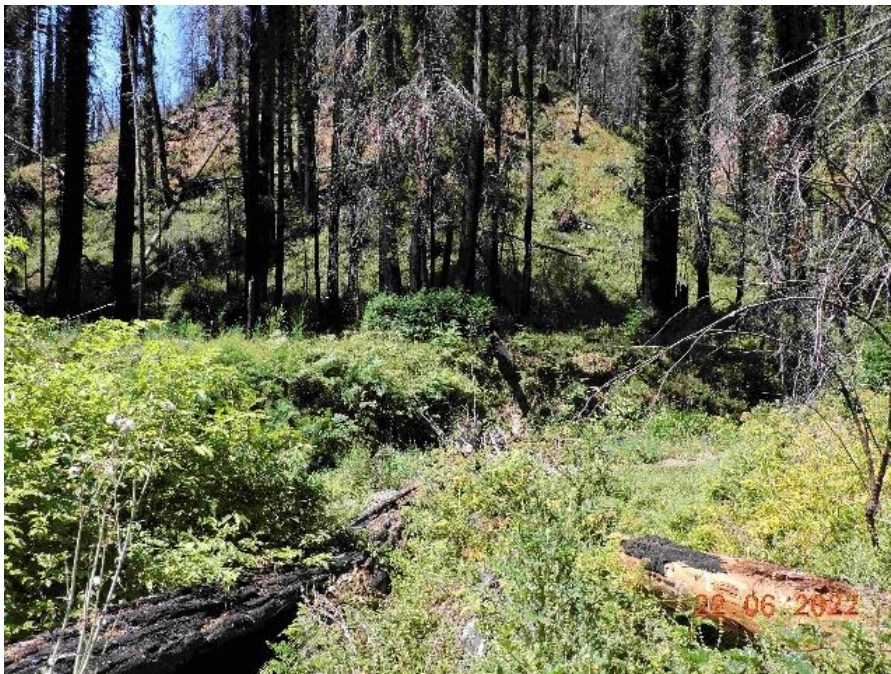
Photo 74. West Fork, mile 3.45+. Looking across aggraded channel to eroded west slope. Downed trunks had created a log jam and high channel step (a significant fish barrier) in 2021. The aggraded channel has buried the channel logs and eliminated the step. Dense ground cover.

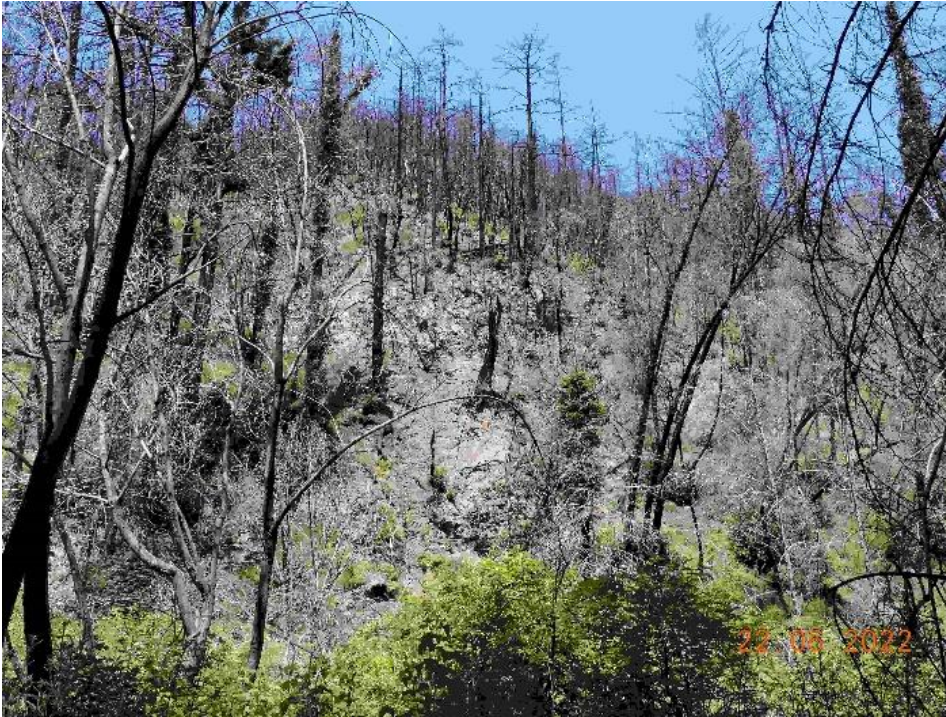
Photo 85. West Fork, mile 3.6+. Steep and eroding west slope, with few live trees.

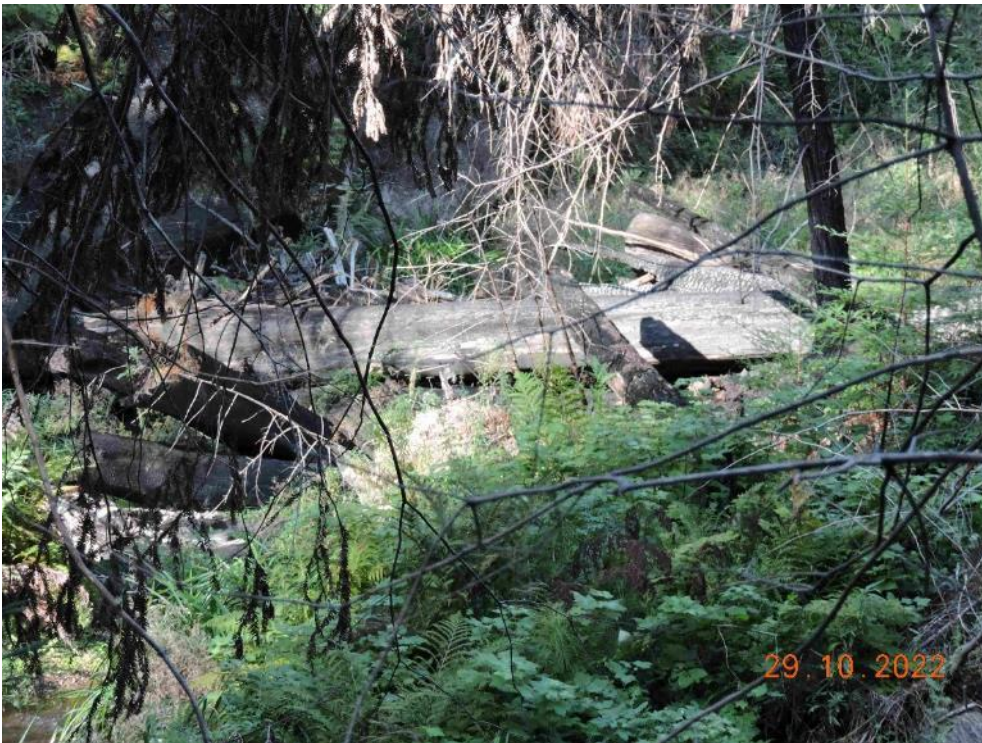
Photo 92. West Fork, mile 3.7. Large fallen trees in aggregated channel.

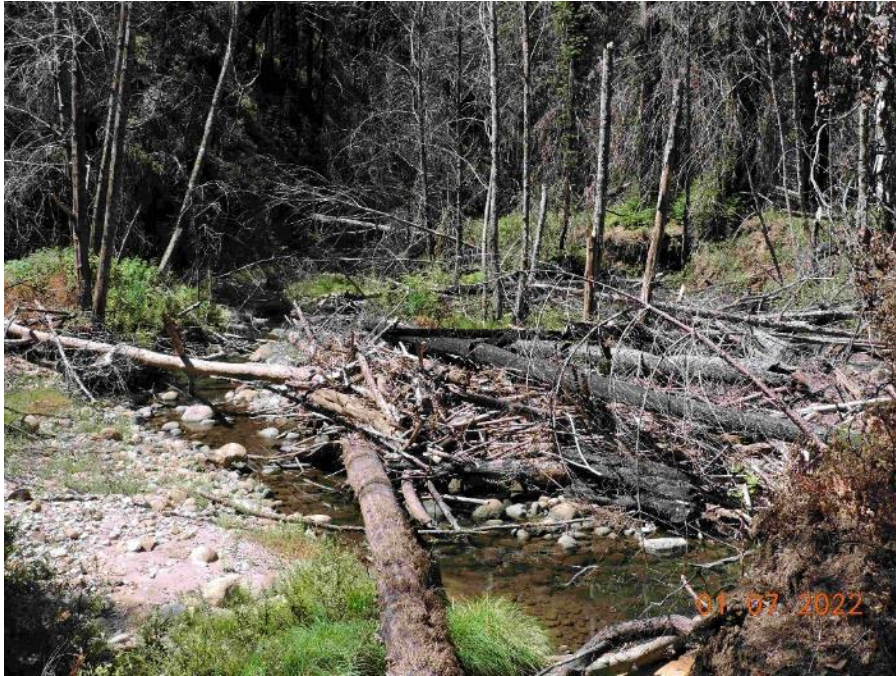
Photo 99. East Fork, bend upstream of bedrock pool, looking downstream. Burned and fallen alders and redwoods from bank scour in bend had forced channel to left and away from 1998 storm pool and large downed redwood near right bank. Evidence of high flows, but no channel aggradation upstream or downstream.

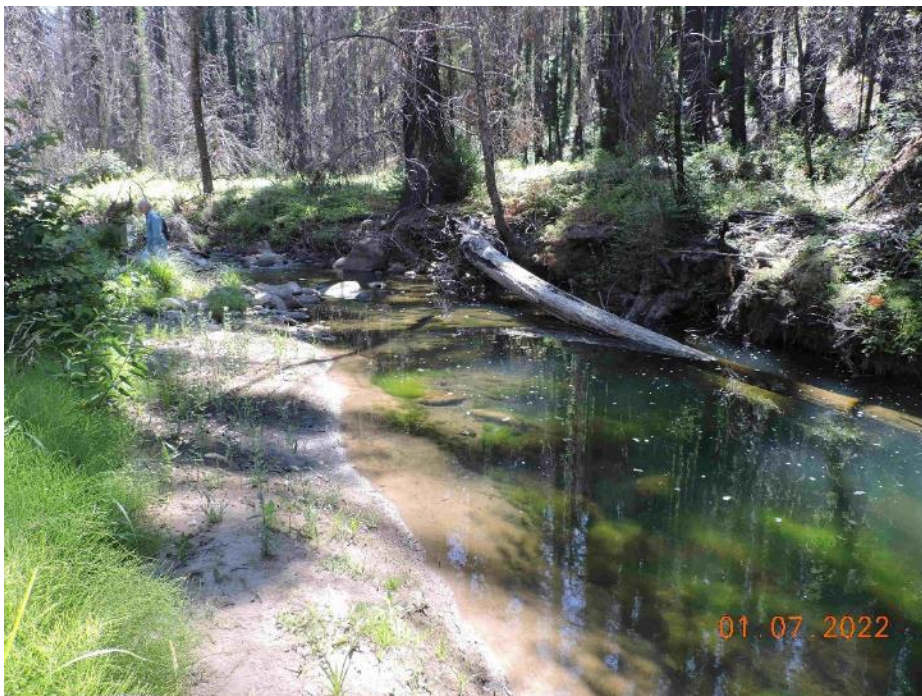
Photo 104. East Fork, mile 0.2. Deep former fish sampling pool with little change except more apparent silt on bottom. No significant filling. Algal growth in mostly unshaded channel.

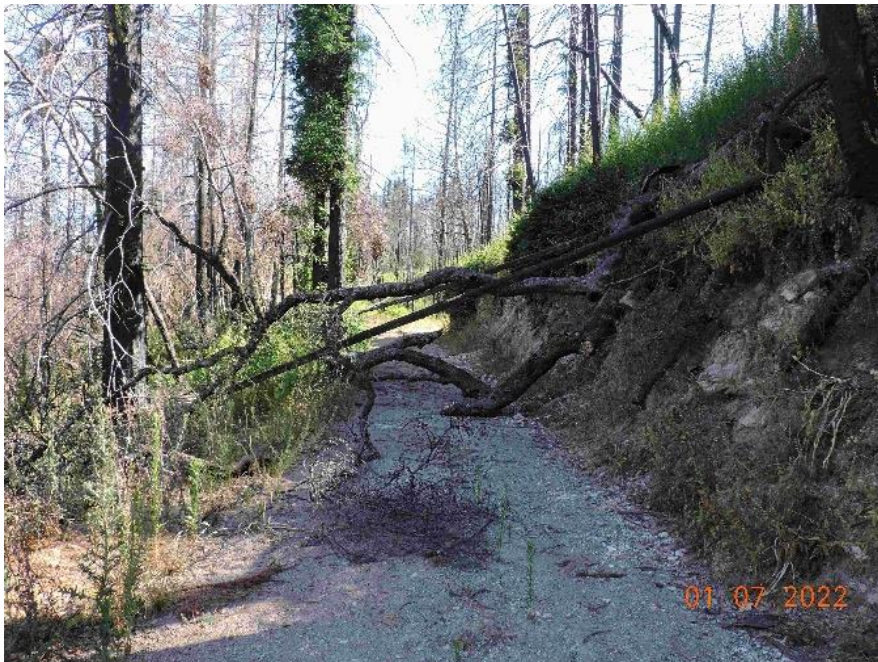
Photo 112. Bypass road = mile 2.75. The only downed tree obstructing road on 1 July.

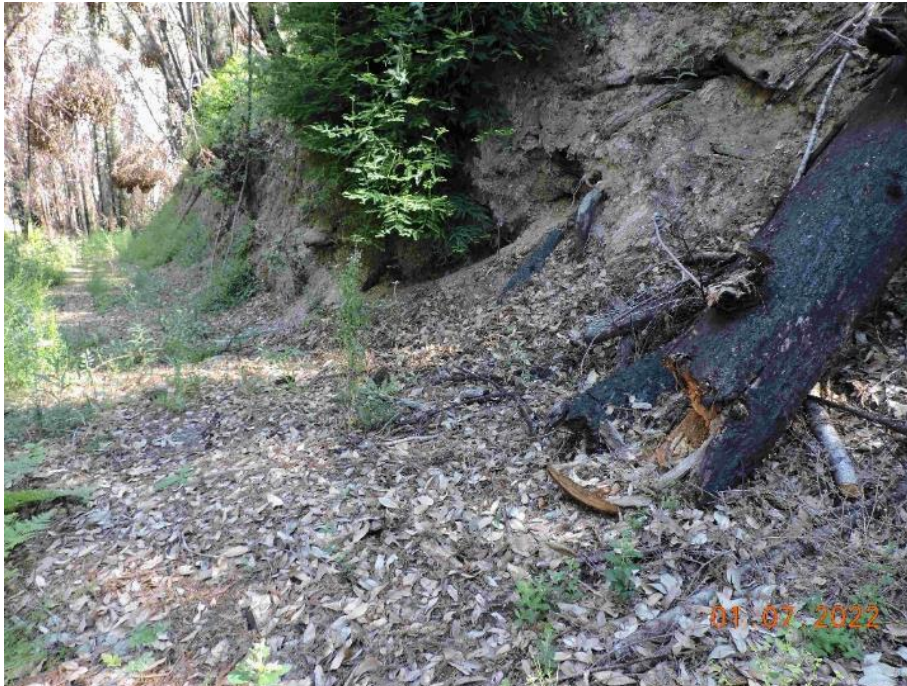
Photo 128. Bypass road, mile=2.95. One several burned and fallen trunks that blocked half the road in 2021. They had been trimmed to allow potential vehicle passage.

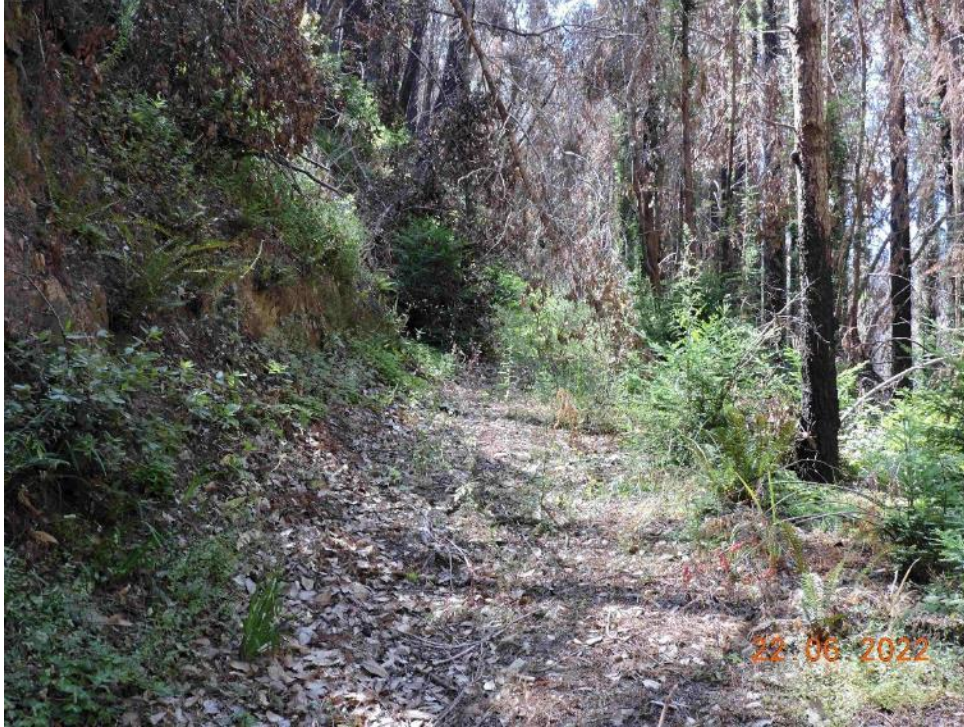
Photo 131. Bypass Road, mile=3.1-. Bottom of bypass road looking uphill. with small leaning tree in road.
