## Waddell Creek Post-fire Resurvey July and October 2022

(revised from August 2022; text revisions are in *italics bold*)

Jerry J. Smith

31 October 2022 (errors corrected on page 5 and photos 110,114,122,125 on 11 November 2022)

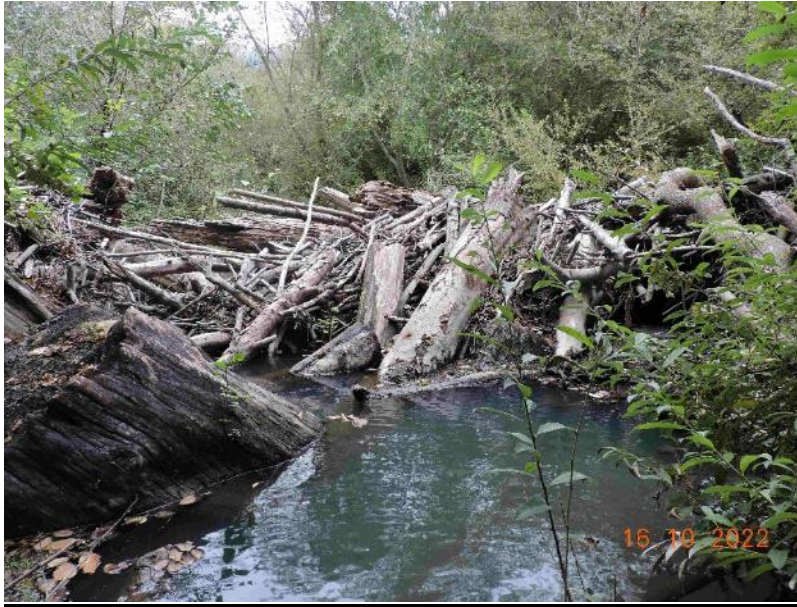
Photo 1. Mile 0.65 (above first bridge). Large newly-formed logjam in 2022 at the upstream limit of the high bar-built lagoon. The jam is tightly packed with recent and old wood and is a likely severe fish passage problem; it may have formed after some adult steelhead and coho had already passed the site in December.

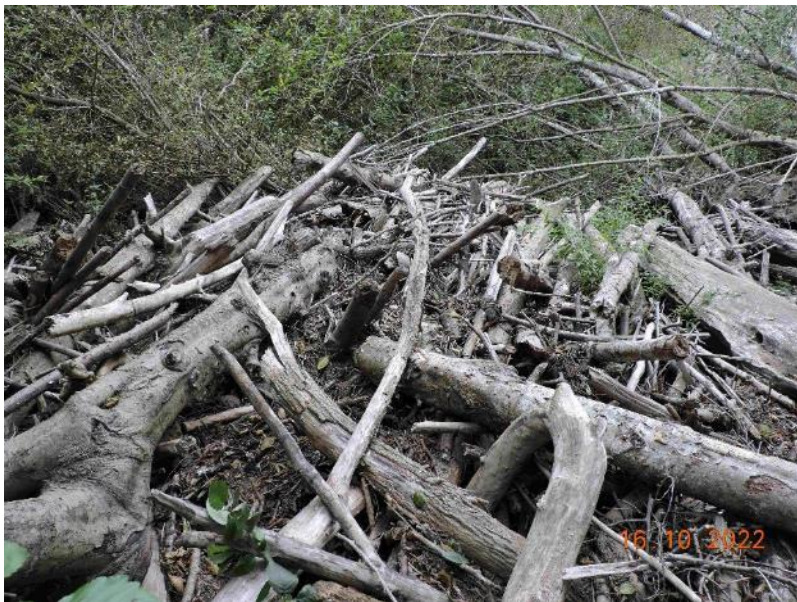
Photo 2. The logjam at mile 0.65 also extends 45 ft across the left bank flood plain, so even most high flows aren't likely to bypass the jam.

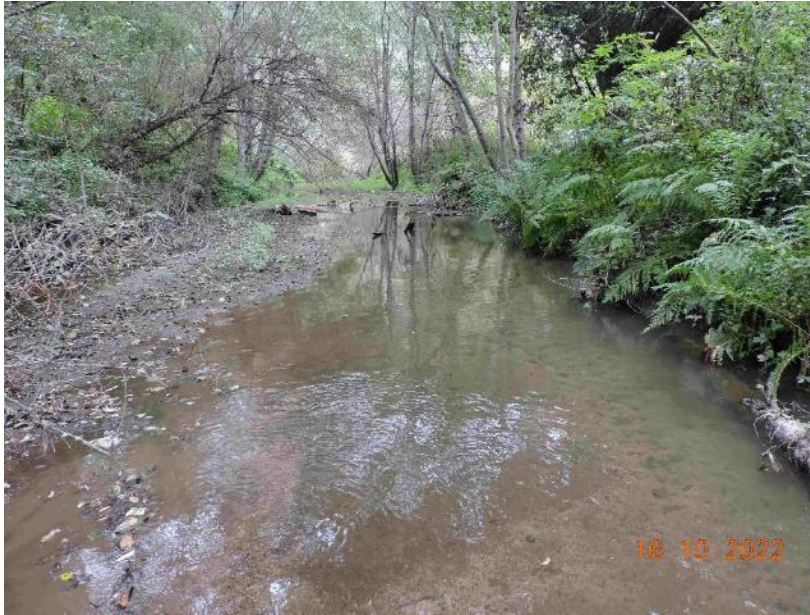
Photo 3. Mile 1.2, looking upstream. Shallow pool and glide from channel aggradation at fish sampling site in 2022. Some depth and cover along the left bank, but channel substrate is primarily silt and fine sand.

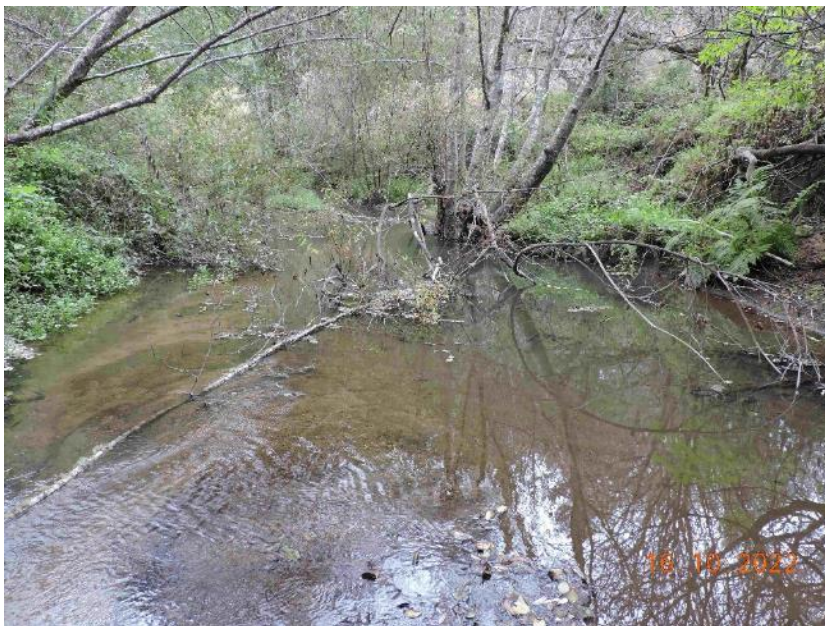
Photo 4. Mile 1.2, looking upstream. Filling of the majority of fish sampling pool (except at the left bank at the multi-trunk alder) by material from farther upstream.

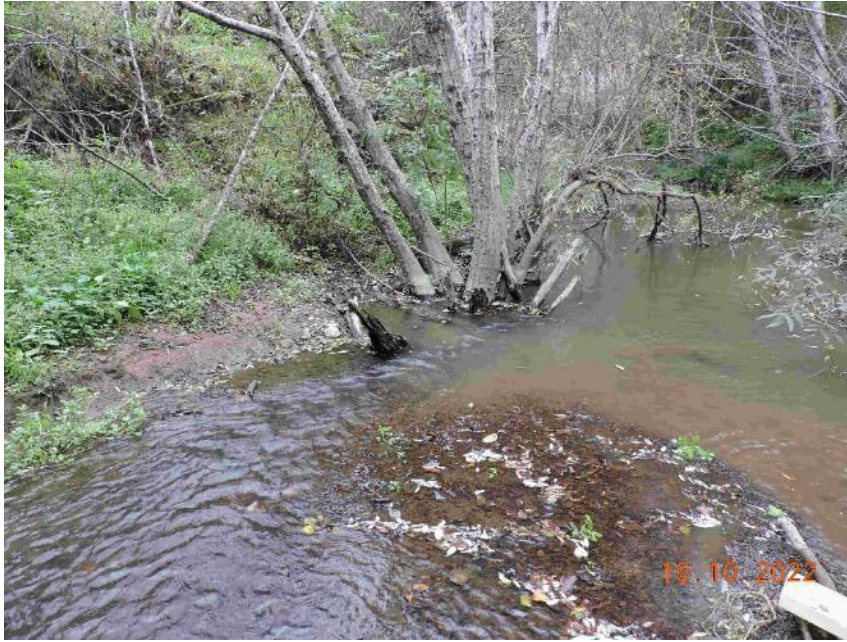
Photo 5. Mile 1.2, looking downstream. Head of the pool in photo 4, with the formerly deep portion of the pool in the foreground filled and the deep backwater alcove on the left bank behind the alders completely lost to filling with sediment.

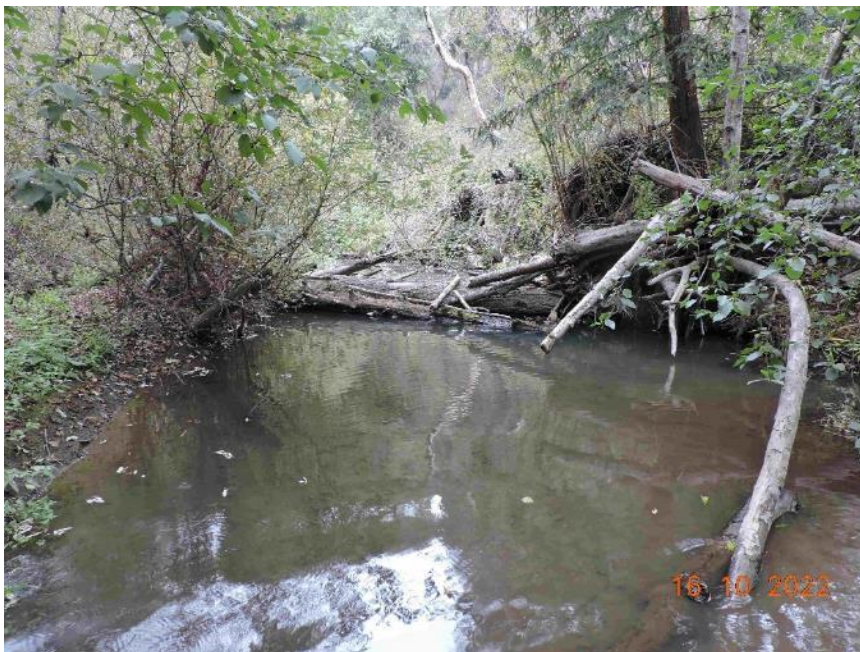
Photo 6. Looking upstream. Formerly deep pool largely filled with sediment except immediately upstream, downstream, and under the partial logjam.

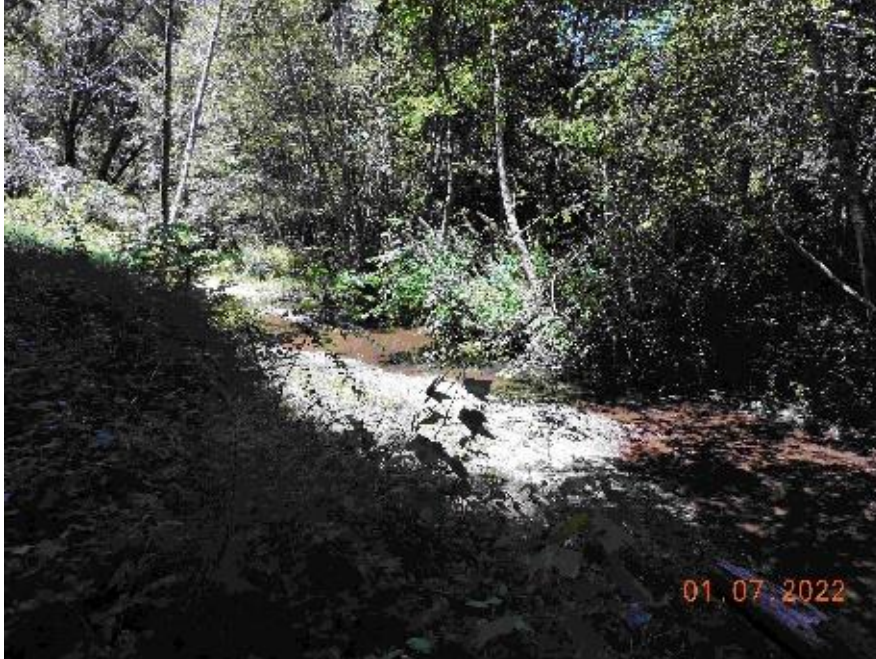
Photo 7. Mile 1.75+, looking downstream, downstream of Twin Redwoods camp. The downstream portion of the long fish sampling pool downstream of the trail ford was almost completely filled with sediment.

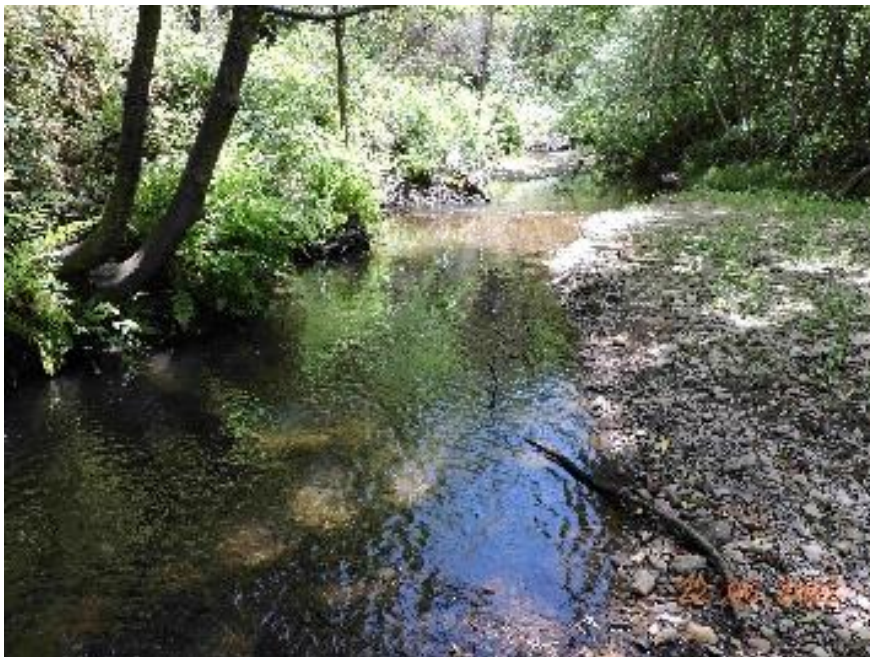
Photo 8. Mile 1.75+, looking downstream. Upstream portion of long filled pool, with scour and depth restricted to head of pool and at a preexisting wood jam (middle background).

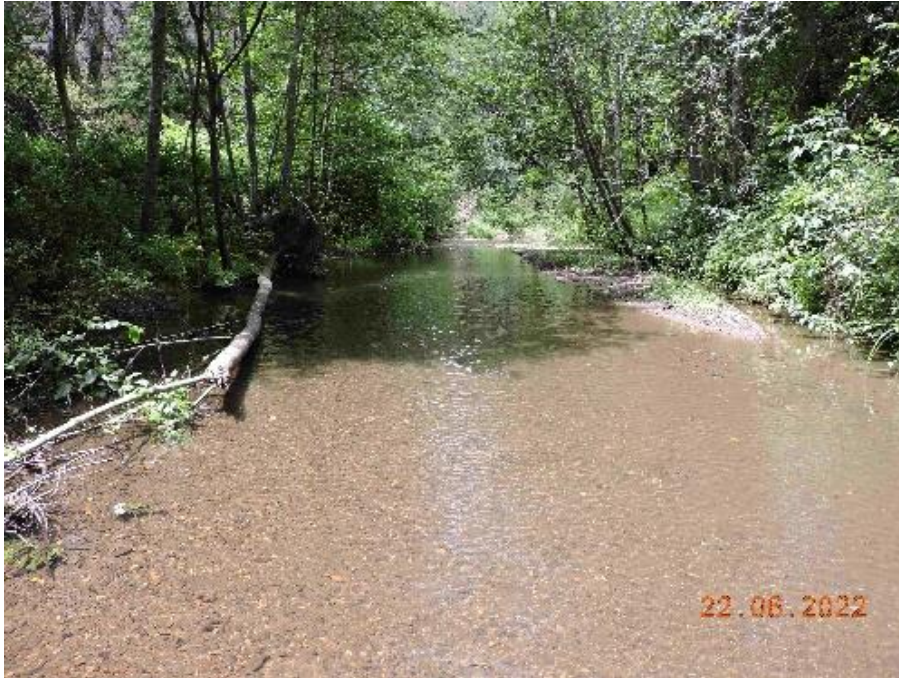
Photo 9. Mile 1.75 +, Twin Redwoods Camp, looking upstream. Shallow glide and pool habitat between ford and seasonal bridge crossing, with fines and small mudstone gravel aggradation filling former scour areas along both banks.

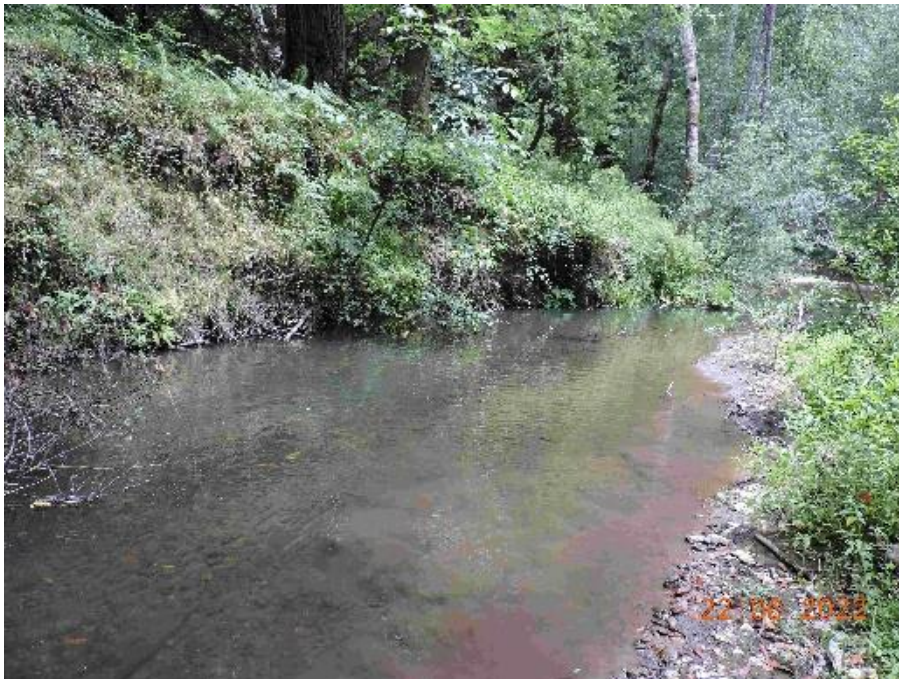
Photo 10. Mile 1.75+, looking downstream, Twin Redwoods Camp. Loss of channel wood downstream and 60% filling of formerly deep pool.

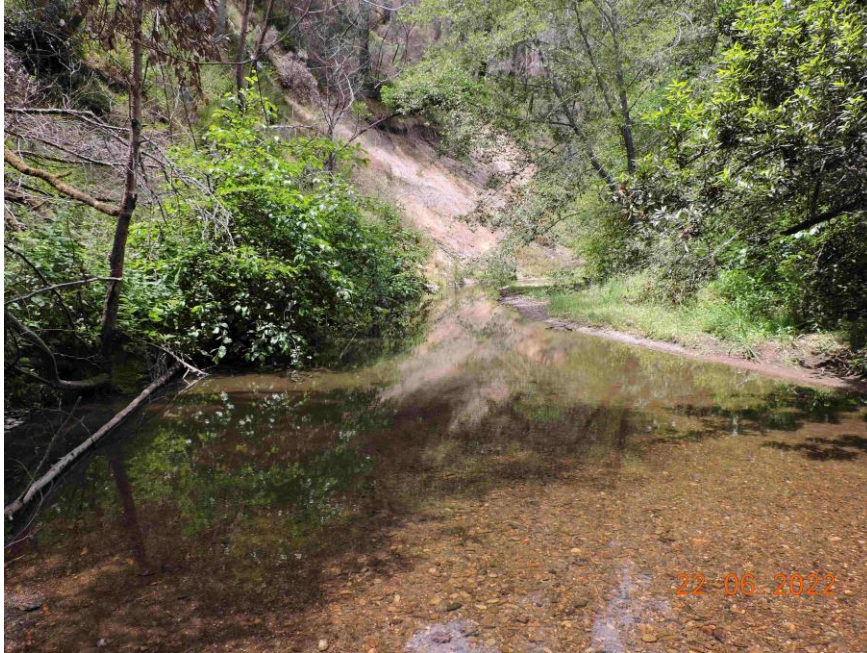
Photo 11. Mile 1.8, looking upstream, Twin Redwoods Camp. Downstream portion of long bend pool, with filling from right (west) bank debris flow.

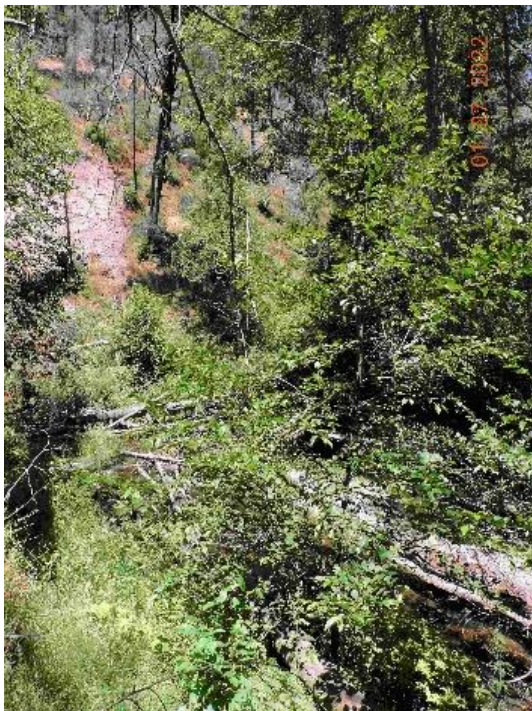
Photo 12. Mile 1.8, Twin Redwoods Camp, looking downstream. Debris flow and toppled alders at bend of substantially filled pool.

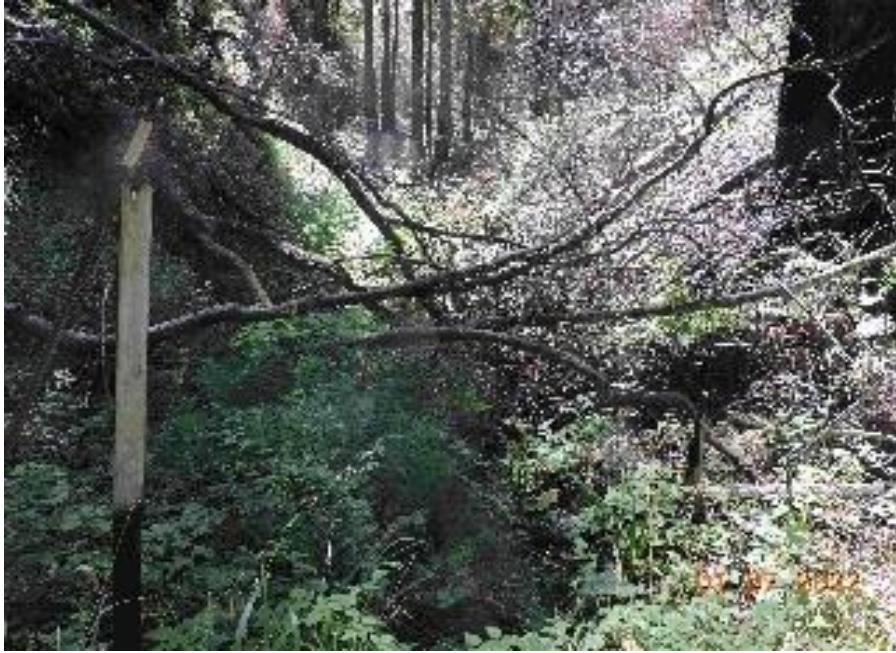
Photo 13. Mile 2.05. "Tramway Springs" drainage upslope of road.

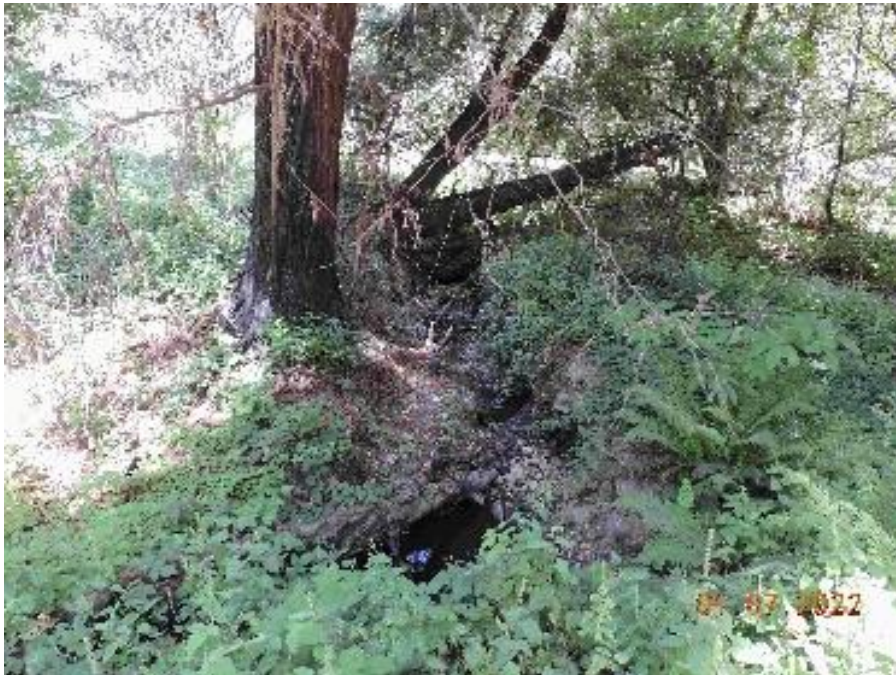
Photo 14. Tramway Springs drainage downstream of road, with little evidence of sediment transport to Waddell Creek in 2022.

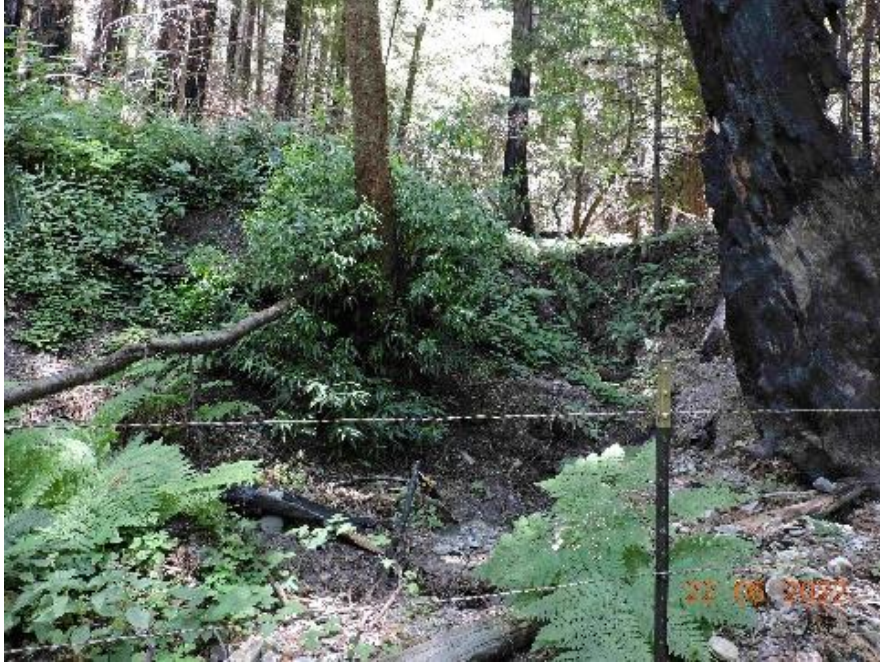
Photo 15. Mile 2.15. Eroded seasonal channel upslope of road.

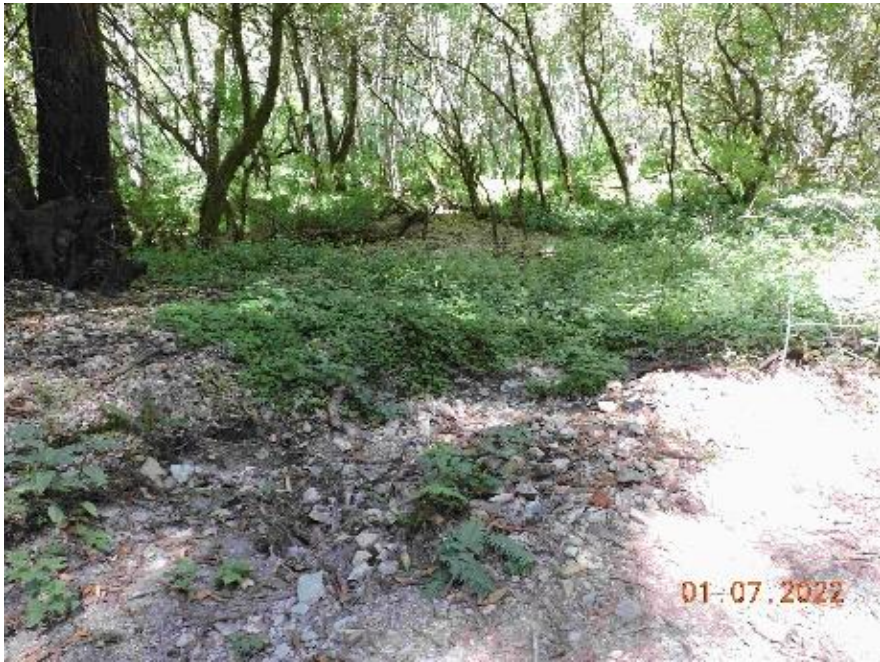
Photo 16. Mile 2.15. The drainage had transported sediment across road into the wide riparian zone, but coarse sediment apparently did not reach Waddell Creek in 2022.

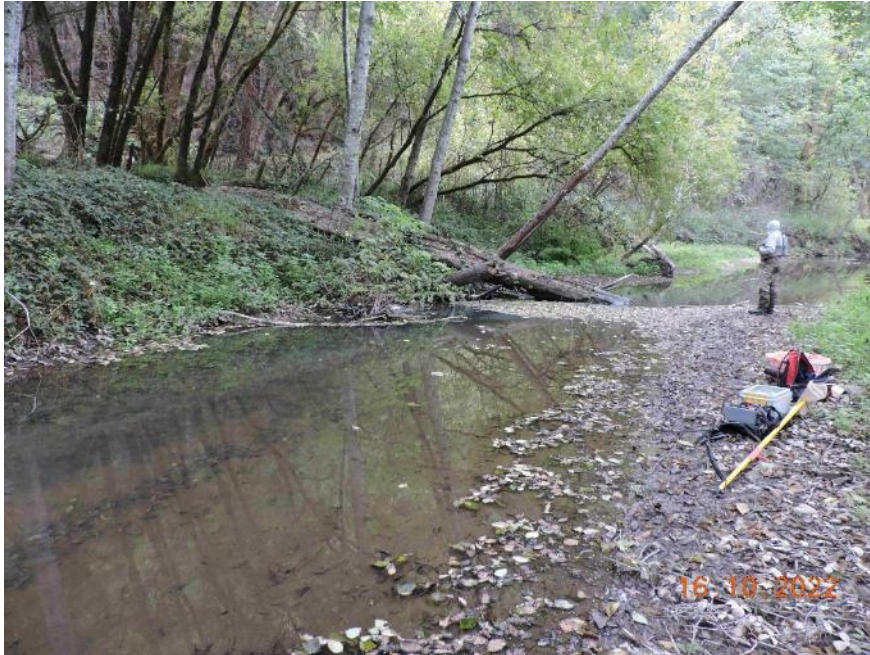
Photo 17. Mile 2.2. Looking downstream. Long, deep pool associated with scattered fallen alders for more than 10 years, lost the alders in the December storms, and most of the pool was substantially filled with sediment, except scour associated with a single large log.

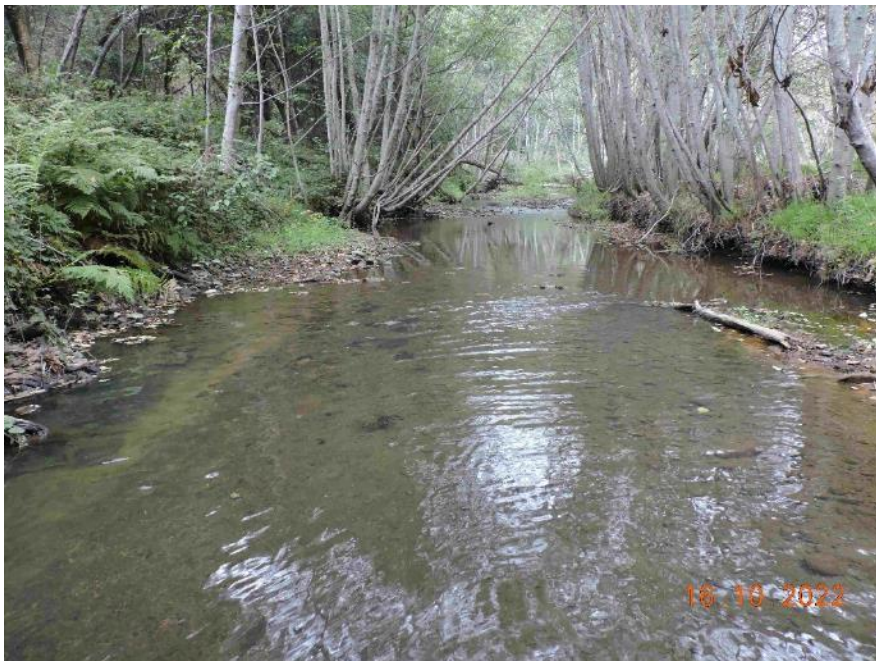
Photo 18. Mile 2.2, looking upstream. A pair of shallow pools and glides lost local scour/small wood and undercut banks in 2022. Fine sediment dominates the stream bed. Canopy is intact.

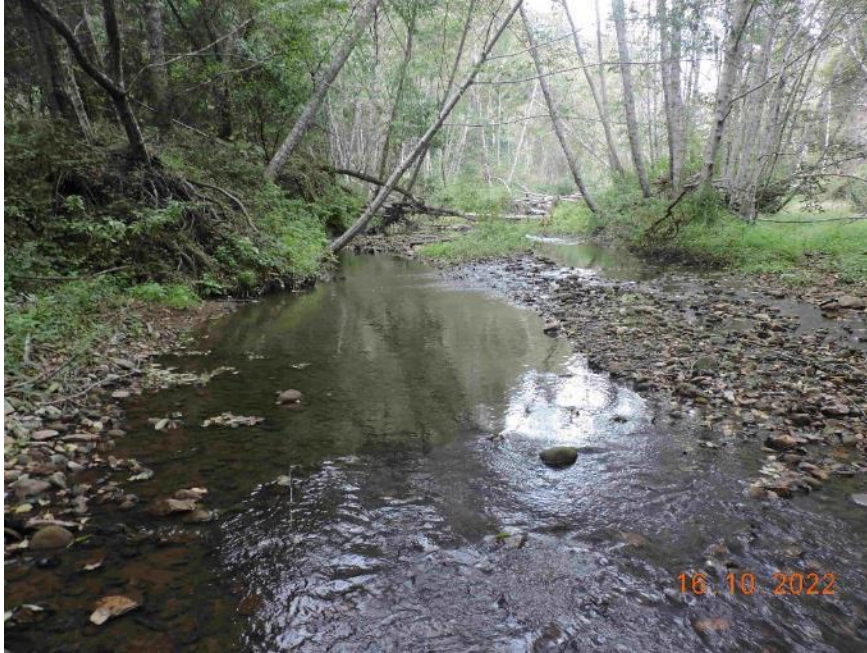
Photo 19. Mile 2.2, looking upstream. Glide with deeper (2-2.5 ft) pool at head was about 60% filled with sediment in 2022.

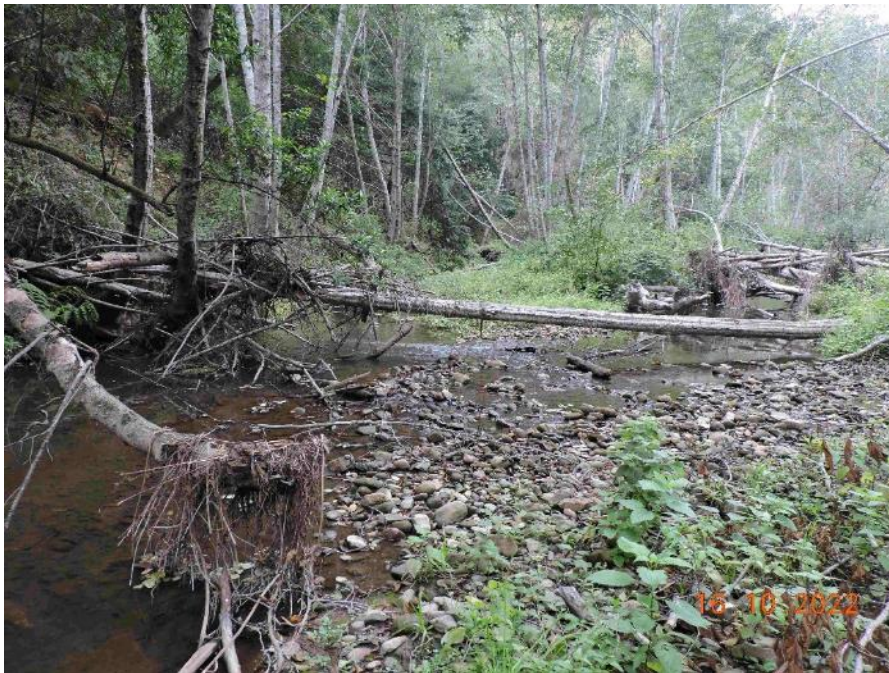
Photo 20. Mile 2.2, looking upstream. A pair of pools lost depth, but gained complexity from new entrained wood in 2022.

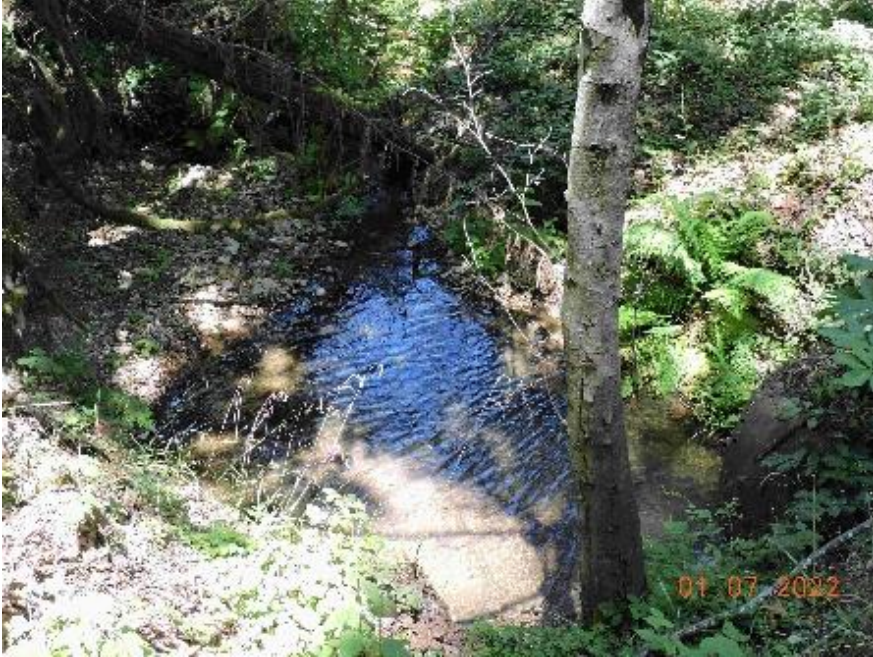
Photo 21. Mile 2.5+, "Aunt May" Creek, downstream of Stevens Camp. Low gradient perennial stream, with clean substrate and no evidence of sediment transport to Waddell Creek.

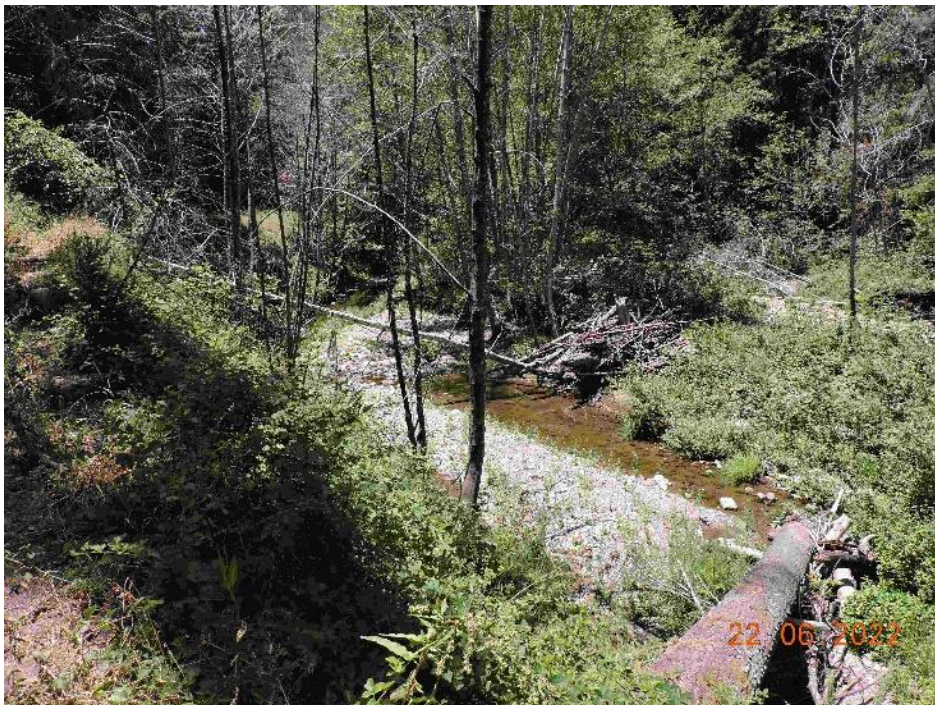
Photo 26. Mile 2.7, looking downstream. Mostly open canopy, with dead and down alders and fallen Douglas fir from upslope fire.

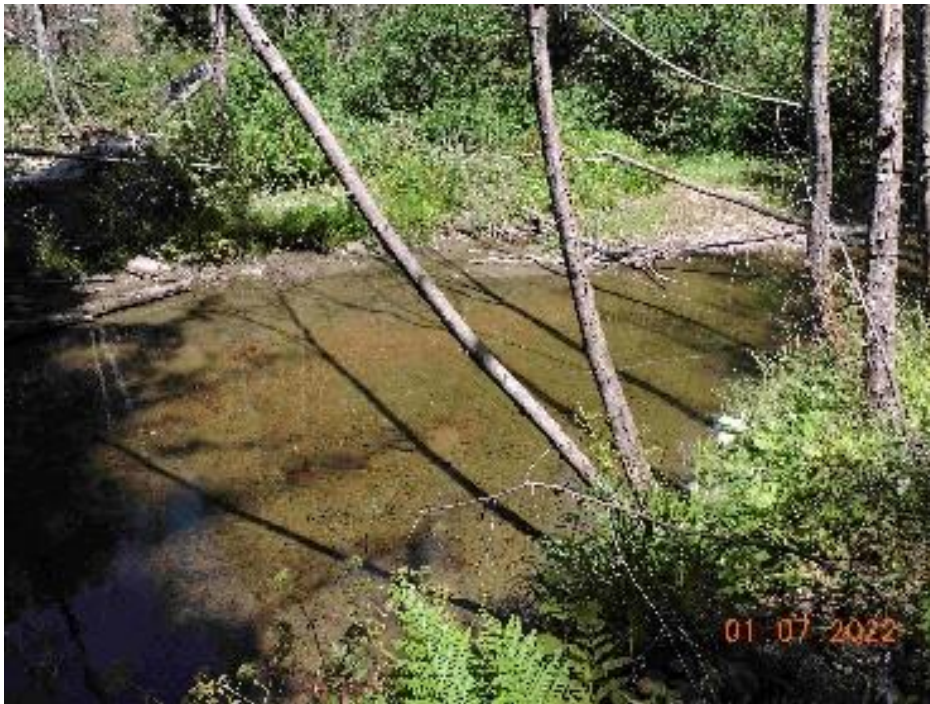
Photo 28. Mile 2.7+. Pool filled with fines and small mudstone gravel.

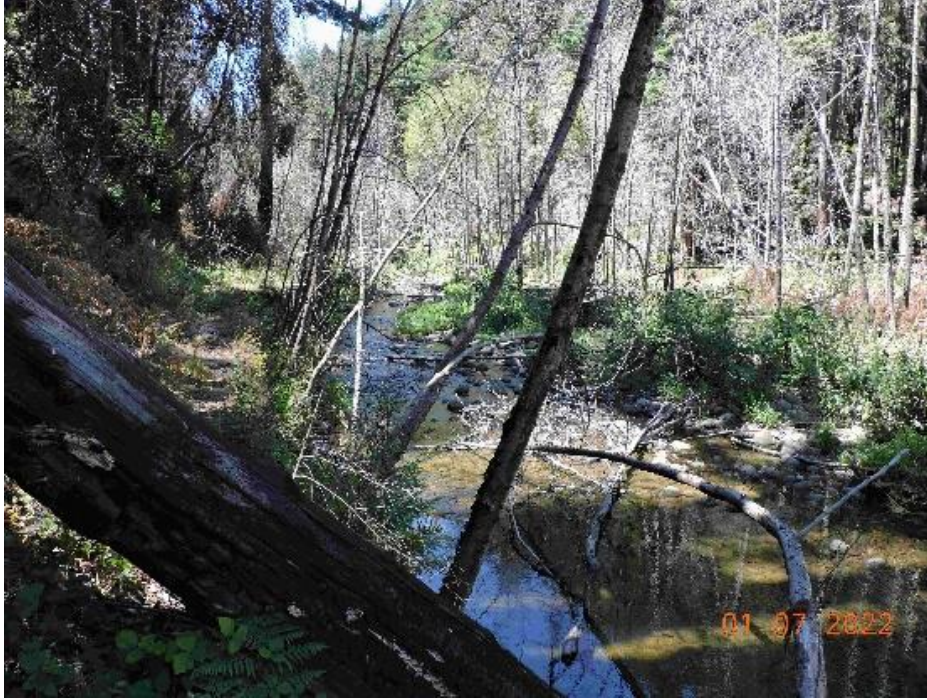
Photo 29. Mile 2.75. Loss of alders cooked by streamside fire and fallen tree from upslope fire.

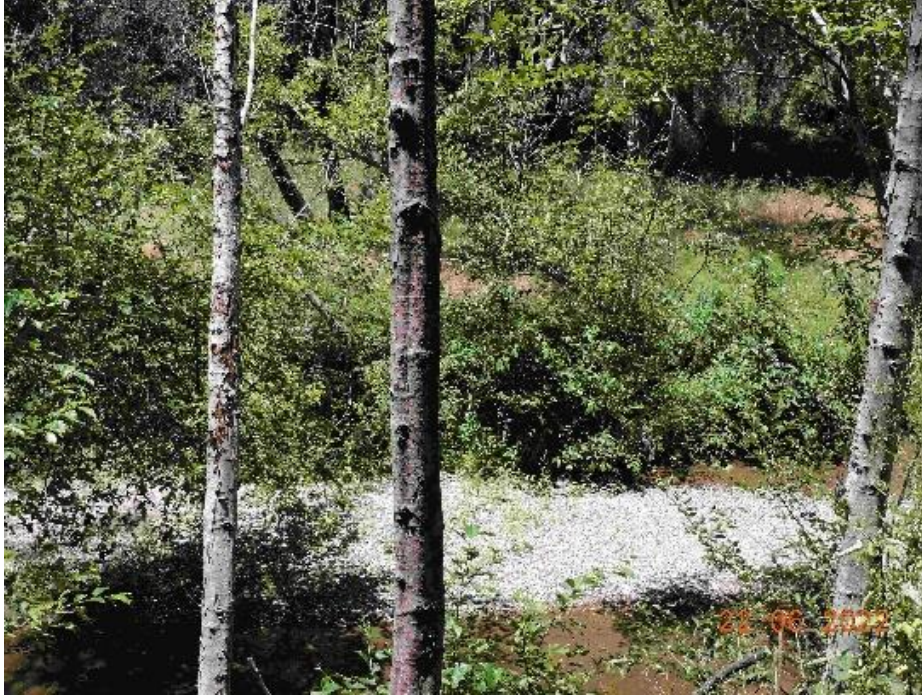
Photo 33. Mile 2.85. Unshaded channel with sparse new alders.

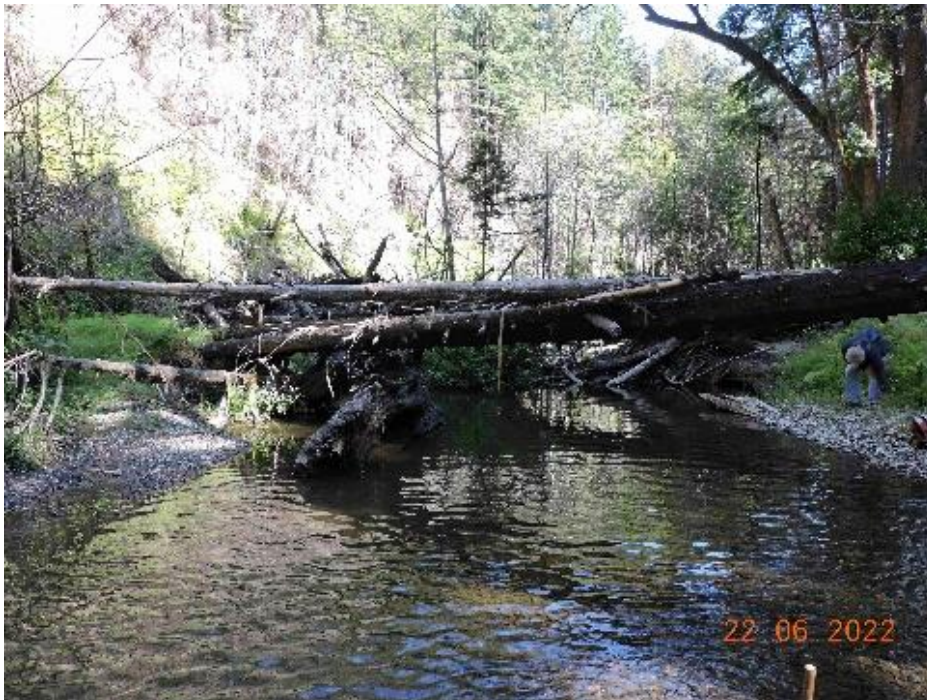
Photo 34. Mile 2.85+. Large partial log jam from fallen trees at west slope 2021 debris flow. The jam had been enlarged upstream by alders that died in 2020 and fell into the stream in winter 2021-2022. The channel up and downstream was substantially aggraded by fines and small mudstone gravel from farther upstream in 2021.

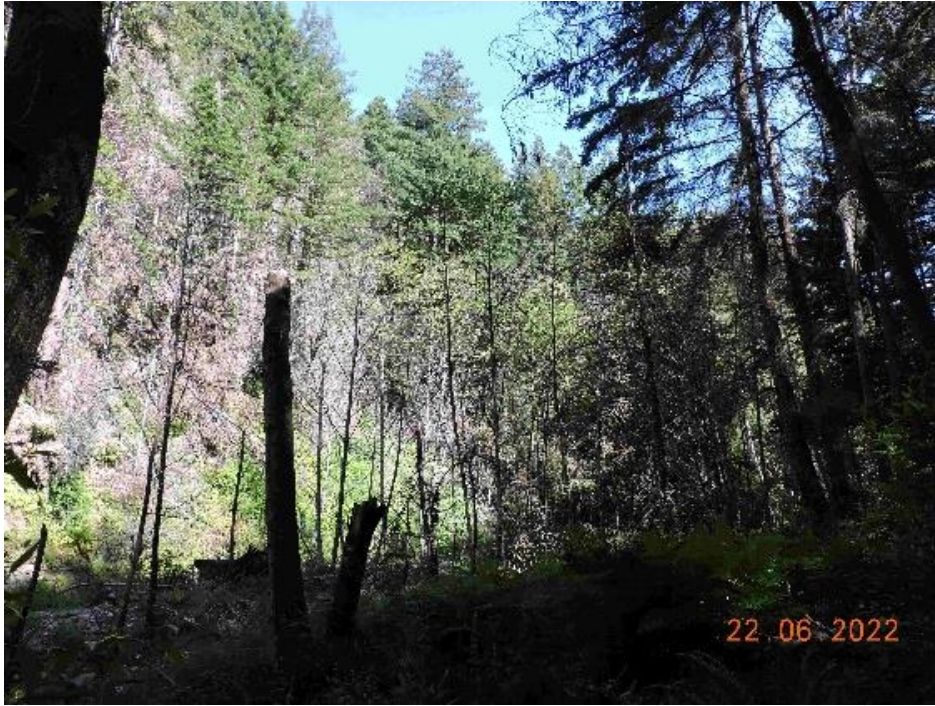
Photo 37. Mile 2.9-. Streamside with 80% dead alders within 0-300 ft upstream of logjam.

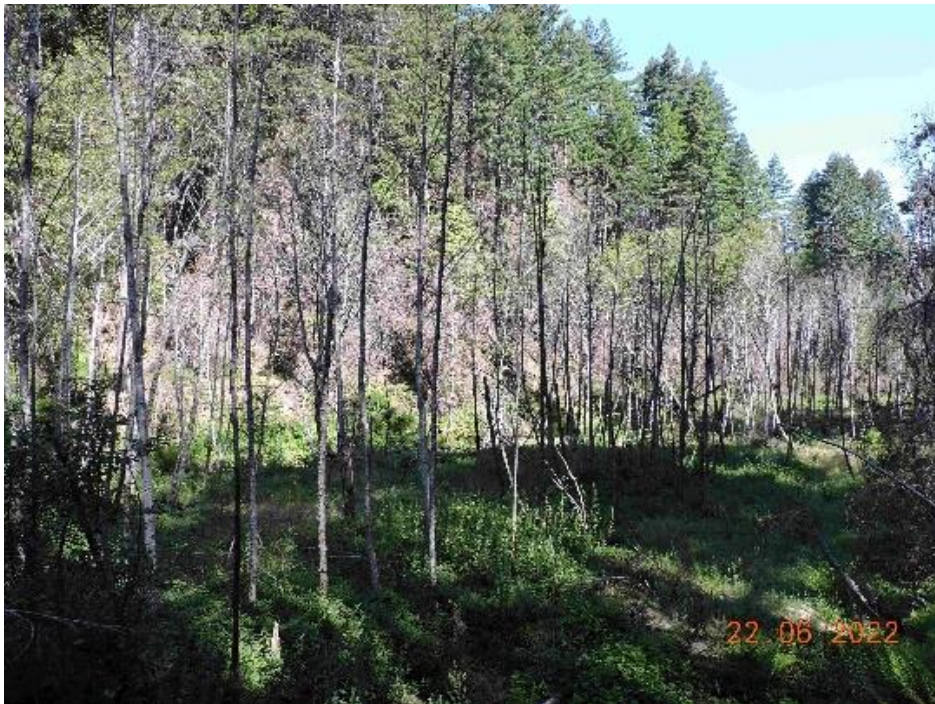
Photo 38. Mile 2.9-. Flood plain alder forest 300-800 ft upstream of logjam, with alders killed by fire, except for a few immediately along stream.

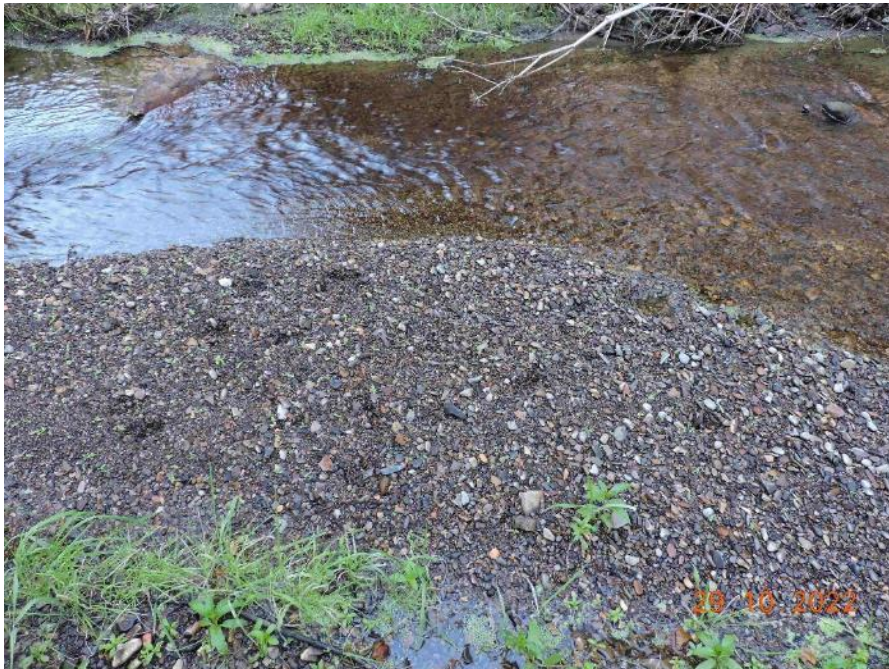
Photo 42. Fine, angular “kitty litter” gravel of Santa Cruz Mudstone, that was filling pools and dominating the channel between mile 2.9 and the forks in 2021 and 2022 from the west slope of Waddell Creek. In 2022 new west slope erosion severely filled the channel on the West Fork of Waddell from the forks upstream to above mile 3.7.

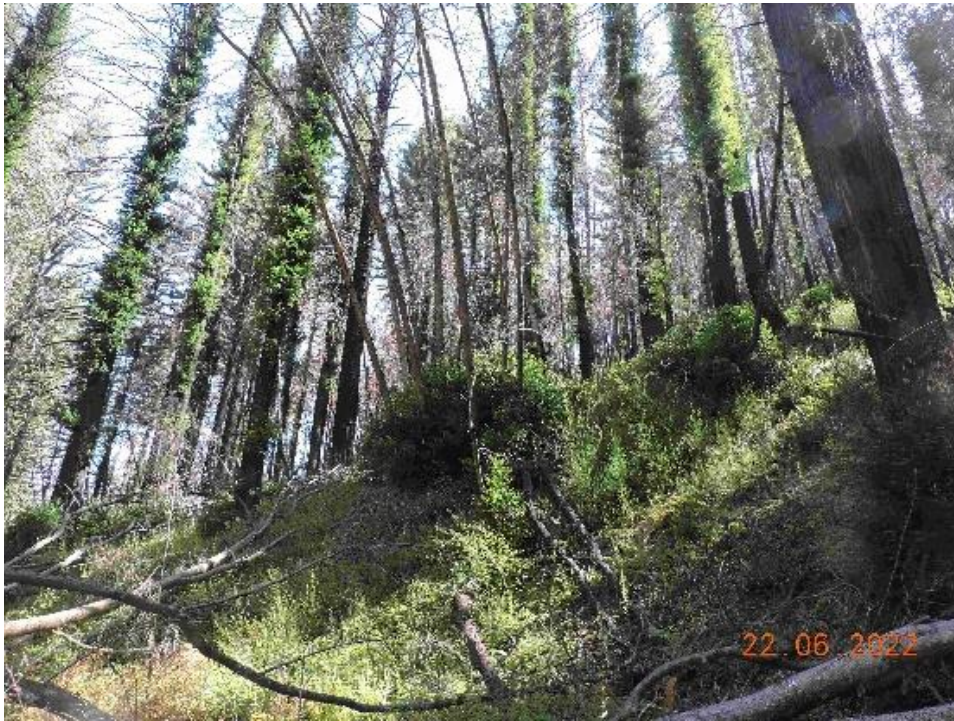
Photo 47. Mile 3.0. East slope from trail, with trunk sprouts on redwoods and basal sprouts on tanbark oaks.

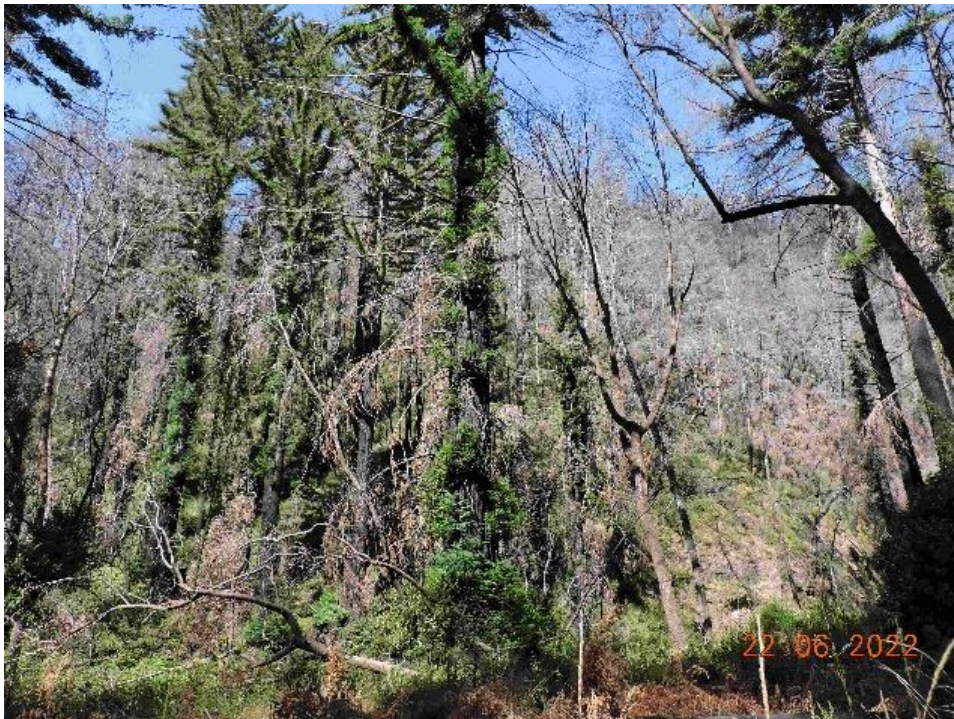
Photo 48. Mile 3.0. West slope from near the trail. Some redwoods with sprouts on branches.

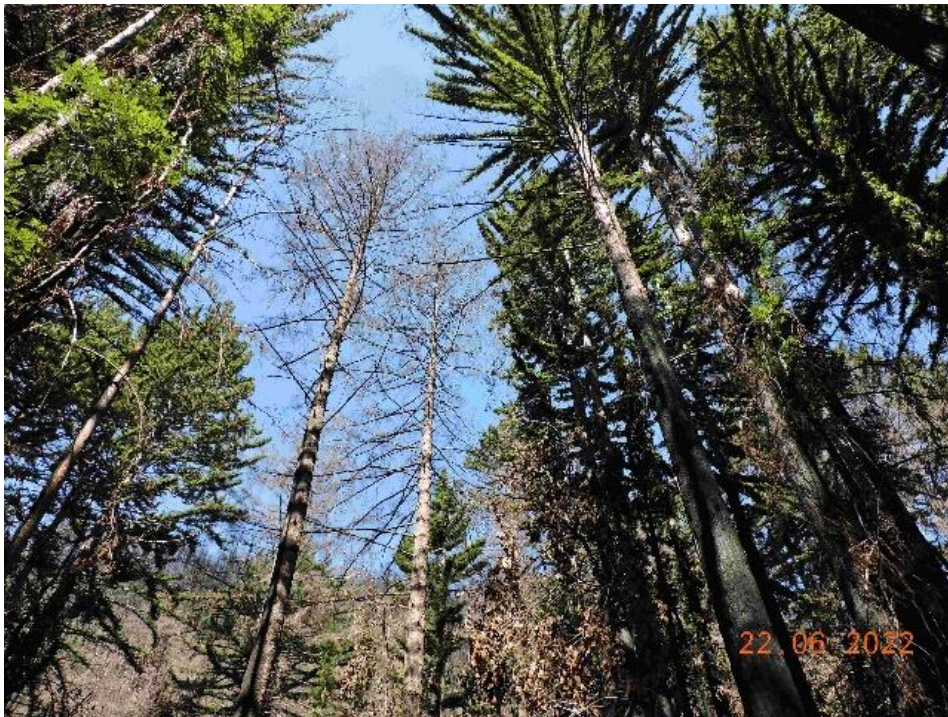
Photo 50. Mile 3.05+, Camp Herbert. Redwoods with epicormic trunk and branch sprouts alongside dead Douglas firs.

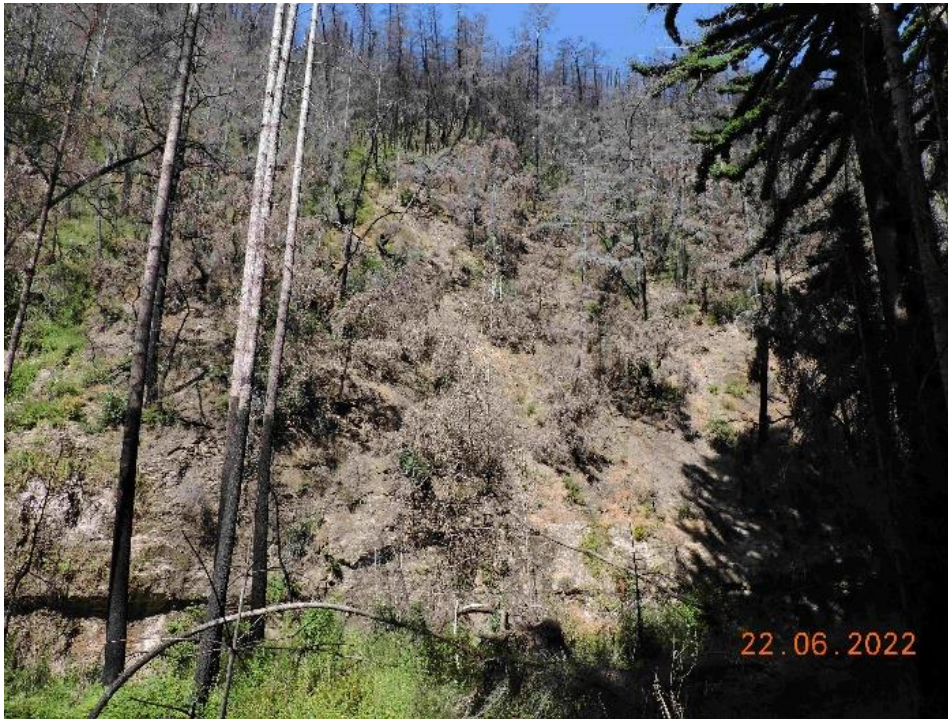
Photo 51. Mile 3.05+, Camp Herbert. Steep, eroded west slope.

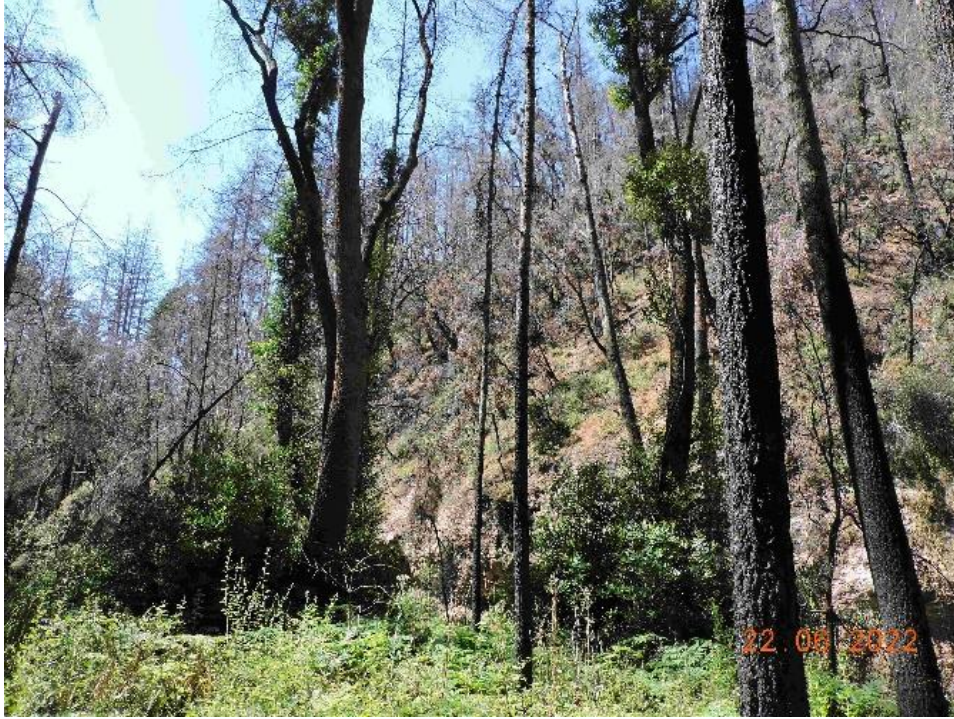
Photo 53. Mile 3.05+. Camp Herbert. Dense ground cover under burned canopy. Recovering burned California bays.

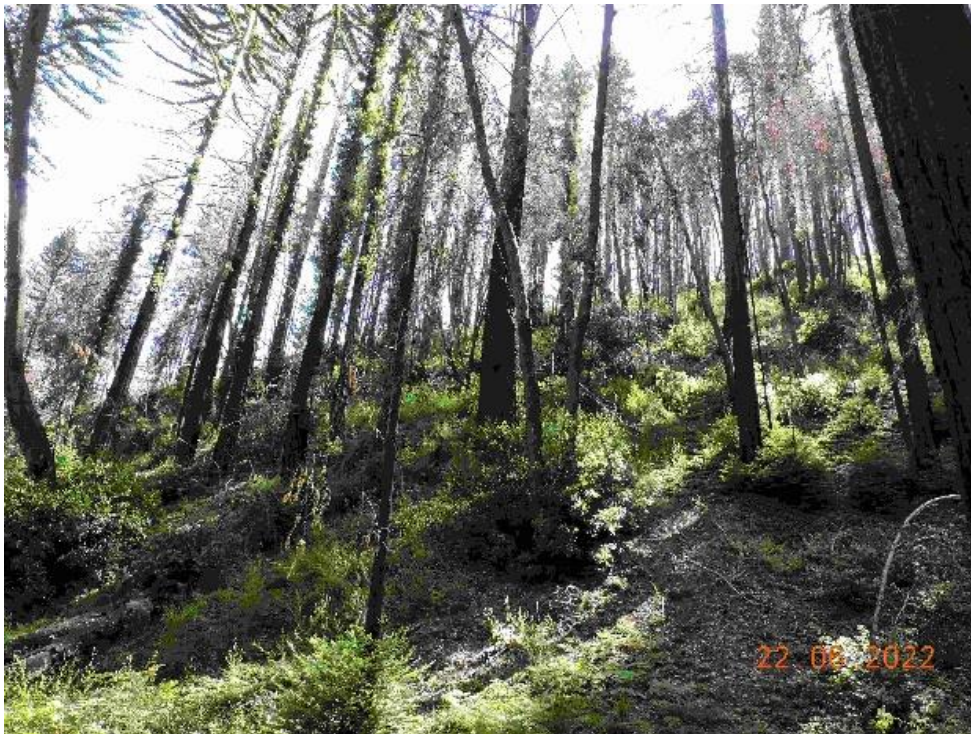
Photo 54. Mile 3.05+. Less steep and vegetated east slope at Camp Herbert.

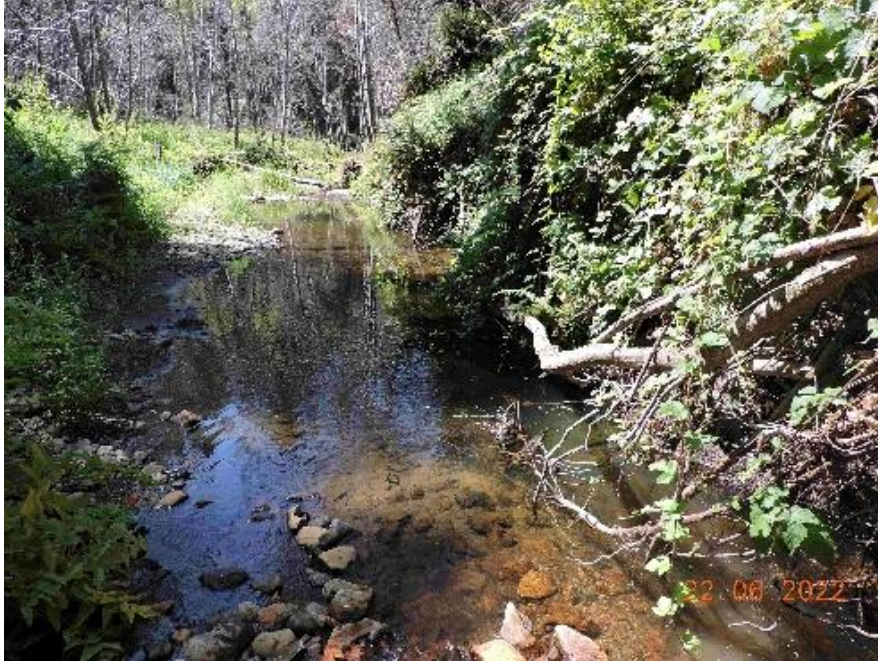
Photo 57. West Fork, mile 3.1+, looking downstream. Formerly a long and deep (2-3+ ft) fish sampling pool, now half filled with sediment, except at head of pool.
