## Waddell Creek Post-fire Resurvey July and October 2022

(revised from August 2022; text revisions are in *italics bold*)

Jerry J. Smith

31 October 2022 (errors corrected on page 5 and photos 110,114,122,125 on 11 November 2022)

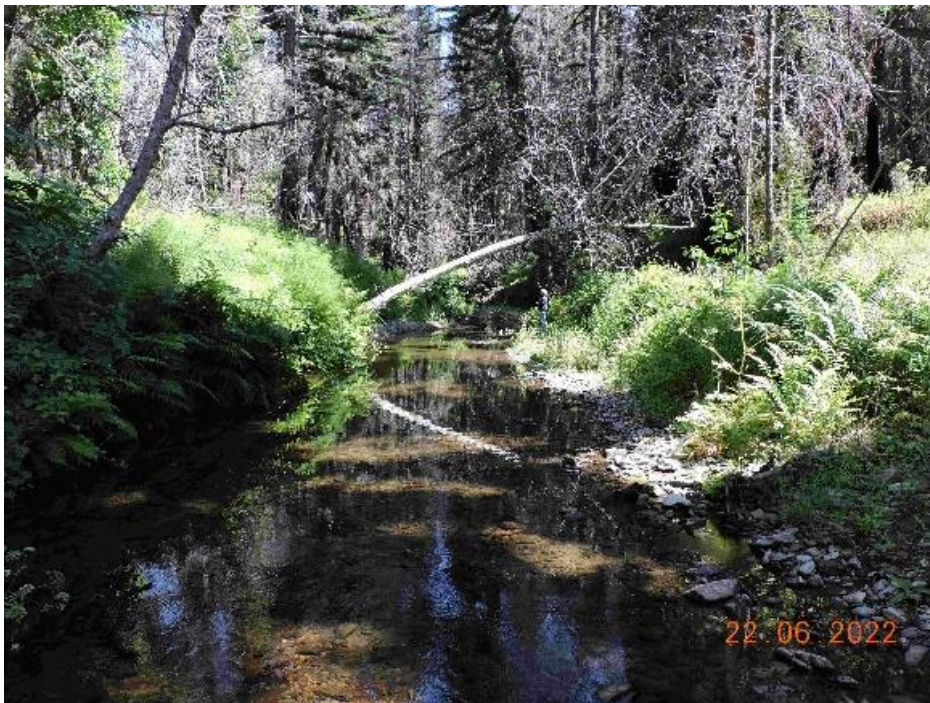
Photo 58. West Fork, mile 3.1+, looking upstream. Long glide and pool fish sampling habitat, now filled as mostly glide habitat.

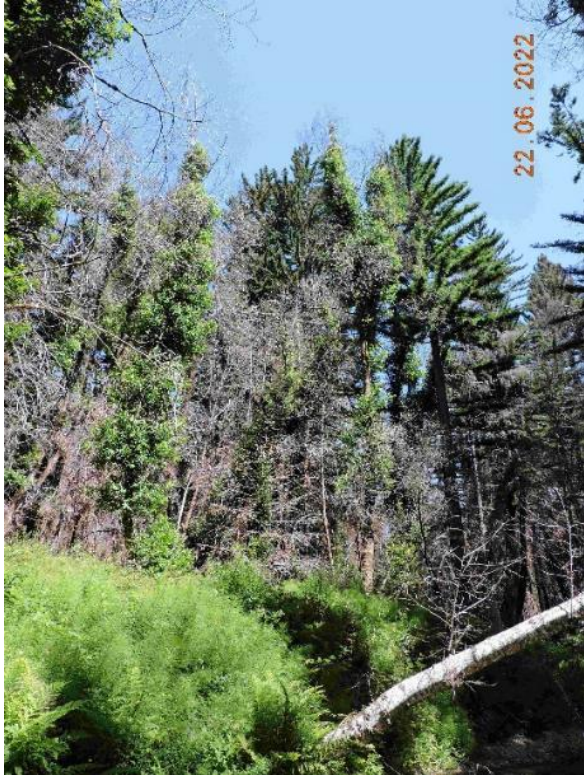
Photo 59. West Fork, mile 3.1+. California bays and redwoods alive, recovering. Tanbark oaks with basal sprouts.

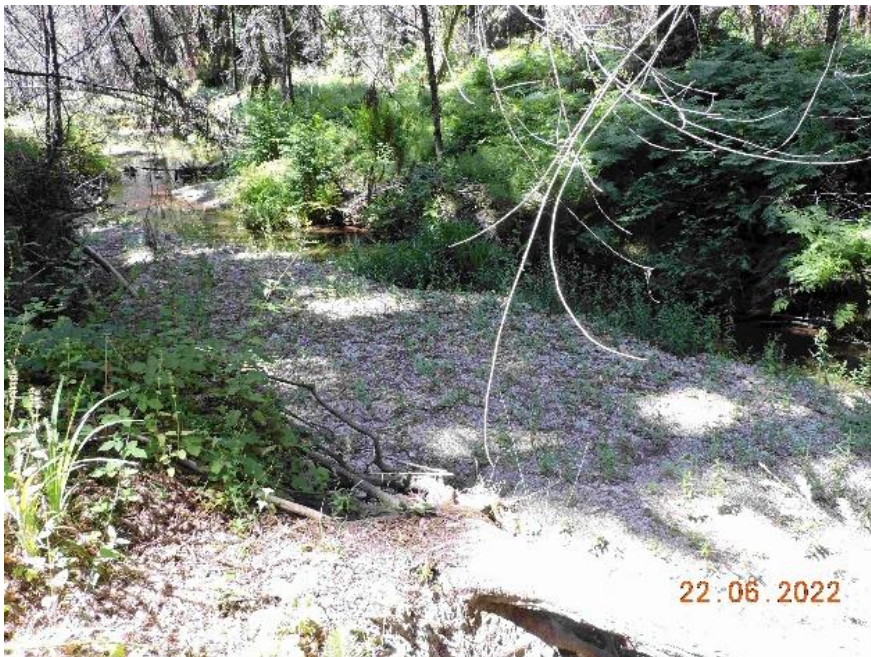
Photo 60. West Fork, mile 3.15+, looking downstream. Downstream portion of large pool formed at old stump with large redwood growing from the nurse stump. Now almost completely filled with fines and small mudstone gravel. Remaining channel is a narrow run along the right bank

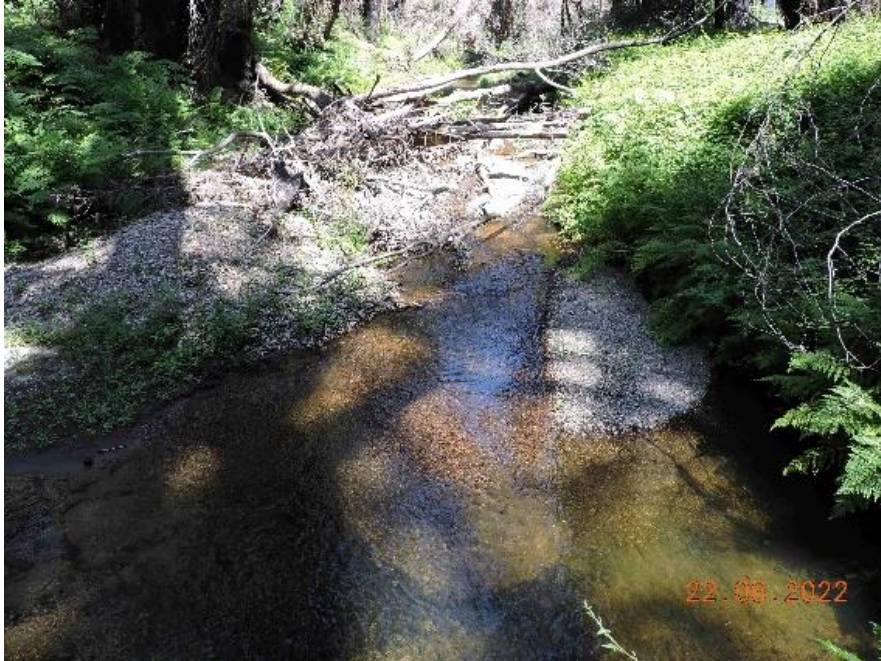
Photo 61. West Fork, mile 3.15+. Upstream portion of large pool at stump, formerly too deep (3-4 ft) to efficiently sample and with deep undercut under the old down trunk. Pool now shortened and 75% filled.

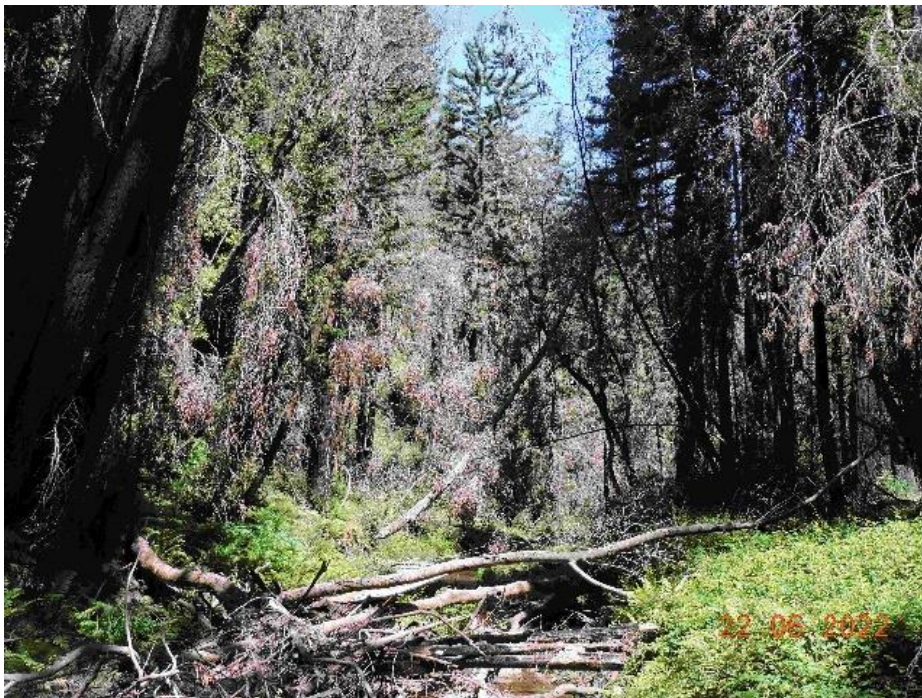
Photo 62. West Fork mile 3.15+. Channel and streamside conditions upstream of nurse tree pool sample habitat.

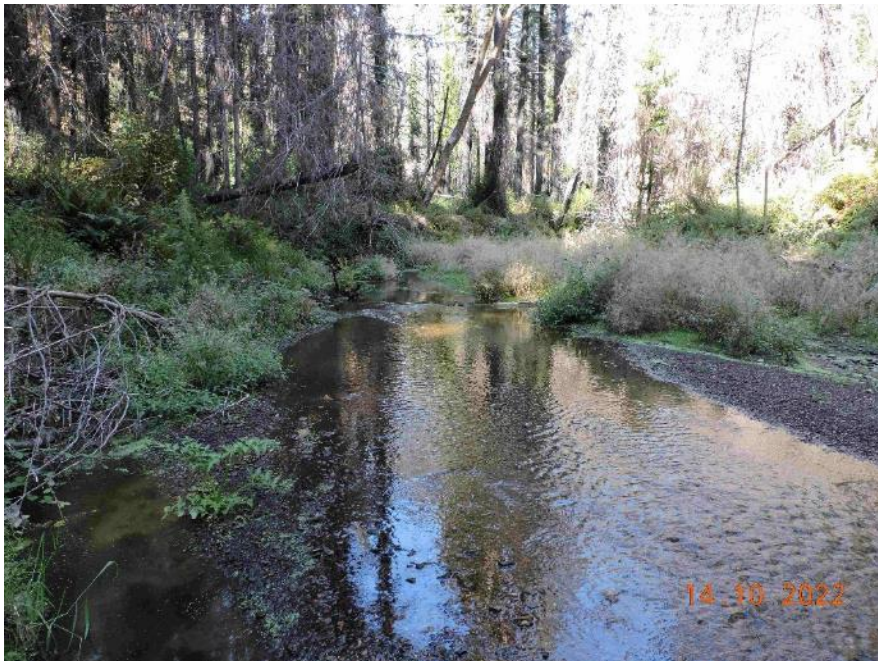
Photo 64. Immediately upstream of the pool in photo 63, looking upstream. This formerly was another large, deep (2.5-3 ft) pool below and immediately above a large spanning log. The log is gone, and only shallow (to 1 ft) glide and pool habitat remains.

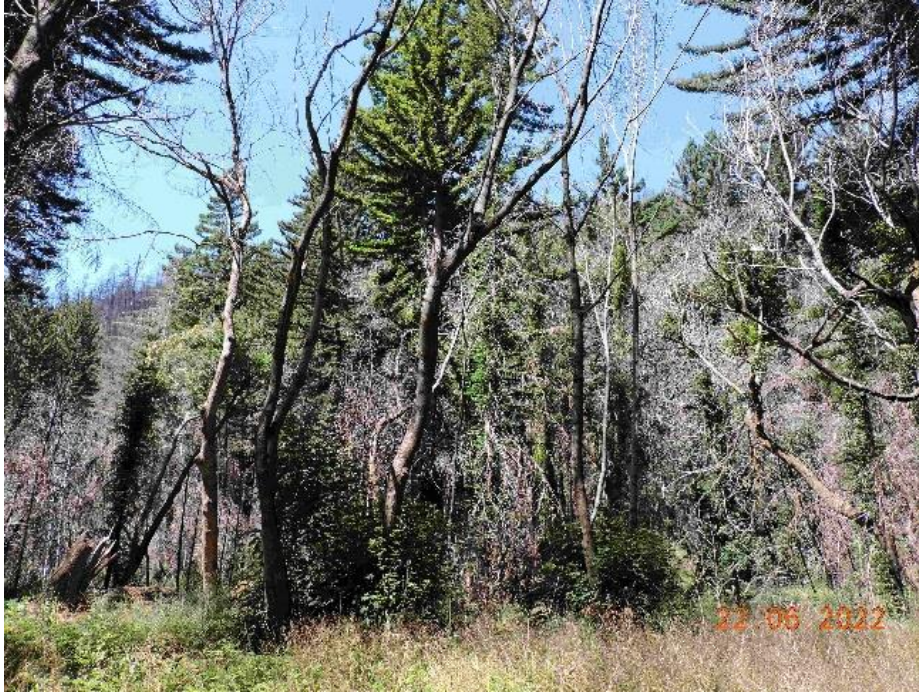
Photo 65. West Fork, mile 3.15. Stand of big-leaf maples with basal sprouts and 1 tree with recovering canopy.

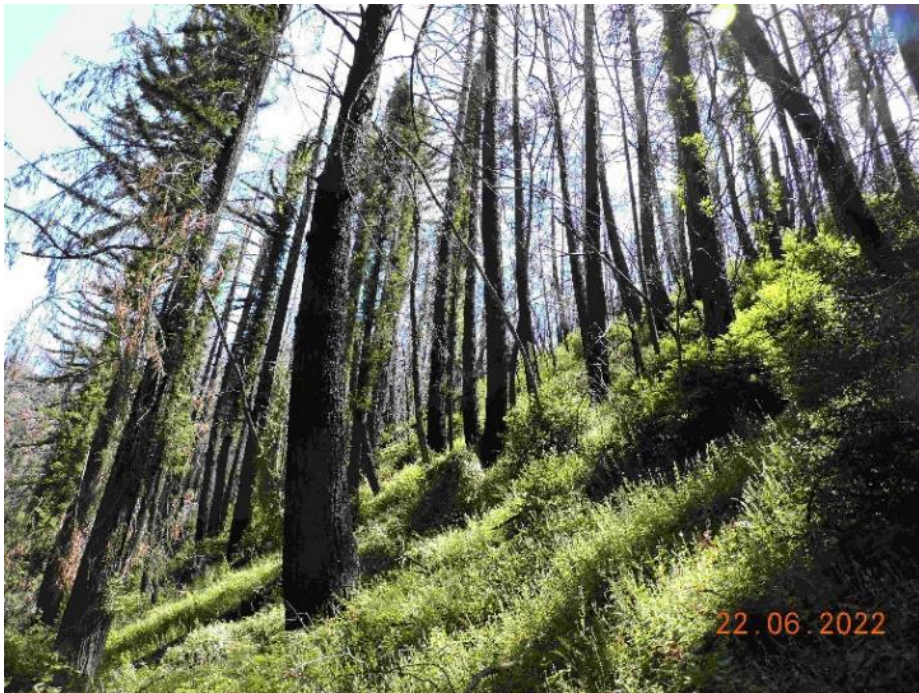
Photo 66. West Fork, mile 3.2, East Slope. Redwoods with epicormic sprouting on trunk and branches, and standing tanbark oaks with basal sprouts. Well-developed ground cover on moderate slope.

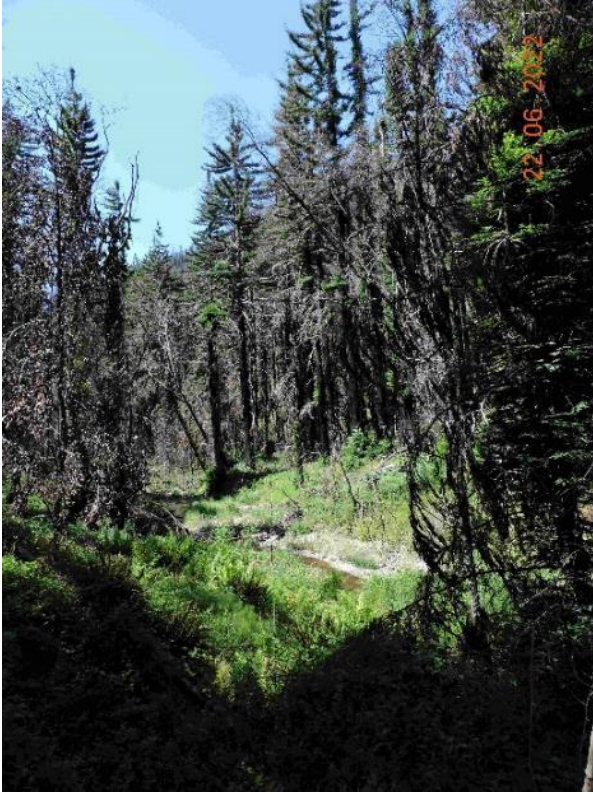
Photo 67. West Fork, mile 3.35, looking downstream. Near-stream habitat, with open canopy, ground cover densely developed, and flat aggraded channel.

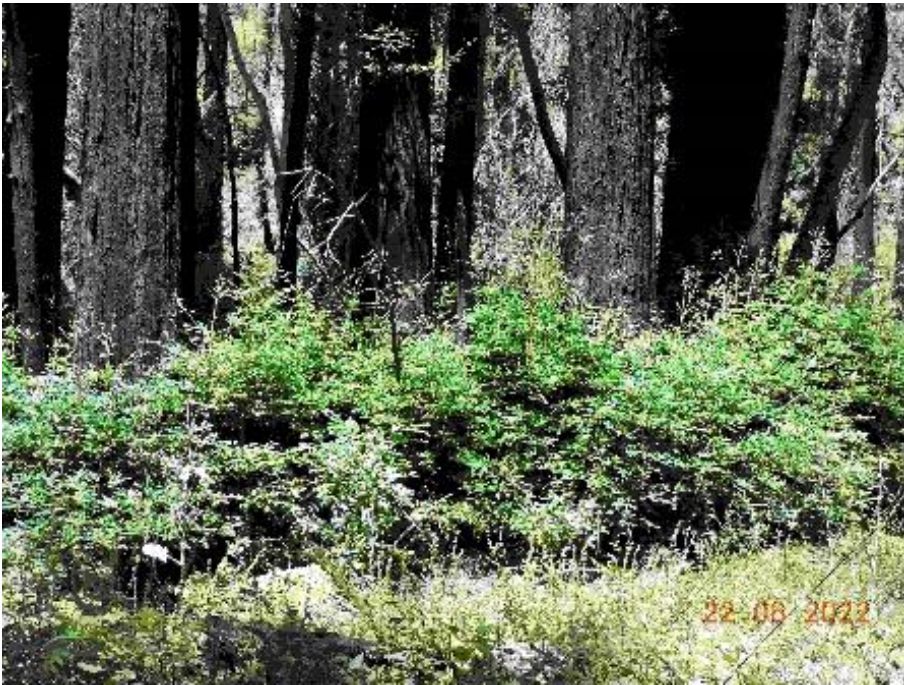
Photo 68. West Fork, mile 3.4. Basal sprouts on burned redwoods.

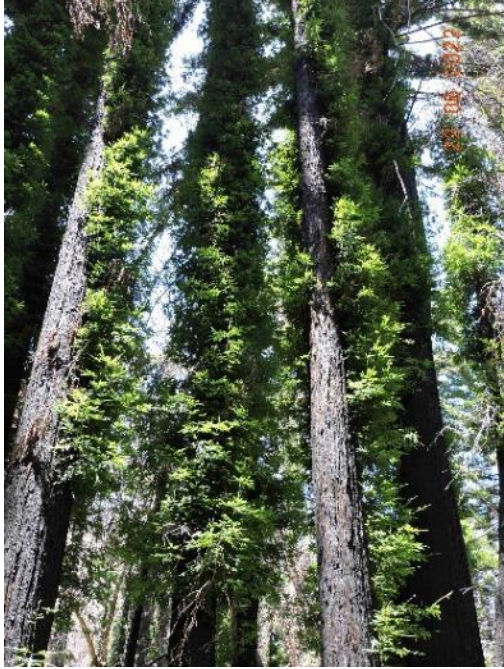
Photo 69. West Fork, mile 3.4. Epicormic sprouts on redwood trunks and branches.

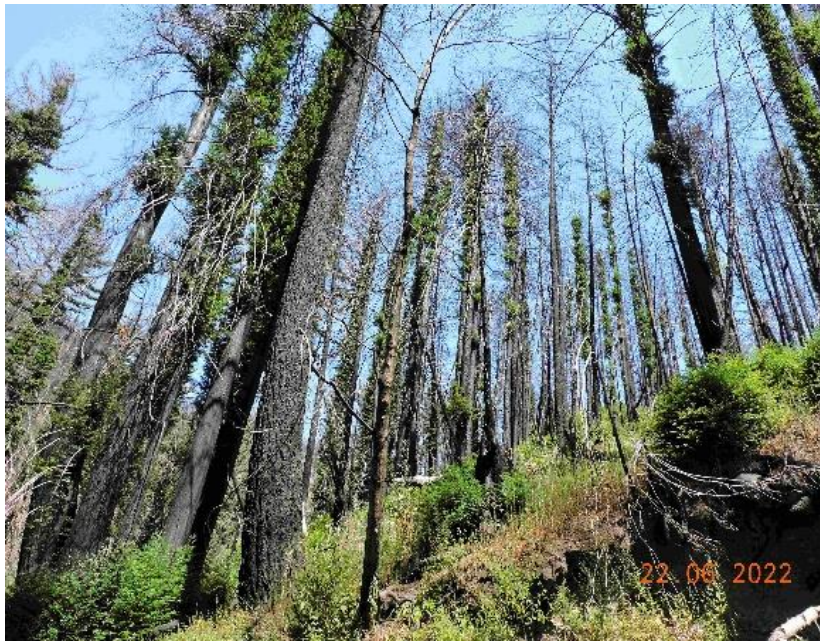
Photo 71. West Fork, mile 3.45. East slope, with ground cover, redwoods with basal and epicormic sprouts, and dead Douglas firs.

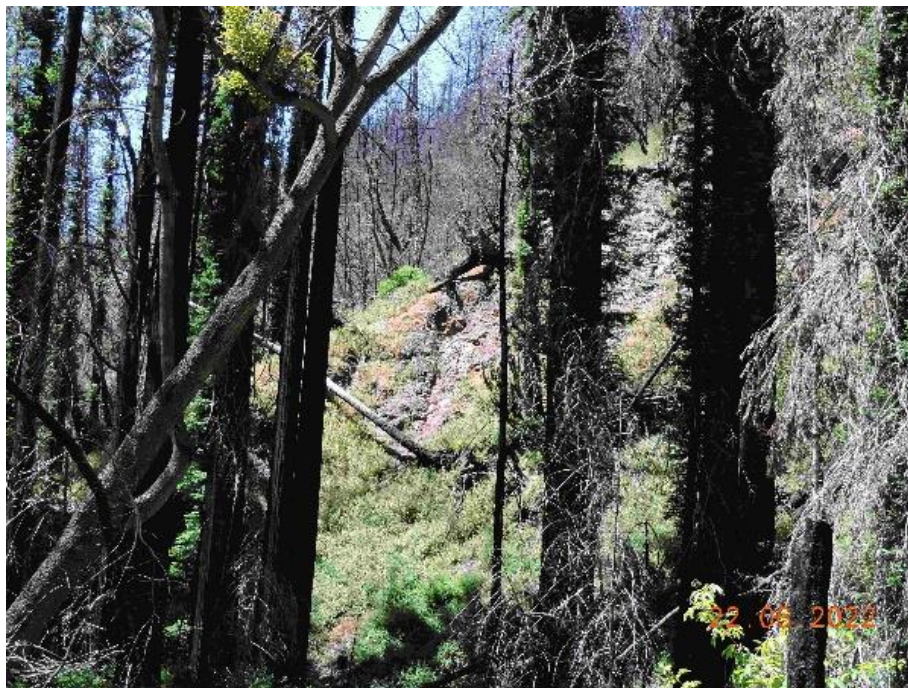
Photo 72. West fork, mile 3.45. Looking across aggraded channel to eroded west slope.

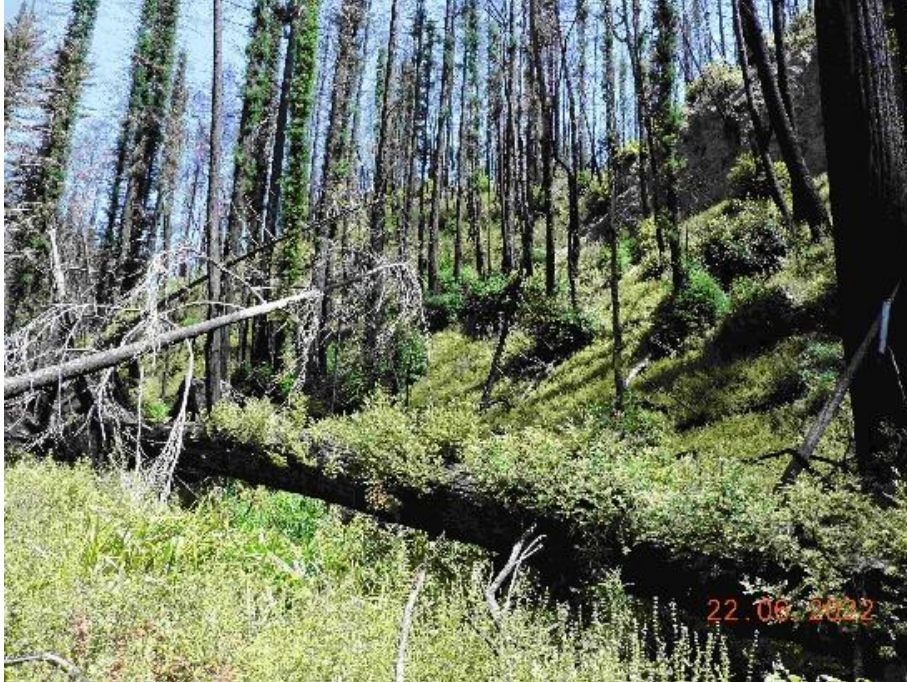
Photo 75. West Fork, mile 3.5. Trailside wetland with 5 large burned redwoods fallen from the wet soil. Even the fallen redwoods have epicormic sprouts. East slope with basal and trunk sprouting redwoods and some dead Douglas firs.

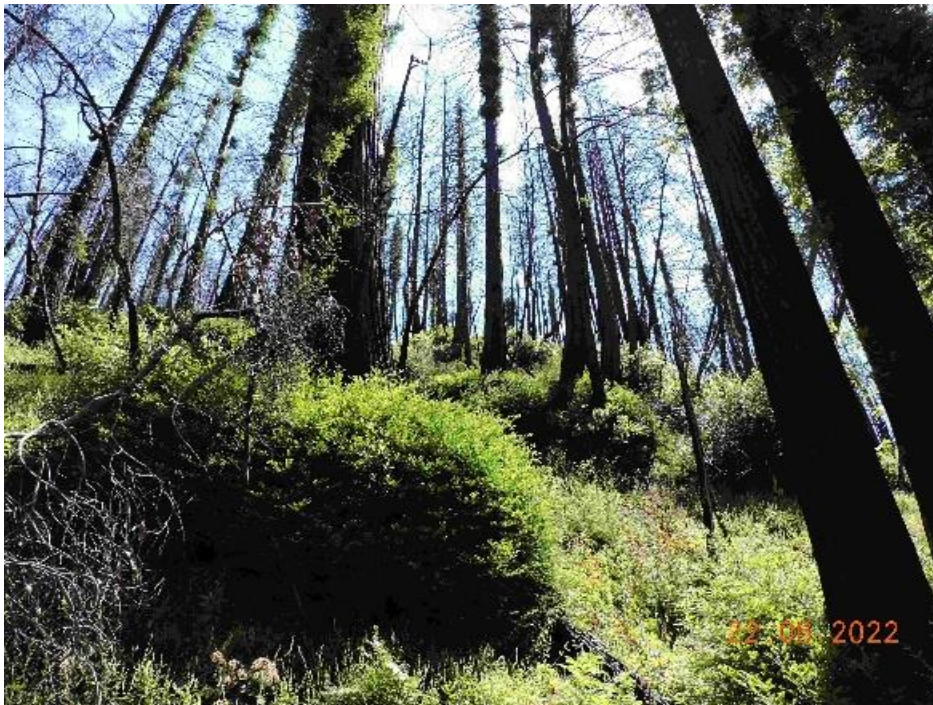
Photo 76. West Fork, mile 3.5+. East slope with dense ground cover, recovering redwoods, and dead Douglas firs.

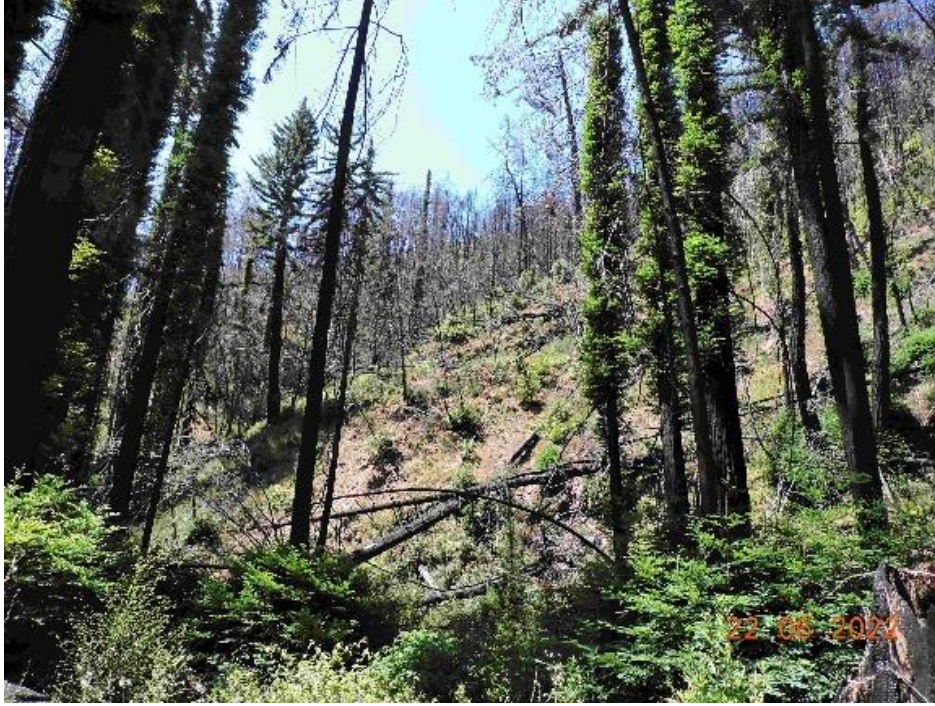
Photo 77. West Fork, mile 3.5+. Largely bare and eroded west slope. Few recovering redwoods except near stream.

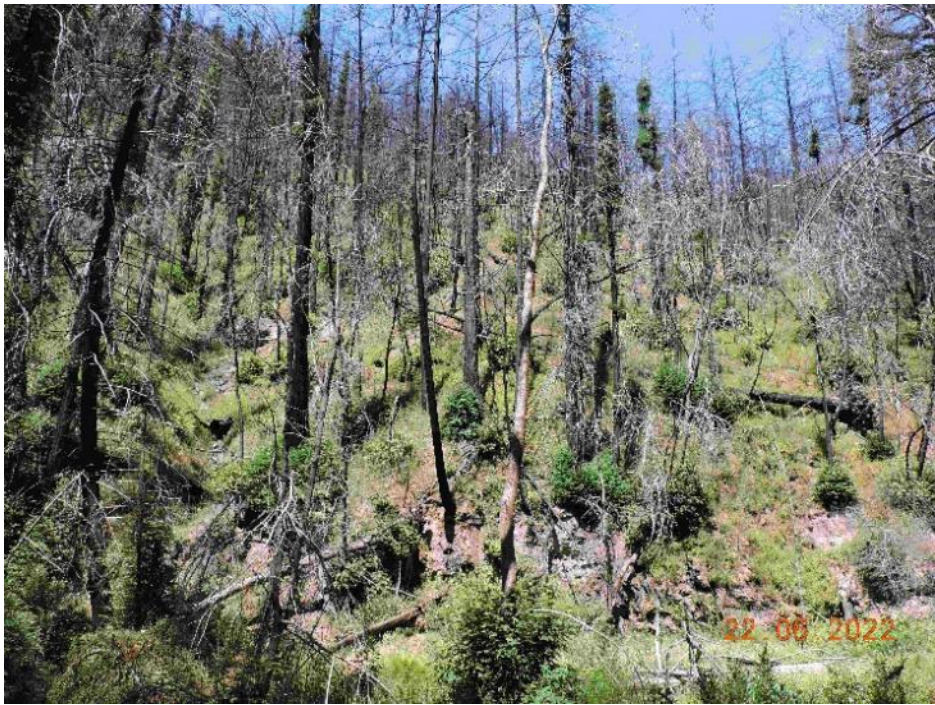
Photo 78. West Fork, mile 3.55. West slope with poor ground cover, and mostly dead trees. An eroding drainage gully is to the left in the photo. Channel is substantially aggraded.

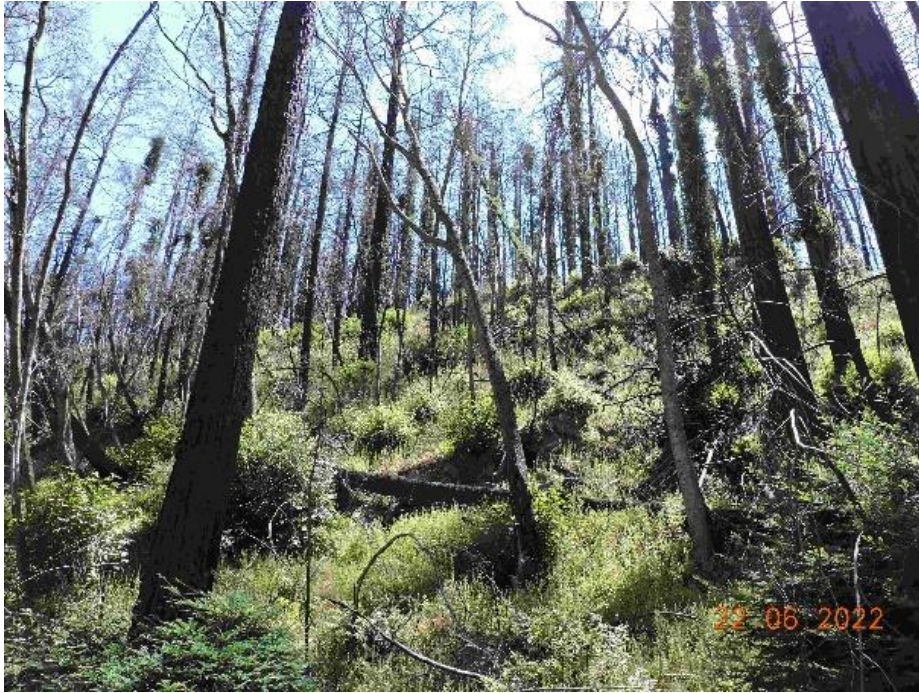
Photo 79. West Fork, mile 3.55. East Slope with gentler slope, more ground cover, and higher density of dead and recovering trees.

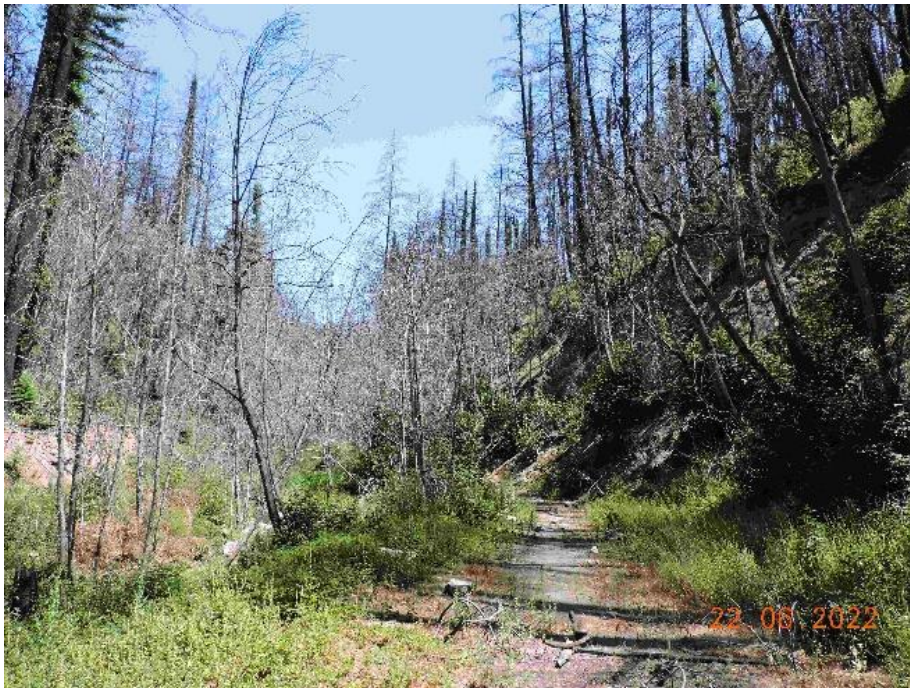
Photo 80. West Fork, mile 3.55+, looking upstream. Bedrock outcrop in channel and on lower slope has narrowed the riparian zone. All alders were killed by fire, but streamside and upslope maples have basal sprouts.

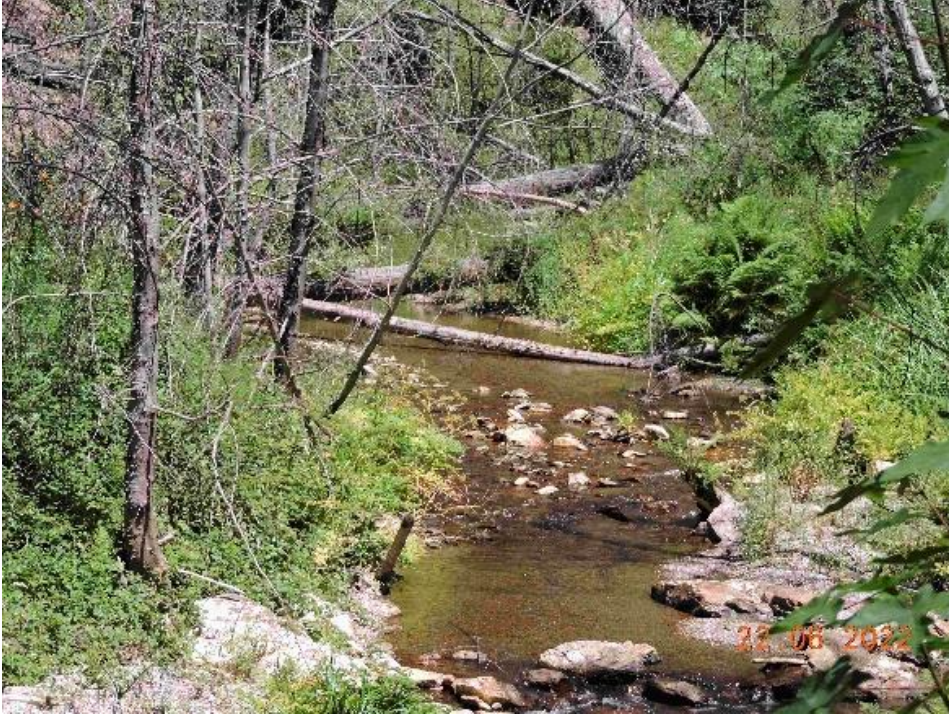
Photo 81. West Fork, mile 3.55+, looking downstream. Bedrock-controlled channel with dead alders.

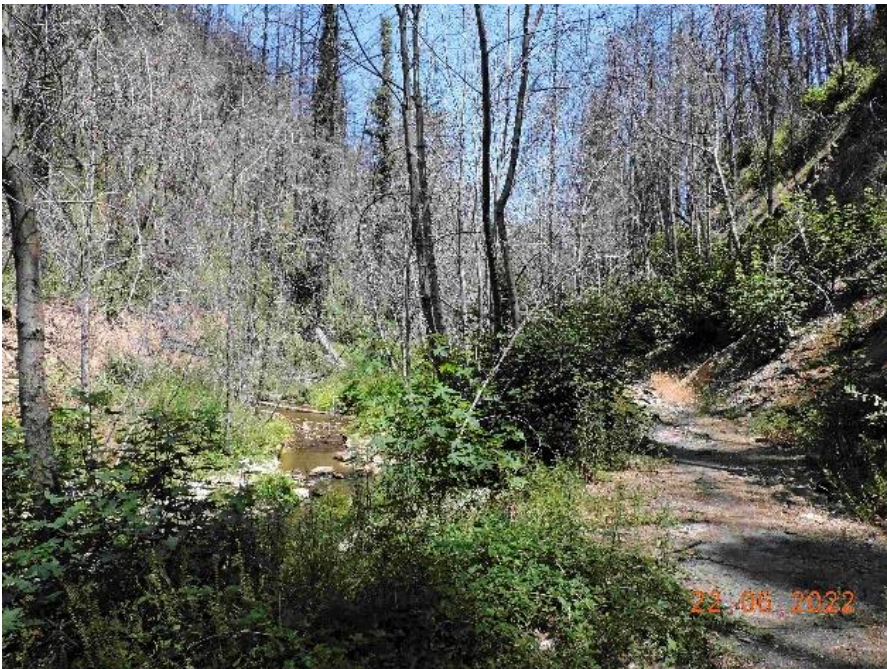
Photo 82. West Fork, mile 3.55+-, looking upstream. All alders dead, all streamside and lower slope maples with basal sprouts; presently no canopy shade.

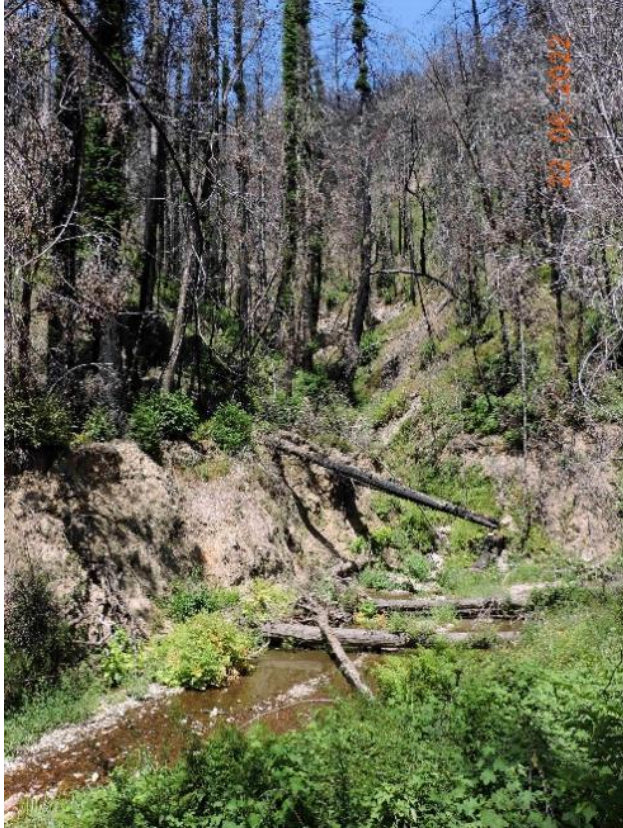
Photo 83. West Fork, mile 3.6-, looking across to west slope. Eroding gully with a sediment and log delta spilling into stream. Terrace to the left of gully may be remnant from an old debris flow.

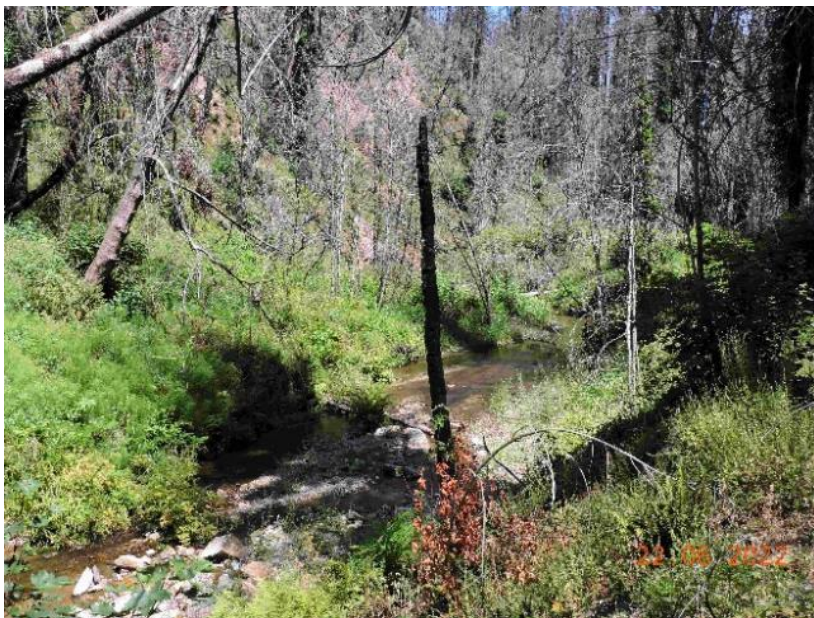
Photo 84. West Fork, mile 3.6, looking upstream. Aggraded channel, dense riparian ground cover, and eroding west slope.

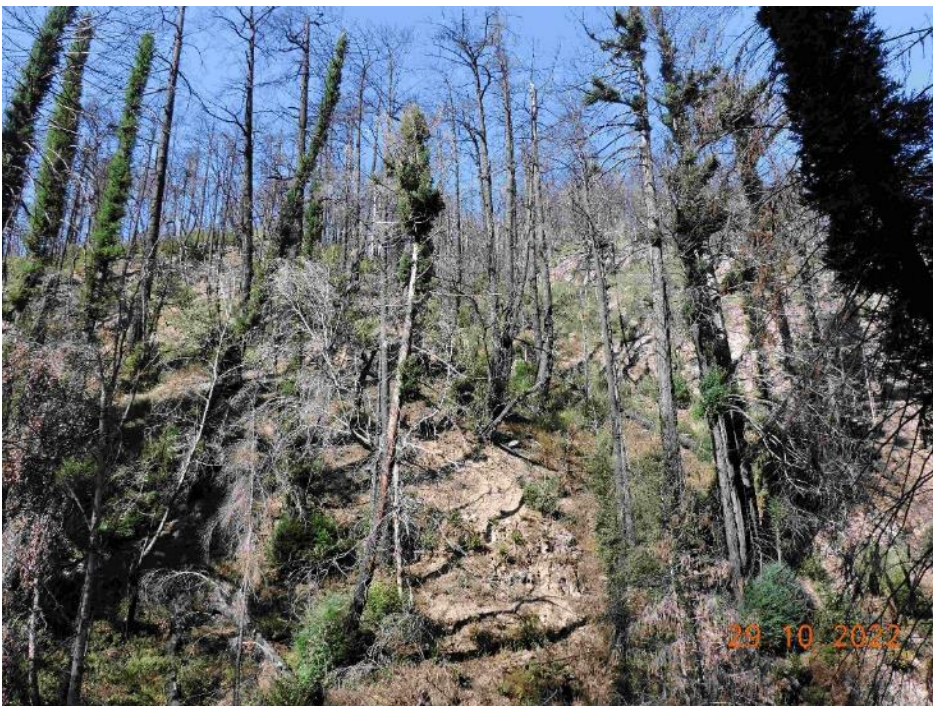
Photo 86. West Fork, mile 3.6+. Steep, eroding west slope, with a few surviving redwoods with trunk sprouts at the bottom of the slope.

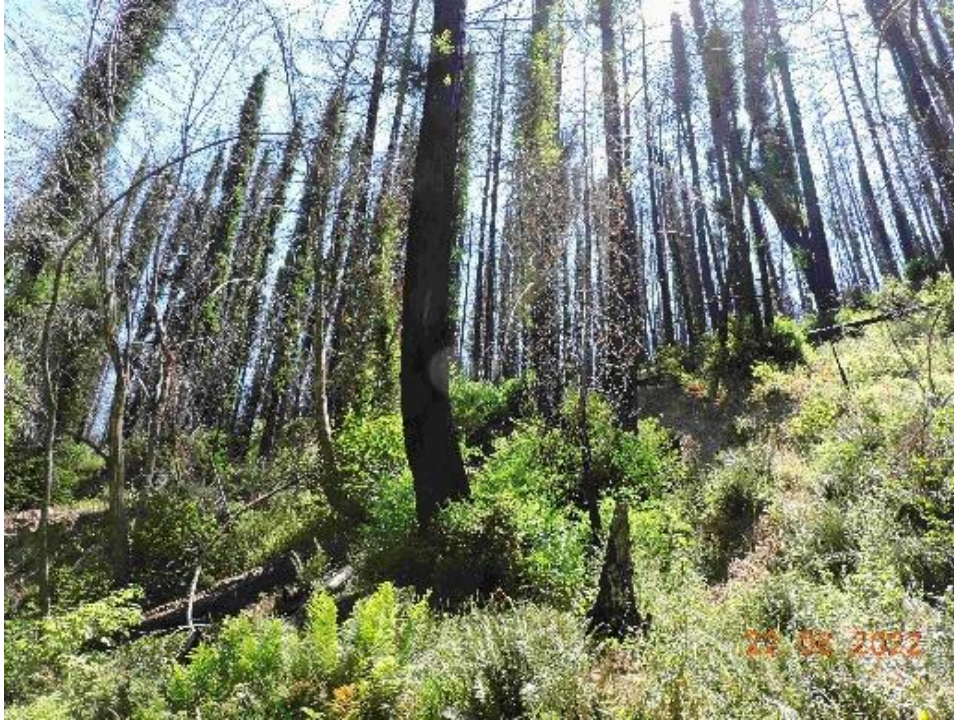
Photo 87. West Fork, mile 3.6+. East slope, with dense ground cover and many recovering trees on less steep terrain than the west slope.

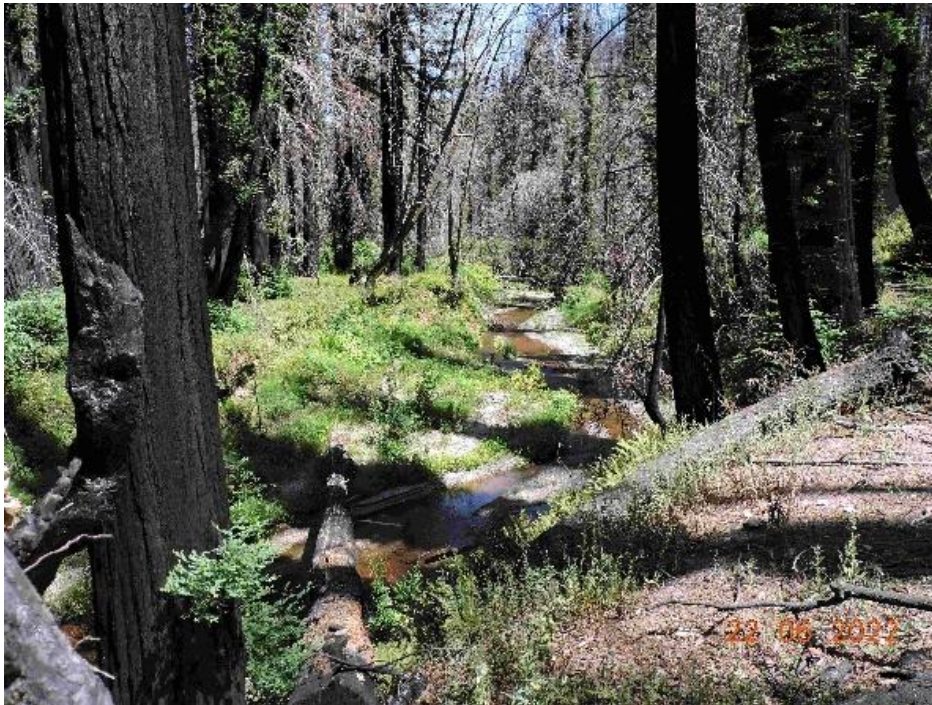
Photo 88. West Fork, mile 3.6+, looking upstream. Streamside habitat and substantially aggraded channel downstream of fish sampling site.

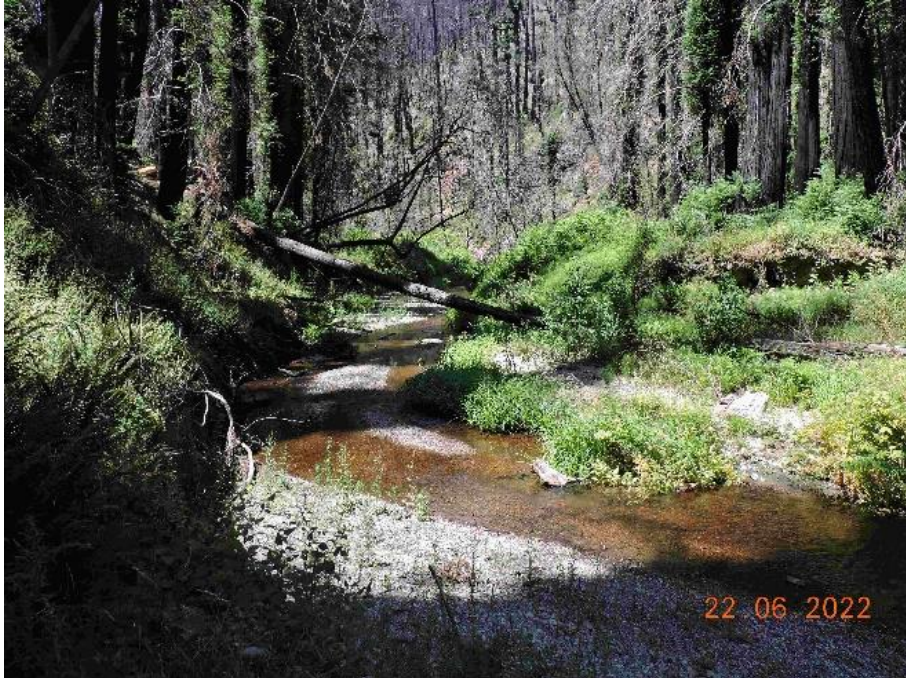
Photo 89. West Fork, mile 3.6++, looking downstream. Uppermost sampling pool of fish sampling site was deep (3+ ft) and long through 2021. The pool was completely filled in winter 2021-2022. Steep eroding west slope is in background.

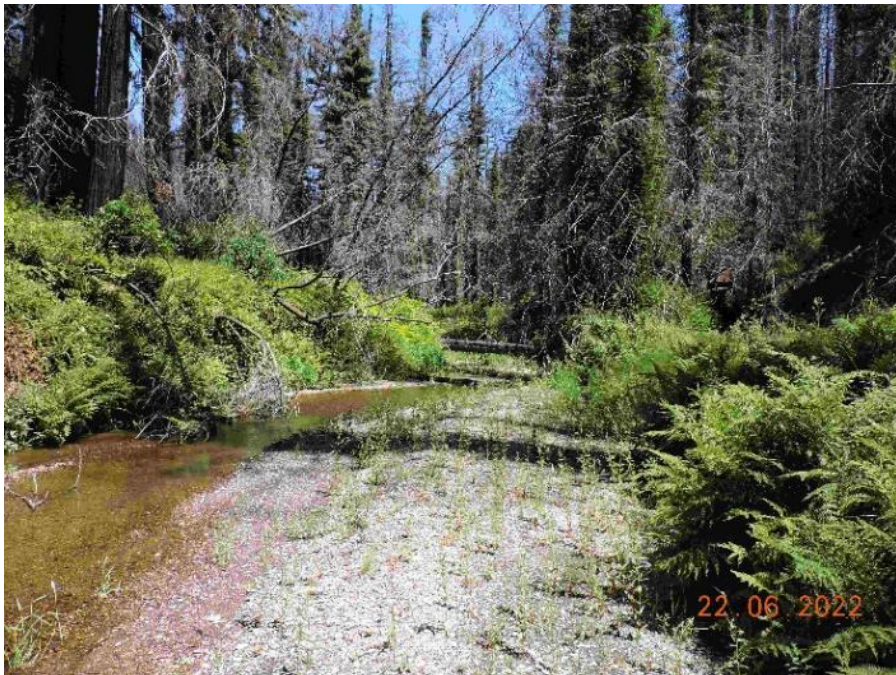
Photo 90. West Fork, mile 3.6++, looking upstream. The large, deep pool immediately upstream of the sampled habitats was previously too deep to electrofish. Now it is 95% filled with fines and gravel, except for a small scour pocket at a rootwad at the upstream end.

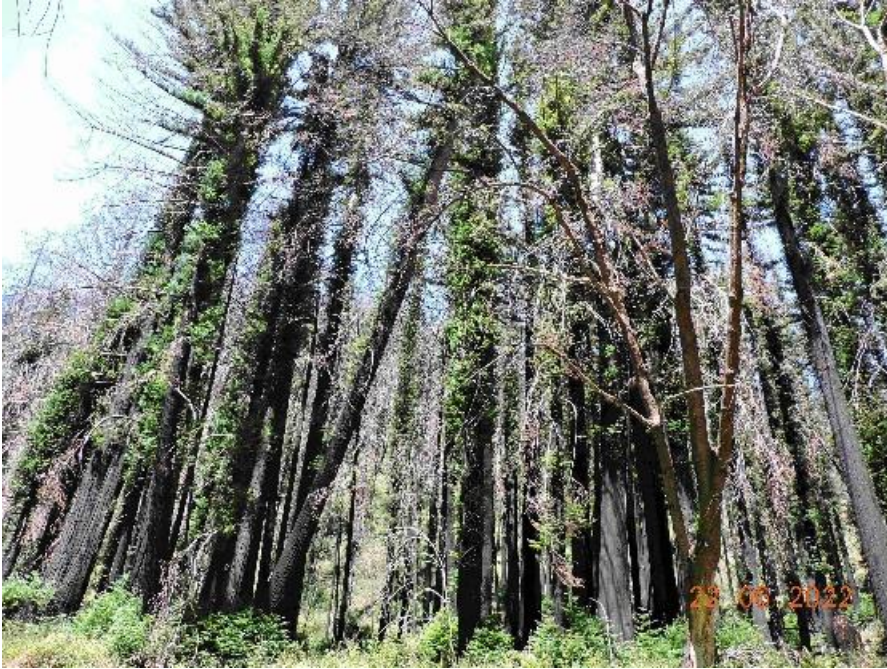
Photo 91. West Fork, mile 3.6++, looking across channel to right bank (west) terrace. The narrow, recovering terrace forest is backed by a steep, eroding, west slope, with few live trees.

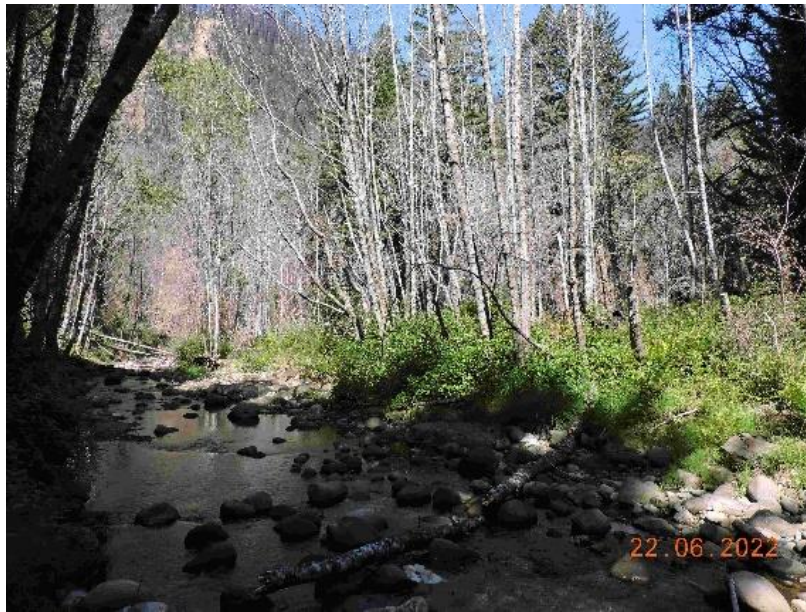
Photo 93. East Fork, looking downstream of trail ford. Almost all alders along stream and on flat were killed by the fire.

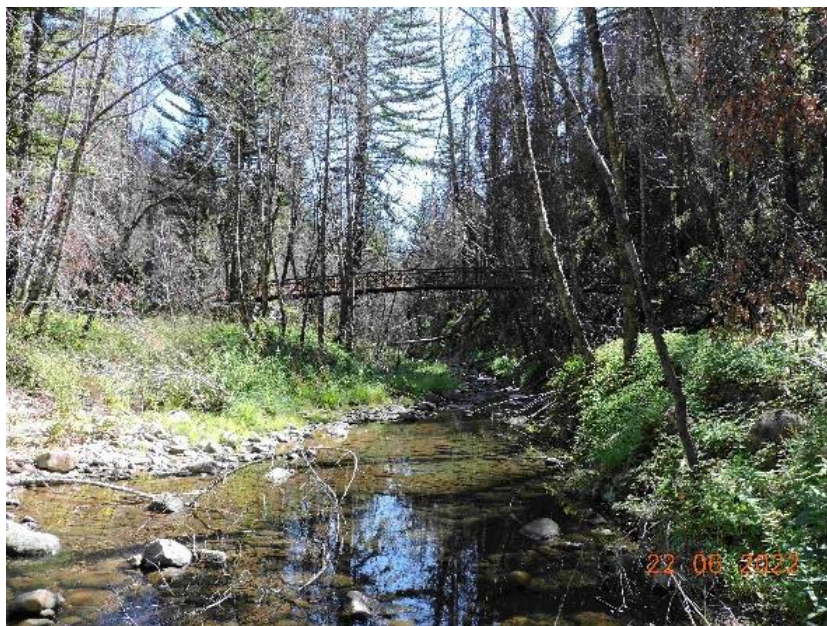
Photo 94. East Fork, looking upstream of ford. Alders and Douglas firs are dead. Tan oaks with basal sprouts on dead trunks, and redwoods recovering with epicormic sprouts. Footbridge with some boards burned in the fire. Channel with sandstone and mudstone cobbles and boulders. The stream is in the Butano sandstone farther upstream.

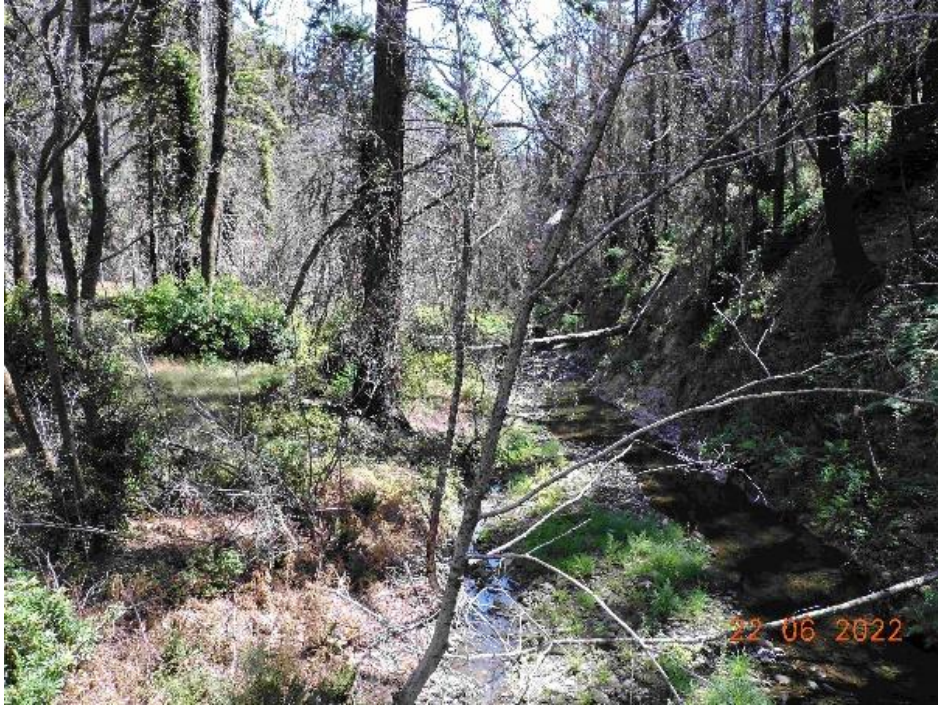
Photo 95. East Fork, looking upstream from footbridge. Streambed immediately upstream is bedrock and boulder pools with little change.

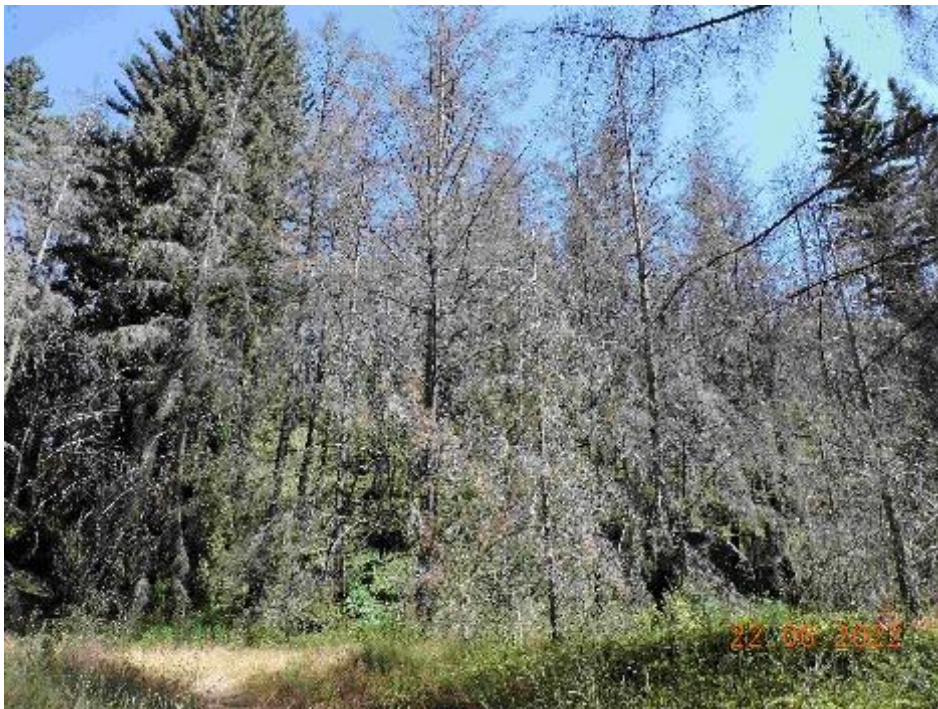
Photo 96. East Fork from trail. North slope and flat with all Douglas firs killed, but redwoods survived.

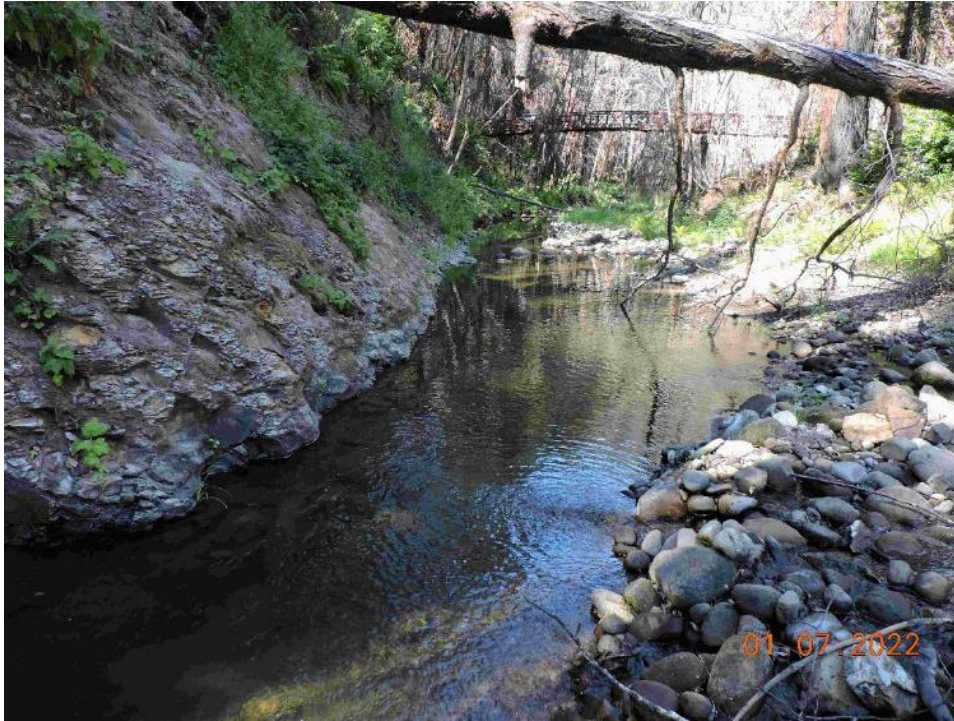
Photo 97. East Fork, bedrock pool upstream of footbridge. Some silt on bottom, but no pool filling.

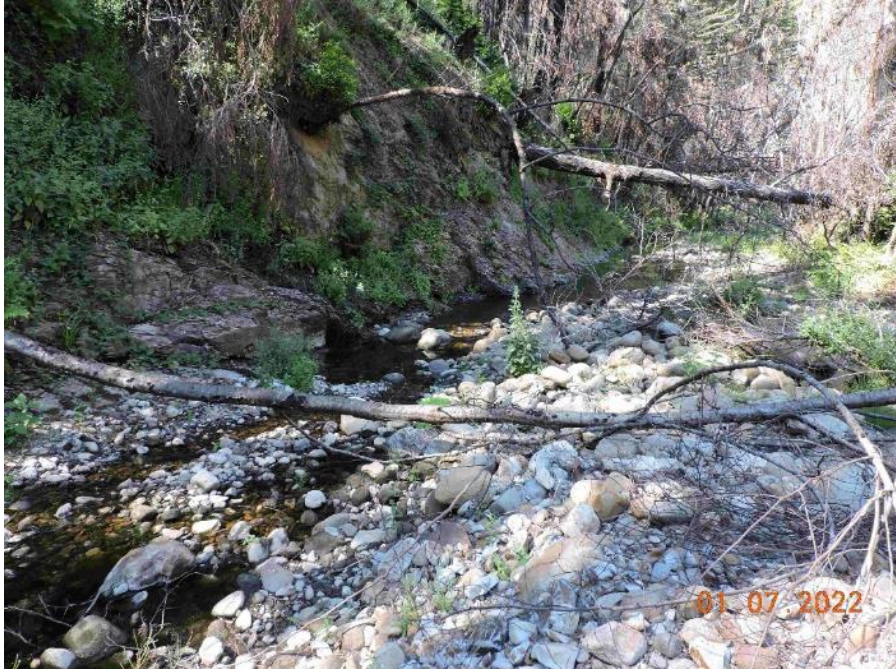
Photo 98. East Fork. Head of bedrock pool cut off by deposition of cobbles and boulders from channel realignment in bend immediately upstream. High flows in October and December 2021 scoured the channel, but no aggradation or pool filling.

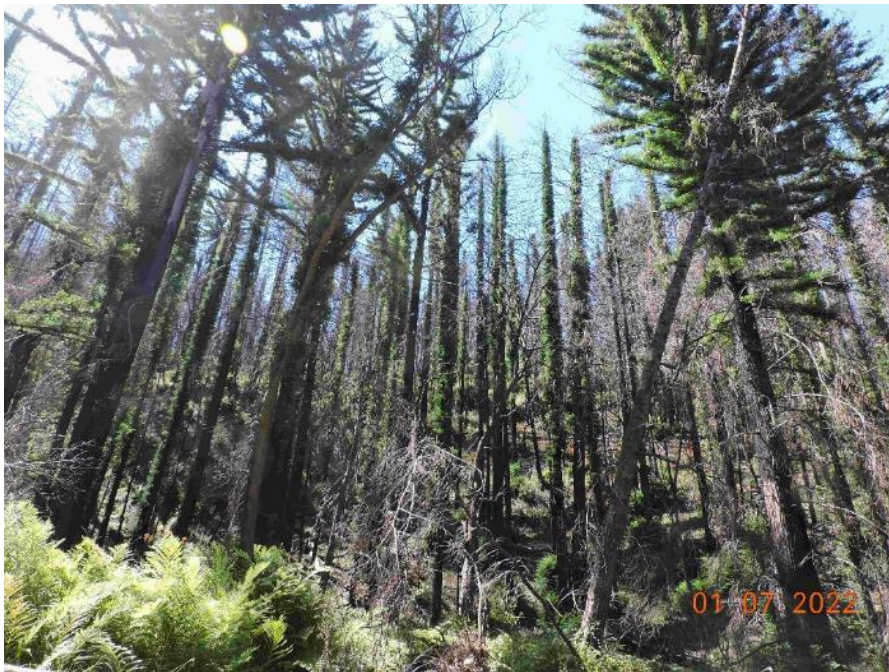
Photo 100. East Fork, mile 0.1. South slope with burned, but recovering redwoods. Few tanbark oaks, with dead trunk, but basal sprouts. The few Douglas firs are dead.
