## Waddell Creek Post-fire Resurvey July and October 2022

(revised from August 2022; text revisions are in *italics bold*)

Jerry J. Smith

31 October 2022 (errors corrected on page 5 and photos 110,114,122,125 on 11 November 2022)

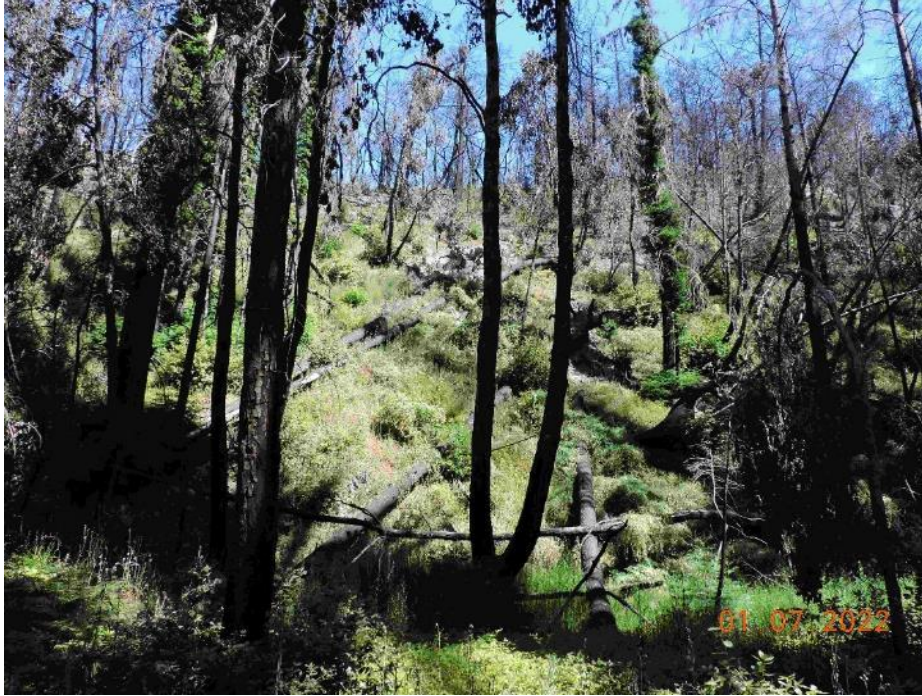
Photo 101. East Fork, mile 0.1. North slope (south-facing) with sparse surviving redwoods, some dead Douglas firs, and tanbark oaks dead, except many with basal sprouts.

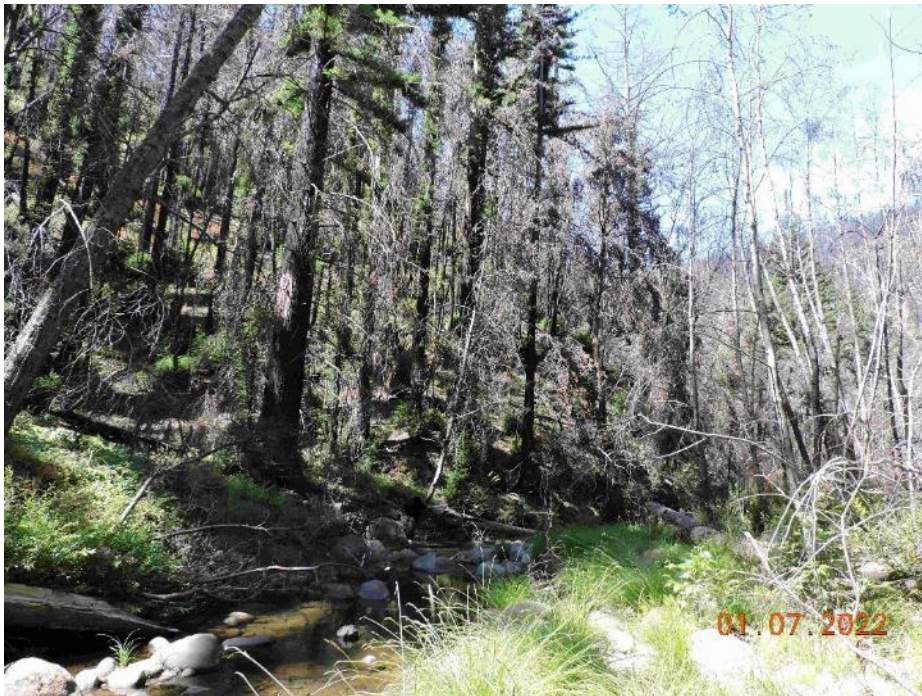
Photo 102. East Fork, mile 0.15+, looking downstream. South slope and channel, with recovering redwoods to streamside and dead alders.

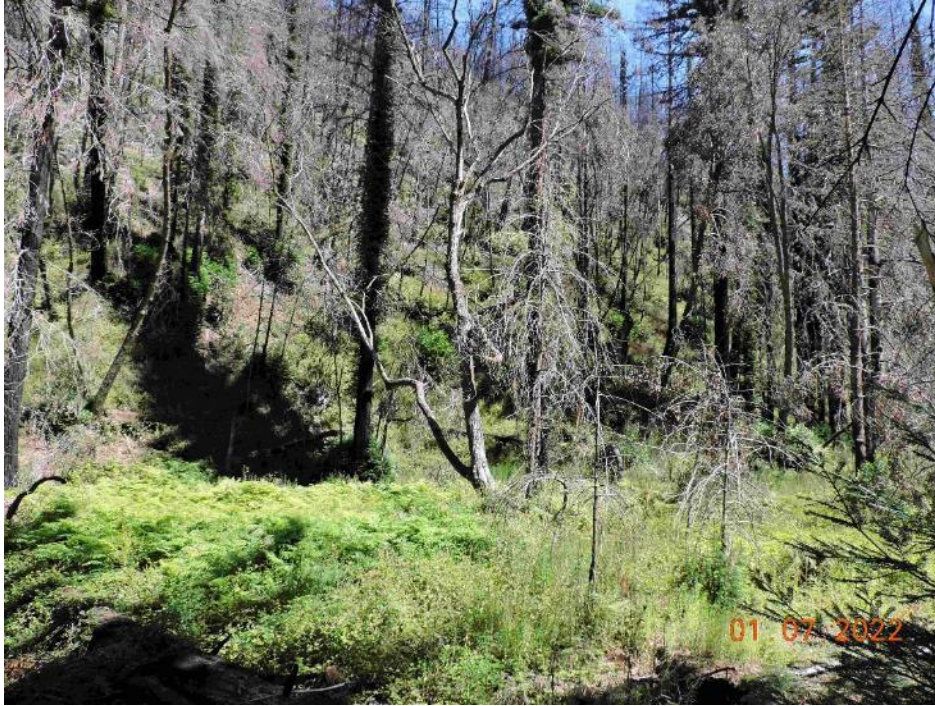
Photo 103. East Fork, mile 0.15+. North slope with surviving redwoods at base and mostly dead Douglas firs and burned tanbark oaks with basal sprouts upslope. Dense ground cover on terrace, including blackberry.

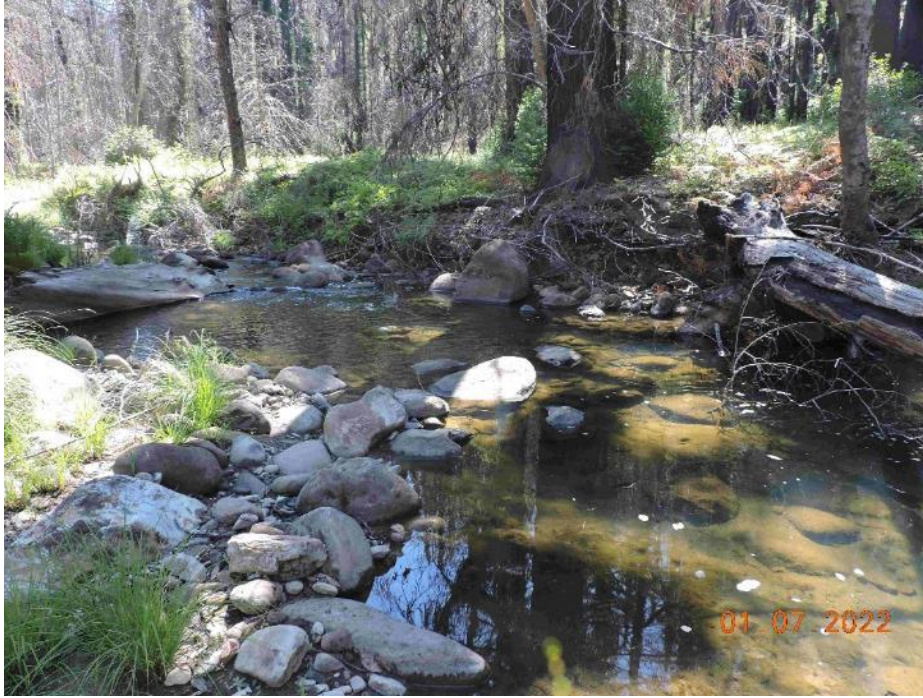
Photo 105. East Fork, mile 0.2. Head of deep fish sampling pool, with clean substrate, except coating of silt farther downstream.

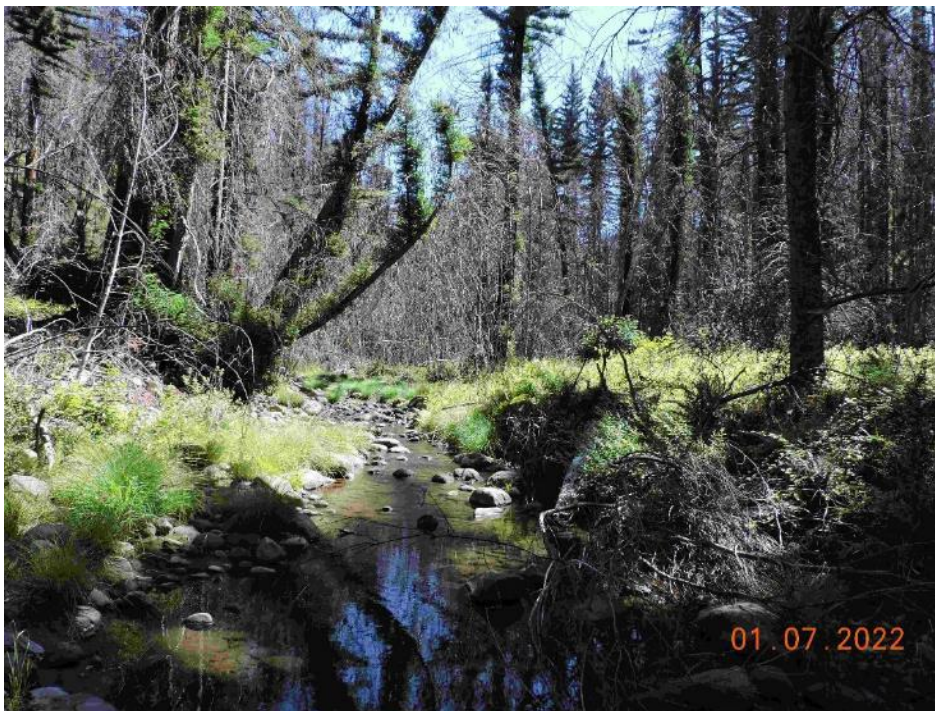
Photo 106. East Fork mile 0.2+. Dead alders with recovering redwoods with epicormic sprouts on terrace above stream.

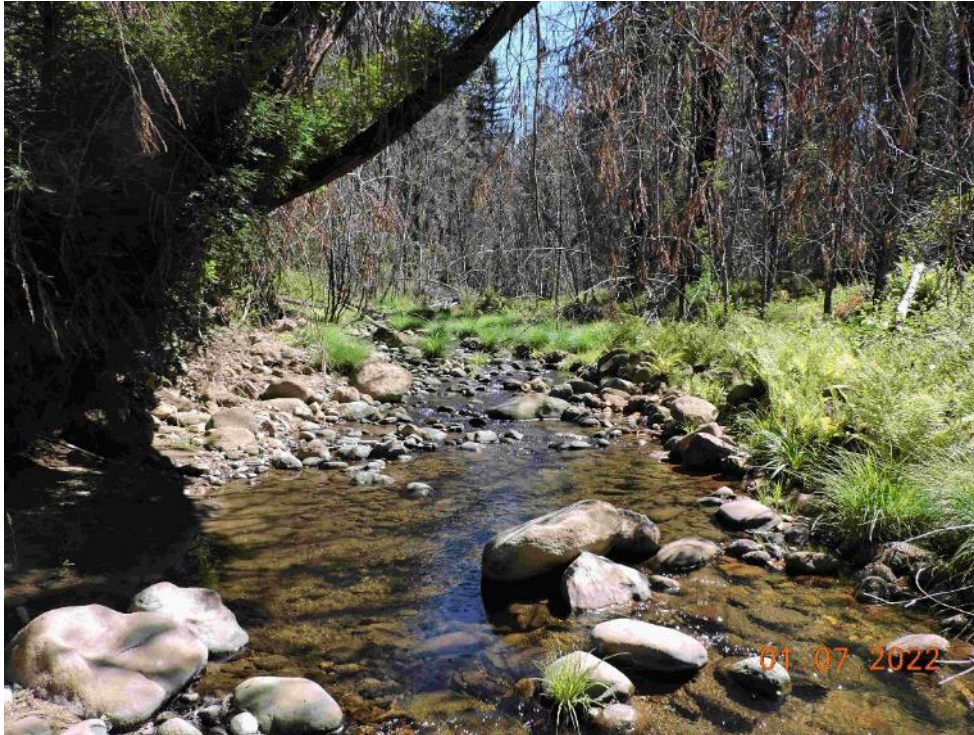
Photo 107. East Fork, mile 0.2+. Clean boulder and cobble channel, but with alder shade removed.

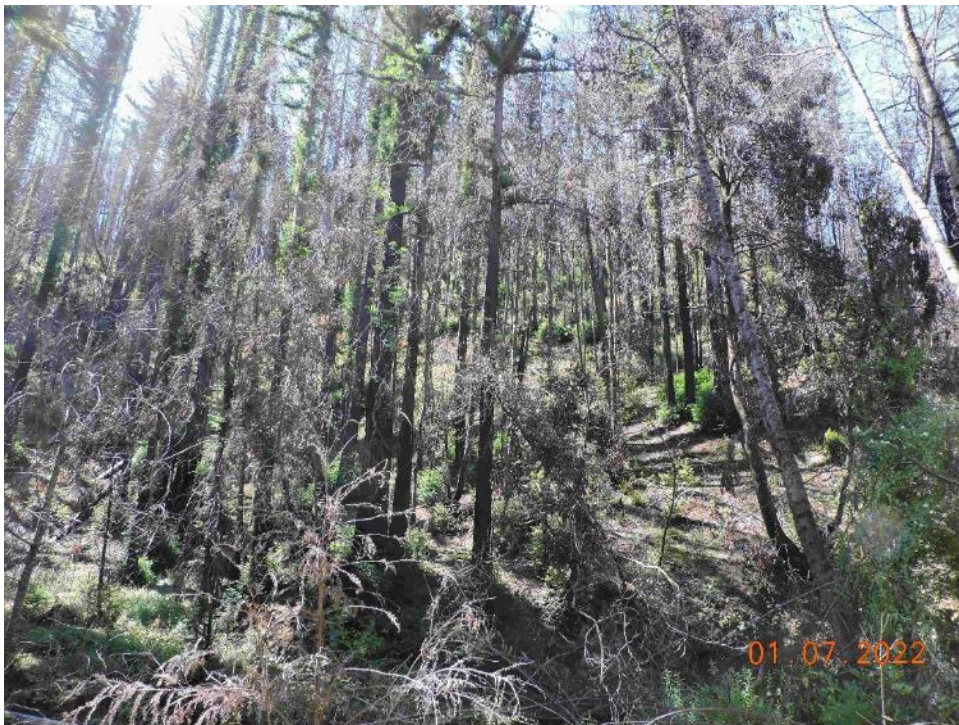
Photo 108. East Fork, mile 0.2+. South slope with dead Douglas firs, many tanbark oaks with basal sprouts, and redwoods with epicormic sprouts on trunk and branches.

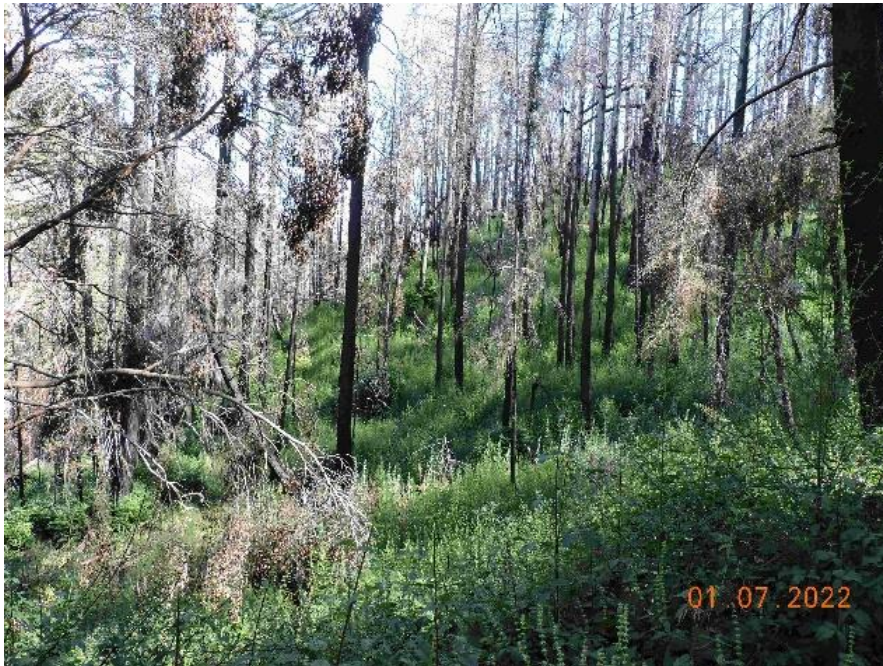
Photo 109. Bypass road = mile 2.7. Dead Douglas firs and burned tanbark oaks, many with basal sprouts. Well-established ground cover, including blue blossom ceanothus.

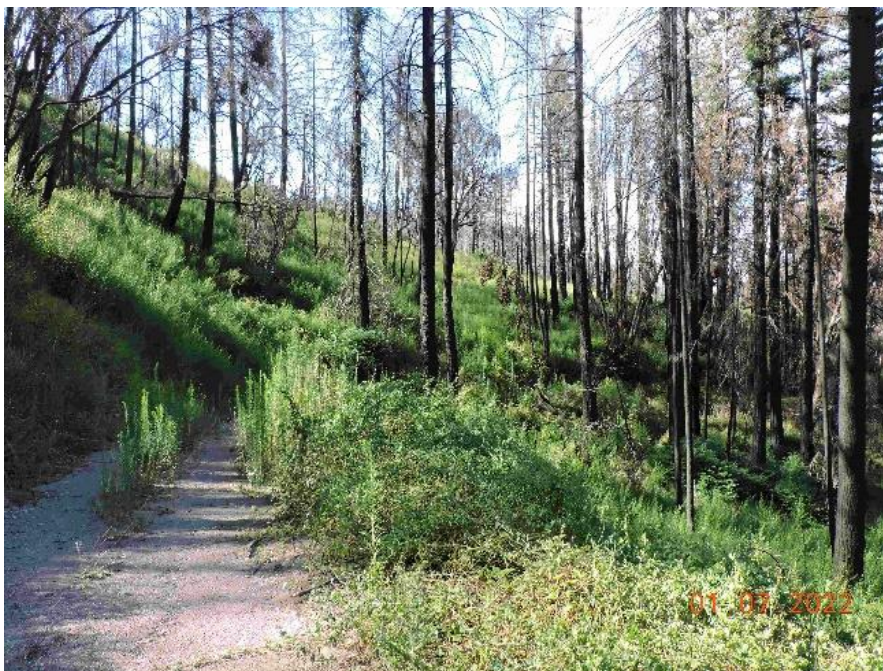
Photo 110. Bypass road = mile 2.7+. Dead Douglas firs and tanbark oaks with basal sprouts. Some surviving redwoods farther down slope. Ground cover includes ***French*** broom in road. No road erosion.

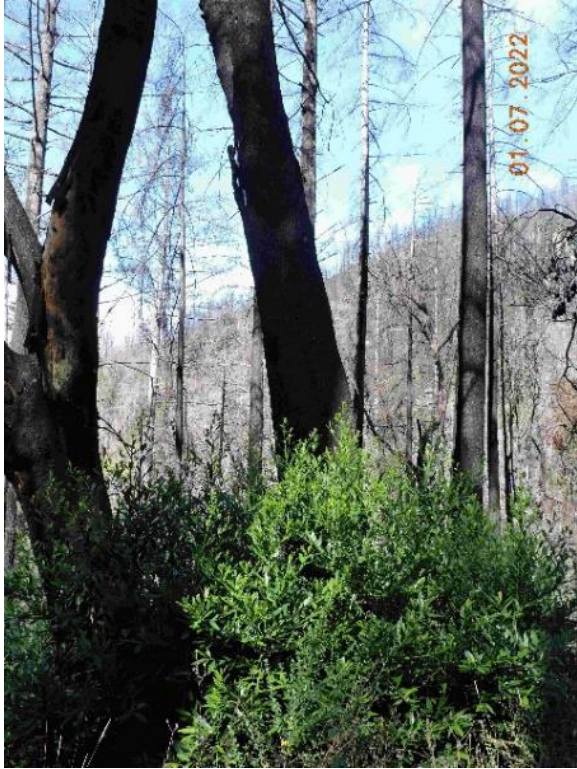
Photo 111. Bypass road = mile 2.7+. Burned California bays with basal sprouts. West slope above Waddell Creek in background.

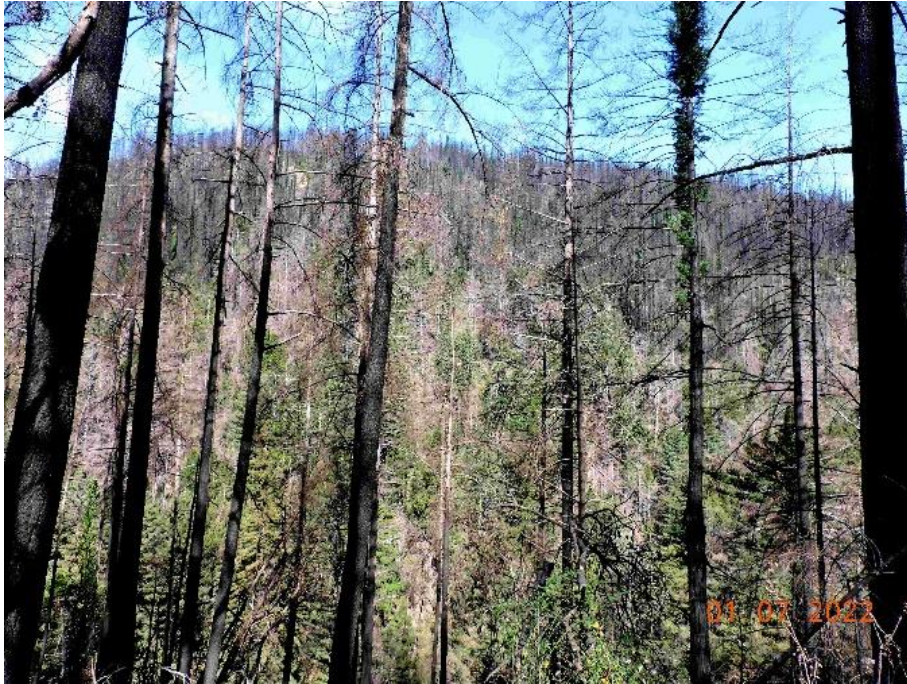
Photo 113. Bypass road = mile 2.75. Looking from road to west slope above Waddell Creek, with severe upper slope burn. Looking through dead Douglas firs and some recovering redwoods with epicormic sprouts.

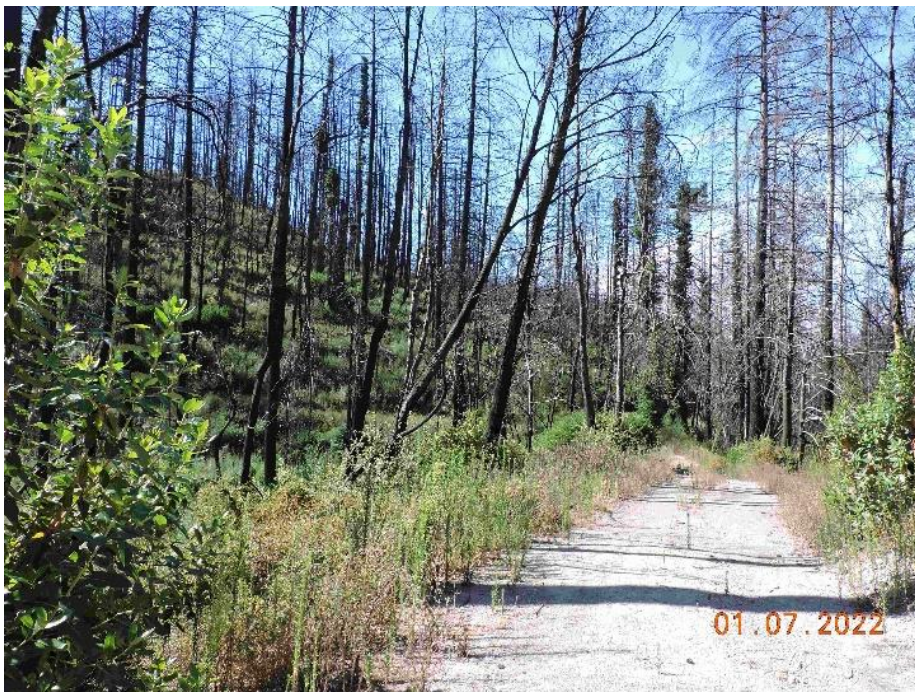
Photo 114. Bypass road = mile 2.8+. Dead Douglas firs, redwoods with epicormic sprouts, and tanbark oaks with basal sprouts. ***French*** broom in road.

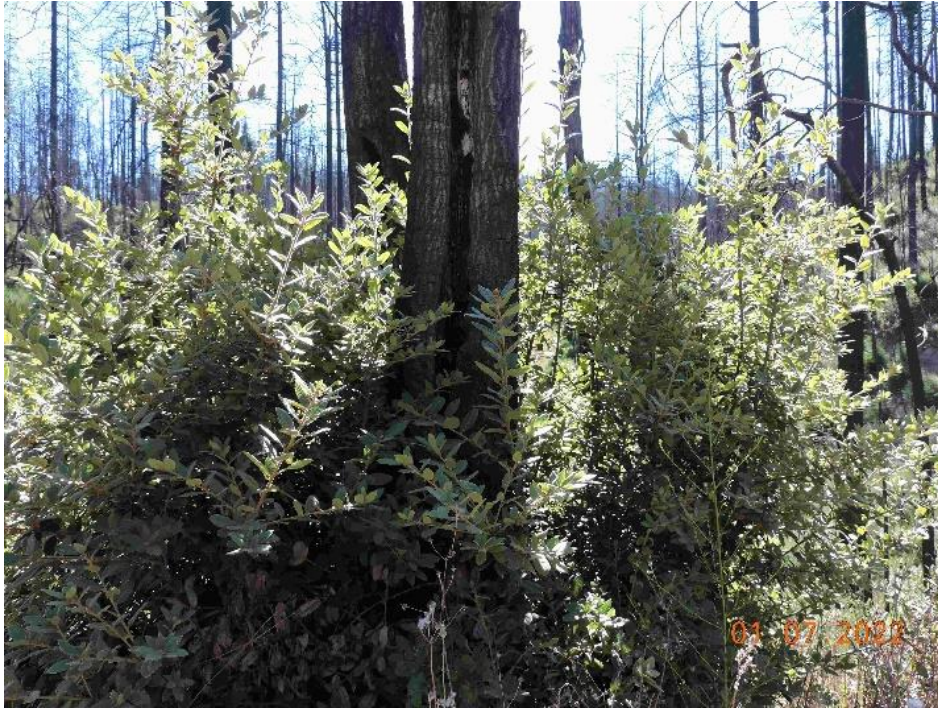
Photo 115. Bypass road = mile 2.8+. Basal sprouts at base of dead tanbark oak trunk.

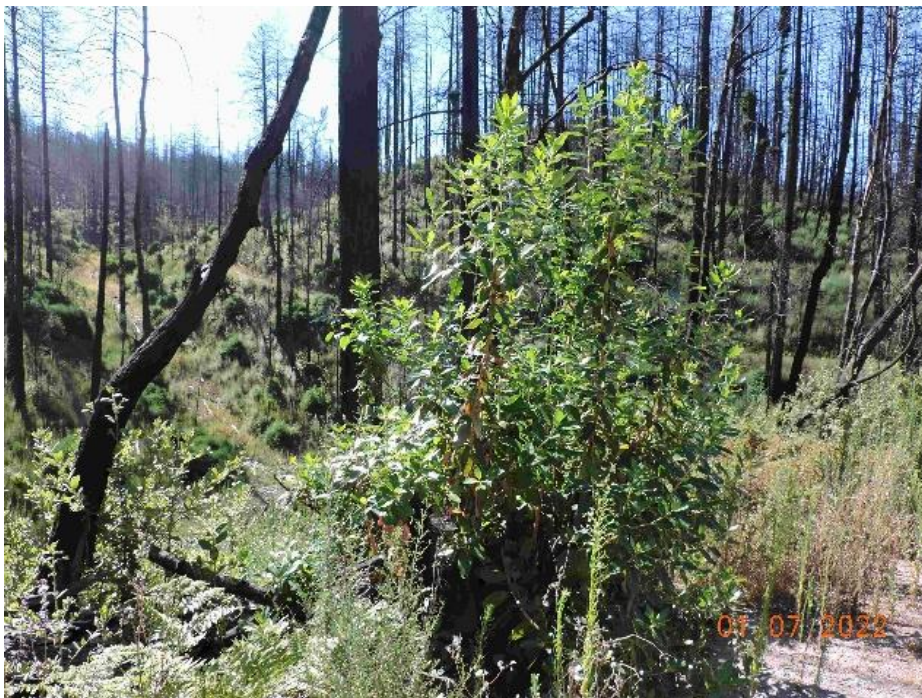
Photo 116. Bypass road, mile=2.8+. Basal sprouts from dead and down madrone. 2021 salvage logging in background.

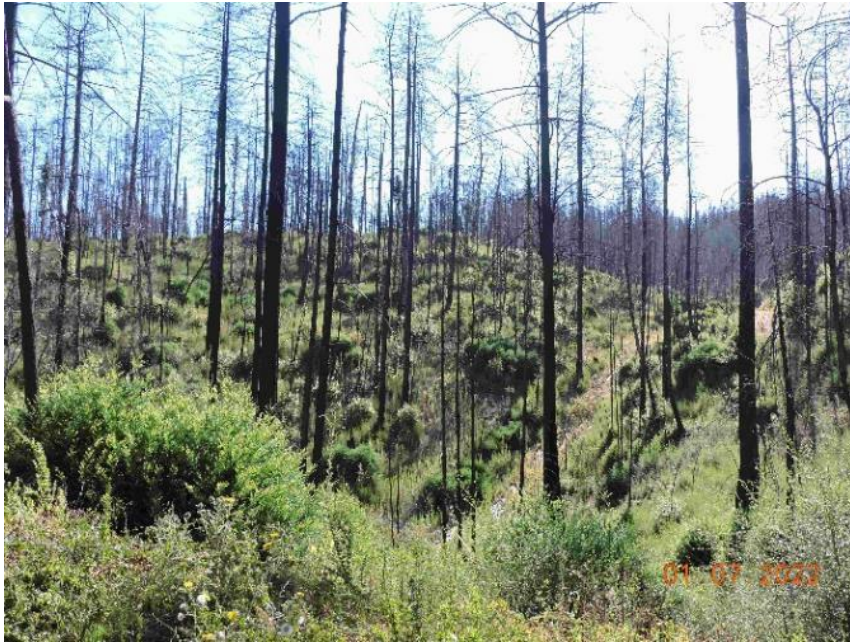
Photo 117. Bypass road, mile=2.8+. 2021 salvage logging, with many dead Douglas firs left standing. Damaged redwoods cut and stump sprouting. Ground cover is dominated by blue blossom ceanothus.

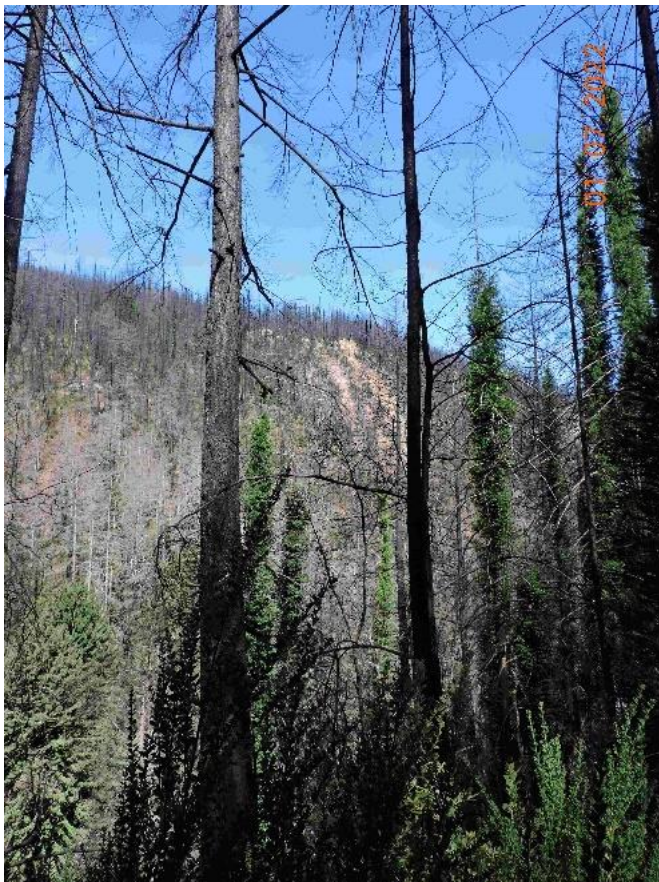
Photo 118. Bypass road, = mile 2.8+. Looking across and upstream to west slope, with the ridge to creek debris flow scar at the confluence of the forks. Branchless redwoods with trunk epicormic sprouts.

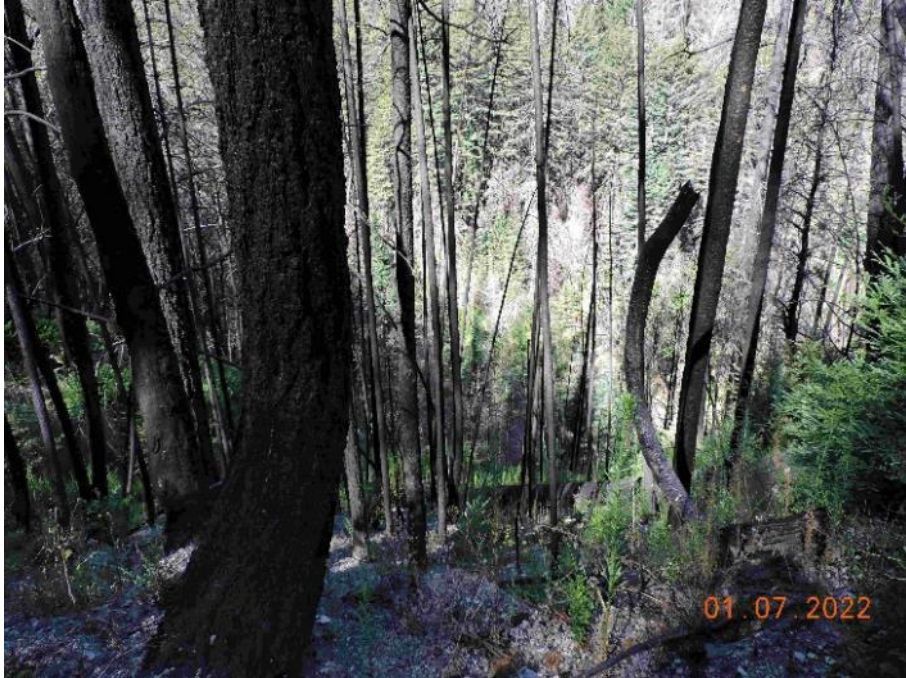
Photo 119. Bypass road, mile=2.8+, looking downslope from road near top of slope. Dead Douglas firs, some tanbark oaks and redwoods with basal sprouts.

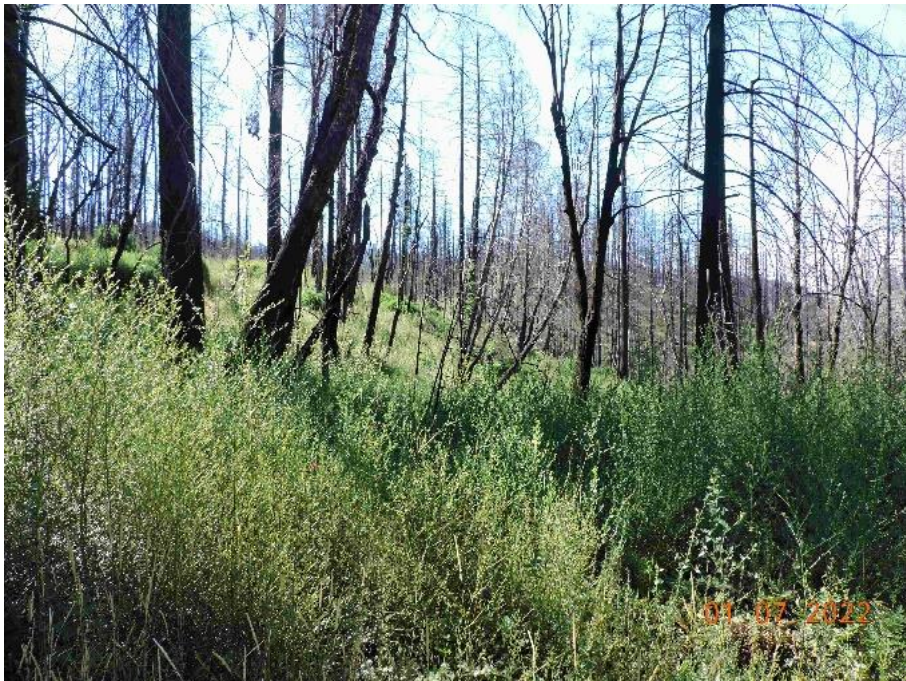
Photo 120. Bypass road, mile=2.85, near crest of road. Blue blossom ceanothus, with 2021 salvage logged area in background.

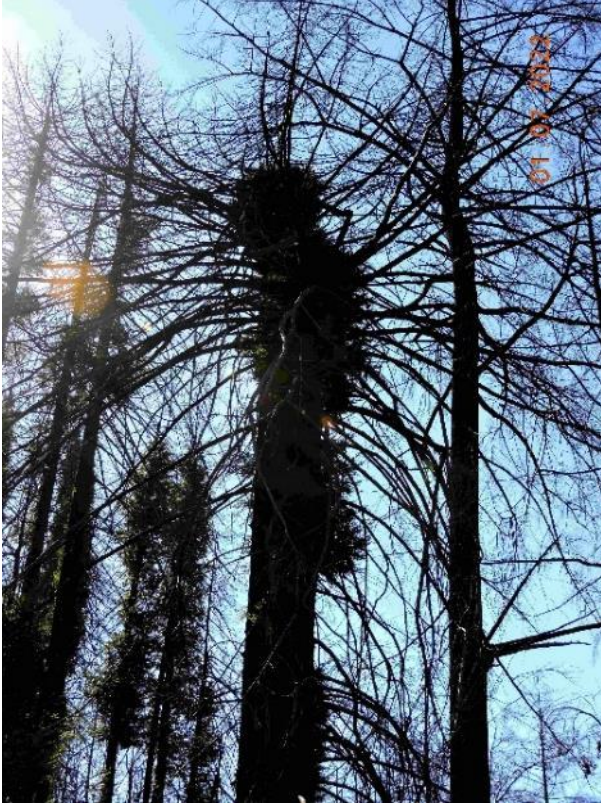
Photo 121. Bypass road, mile=2.85+. Redwoods with epicormic sprouts on trunk and dead Douglas fir (to right) in the salvage logged area.

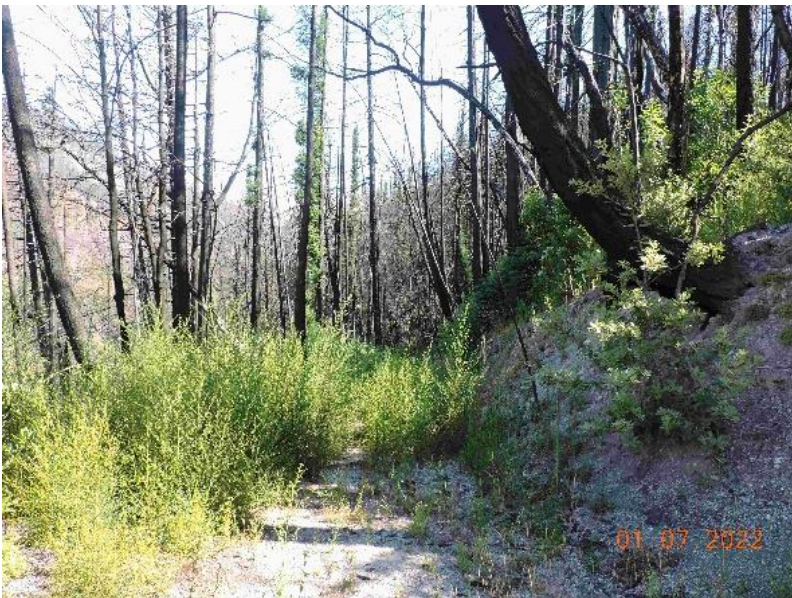
Photo 122. Bypass road, mile=2.85+. Top of unmaintained state park road down to the forks. Basal sprouts on tanbark oaks and trunk sprouts on redwoods. Road in good shape, despite lack of water bars, but with sections of dense **French** broom and blue blossom ceanothus.

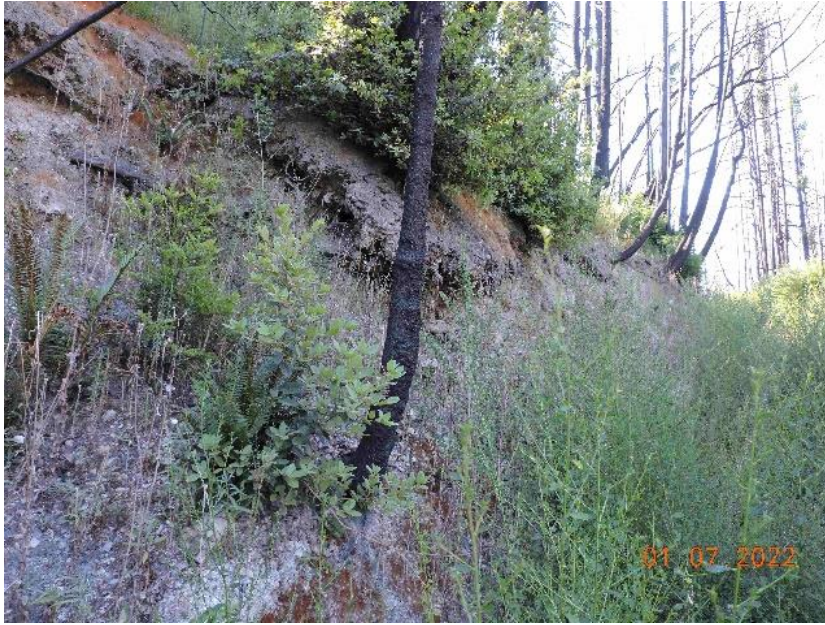
Photo 123. Bypass road, mile=2.85++. Upslope roots of tanbark oak (upper middle in photo) with dead trunk able to hold cut bank soil in place through winters of 2020-2021 and 2021-2022.

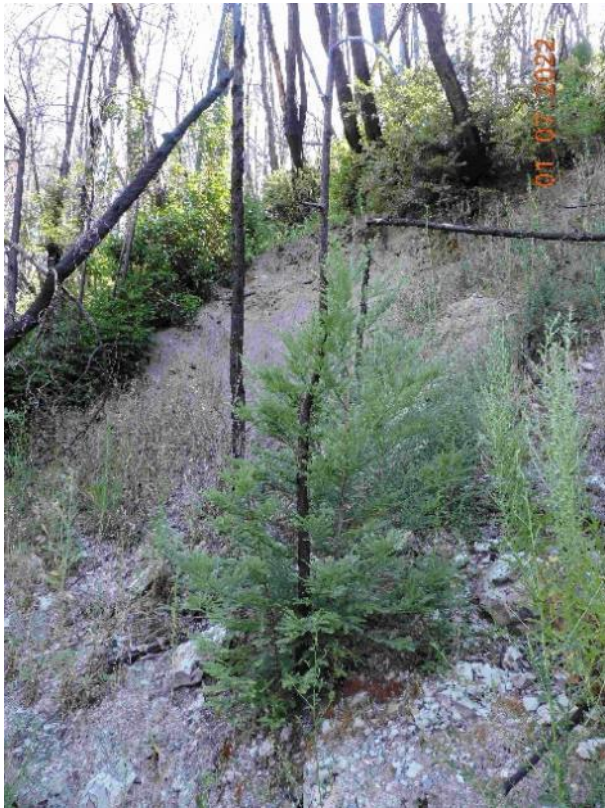
Photo 124. Bypass road, mile = 2.85++. Small redwood (<1" dia), presumed dead in 2021, but with basal sprouts. Upslope with dense tanoak trunks with vigorous basal sprouts.

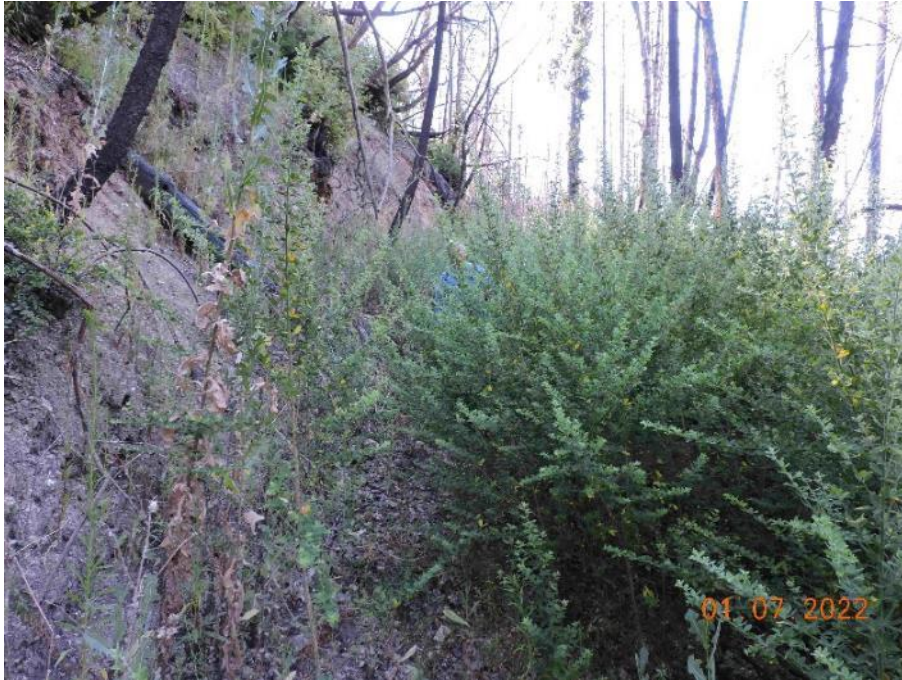
Photo 125. Bypass road, mile=2.9. Tall and dense blue blossom ceanothus and **French** broom in road. High cut bank shows no evidence of erosion.

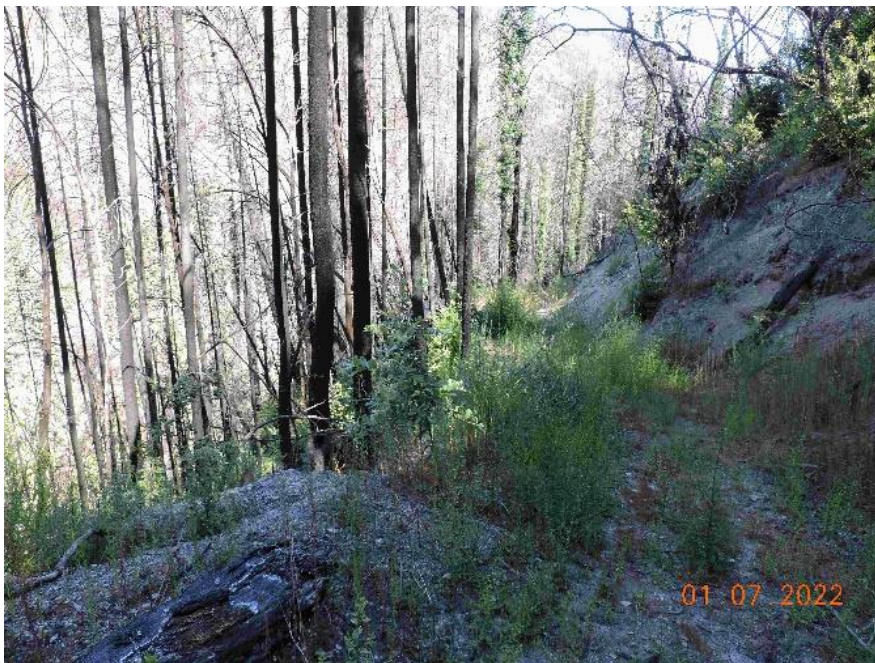
Photo 126. Bypass road, mile=2.9. Upslope tanbark oaks and downslope dead Douglas firs and tanbark oaks with basal sprouts. Remnants of fallen burned trunks located just off the road, which has sparser broom and blue blossom.

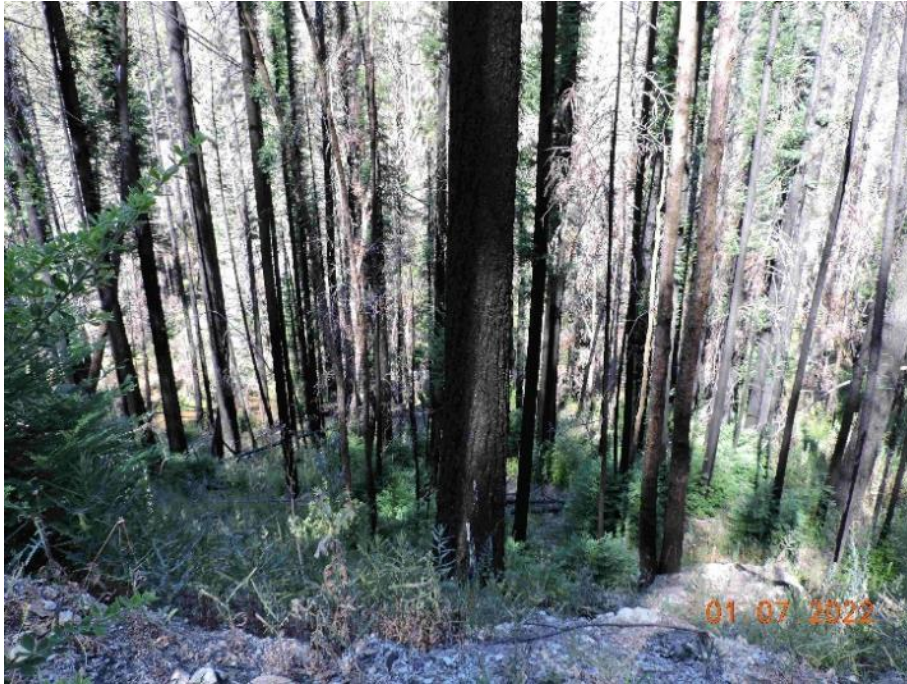
Photo 127. Bypass road, mile=2.9+. Looking downslope from road after it has descended half way to the forks. The lower slope is wetter and has more recovering redwoods.

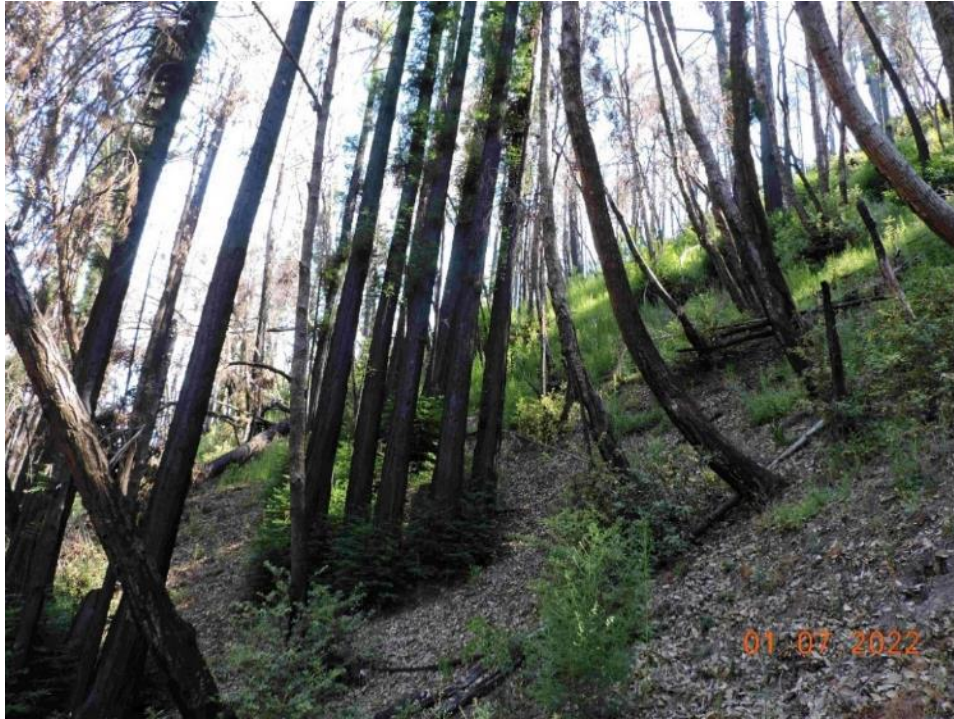
Photo 129. Bypass road, mile=2.95. Looking upslope at recovering redwoods and tan bark oaks with basal sprouts.

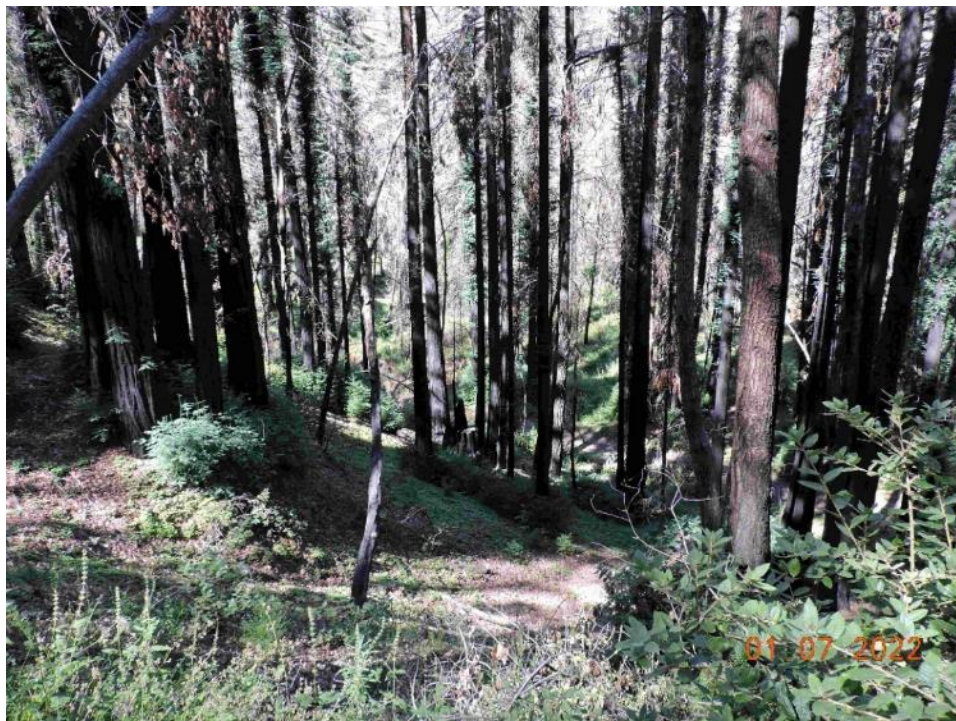
Photo 130. Bypass Road, mile = 3.05. Looking downslope near Camp Herbert, with mostly recovering redwoods with epicormic sprouts.
